Pit or Below-Grade Tank Registration or Closure

Closure Report

Seine B 6 Fee #2H
API # 30-015-35612
Eddy County, NM

Re: Drilling Pit Closure of EOG Resources – Seine B 6 Fee #2H
UL 'A' Sec. 6 T16S R25E Eddy County, NM
API # 30-015-35612

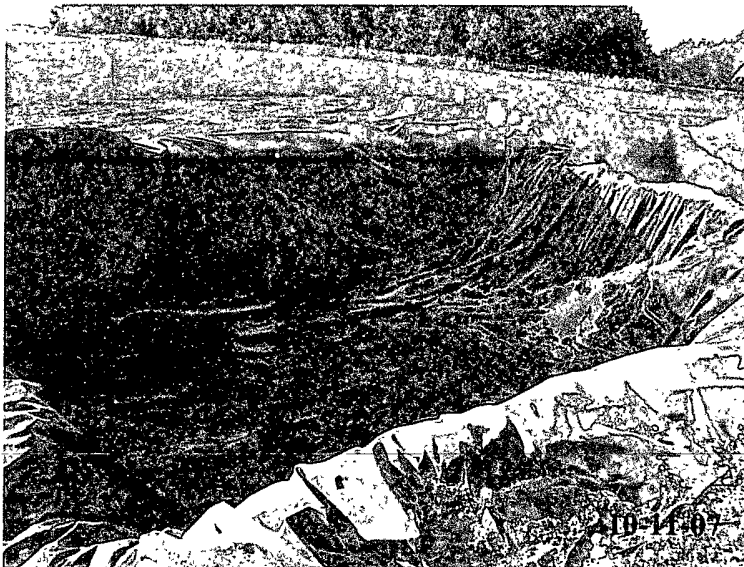
Burial pit lined with a 12 mil impervious liner.

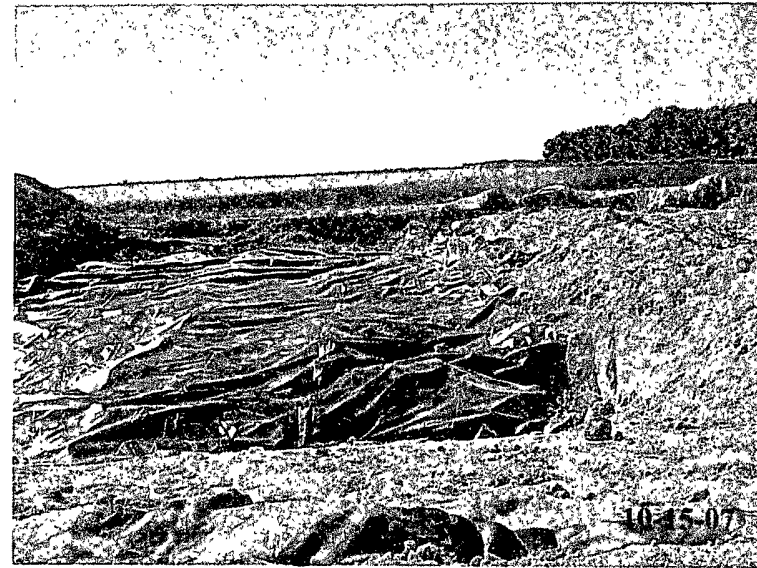
Burial pit capped with a 20 mil impervious liner.

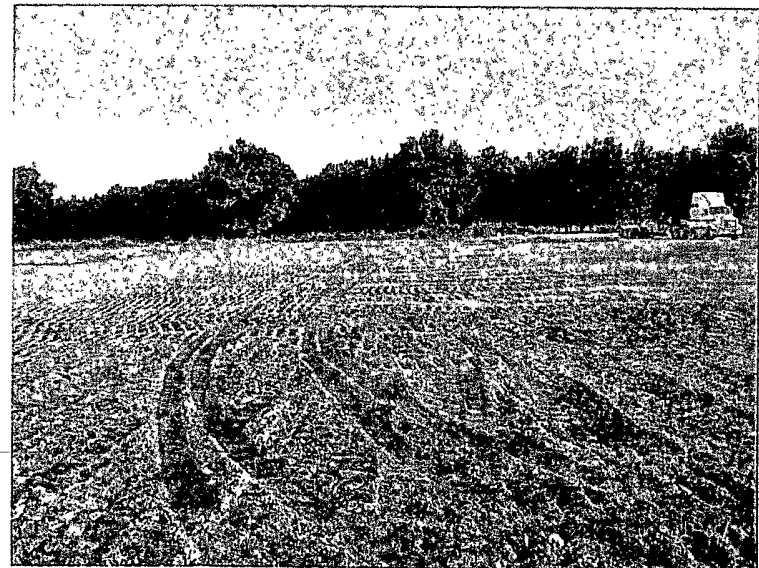
Drilling pit and burial pit after backfill and contouring.
