Re: Closure Report for J Cleo Thompson – Firefox Federal #1

Closure Report

Prepared for
J Cleo Thompson

Firefox Federal #1
API # 30-015-36206
Eddy County, NM

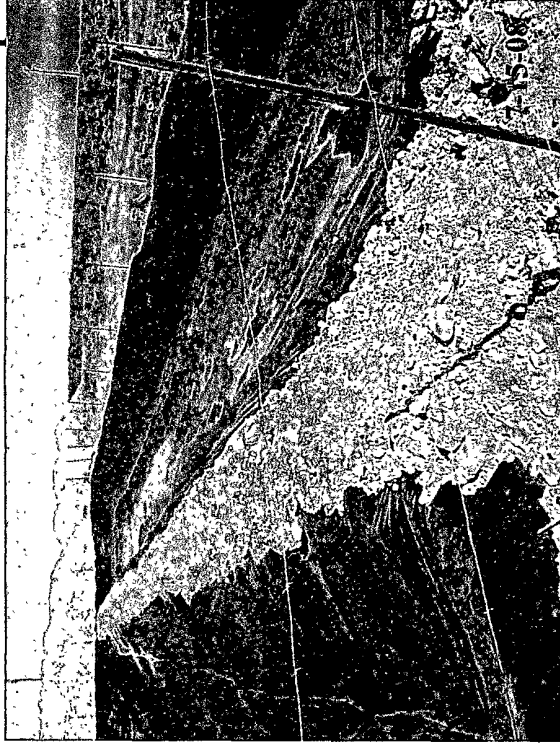
Drilling pit before closure.

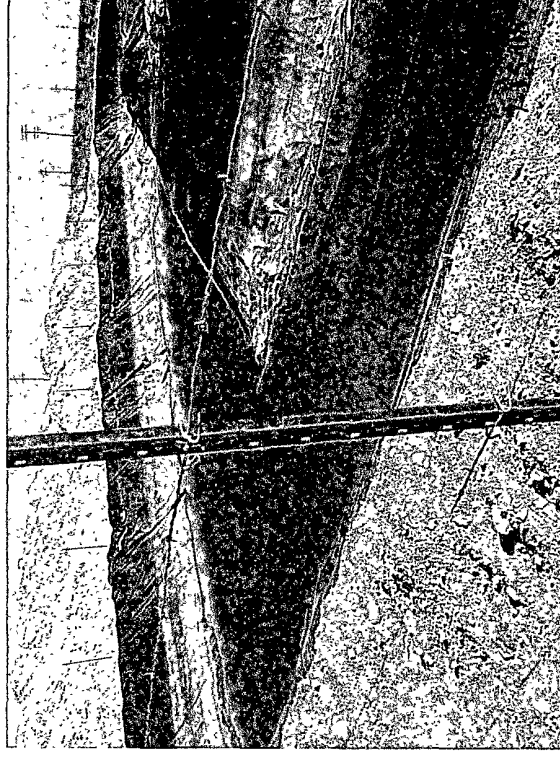
Drilling pit before closure.

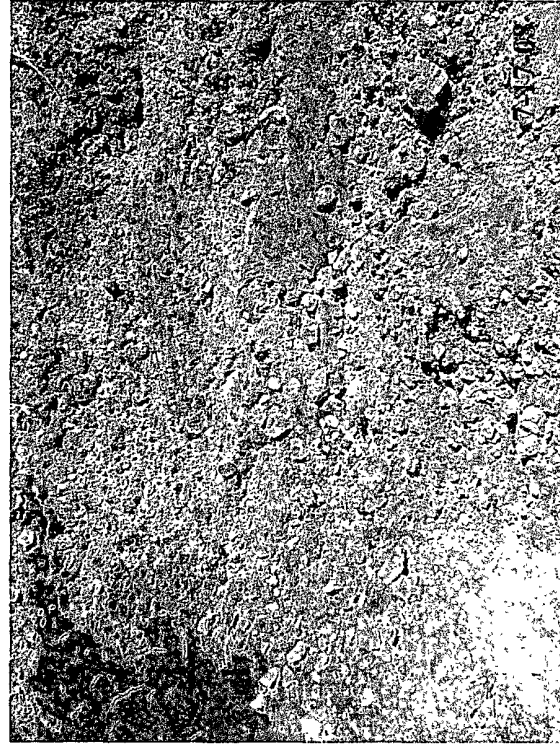
TP5 after removal of liner.

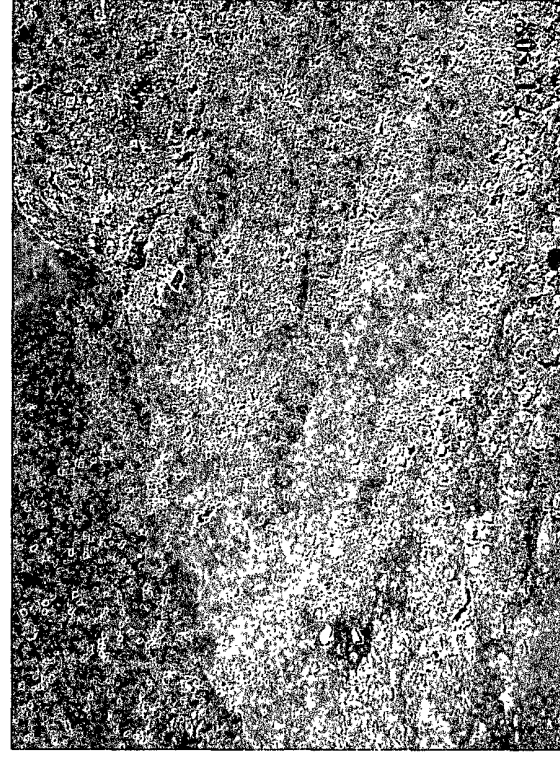
TP5 after excavation of contaminated soil.

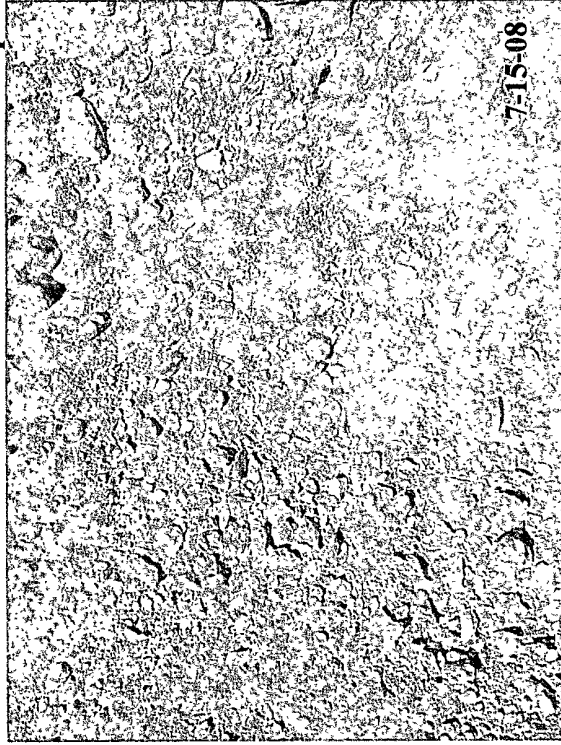
TP1 after removal of liner.

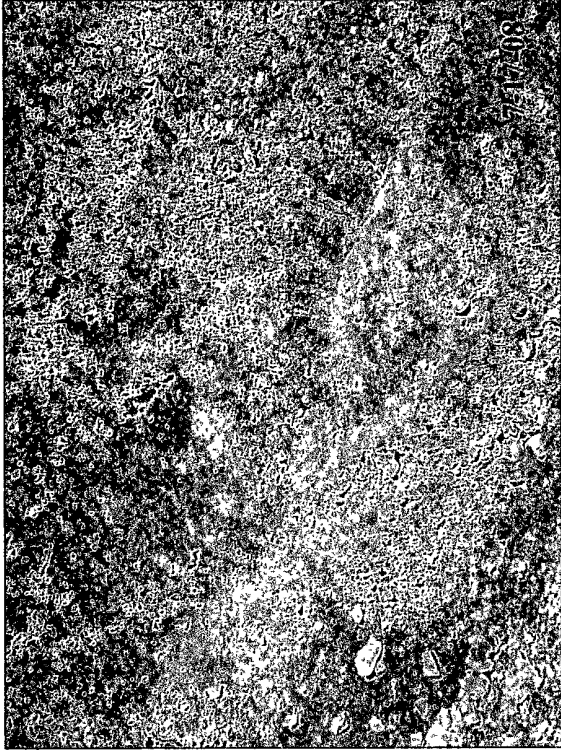
TP4 after removal of liner.

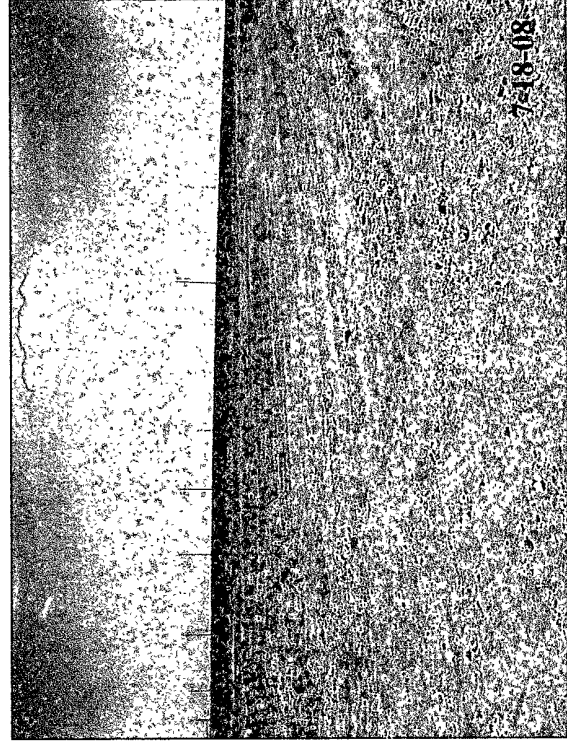
Site after backfill of clean soil and 1' of topsoil.

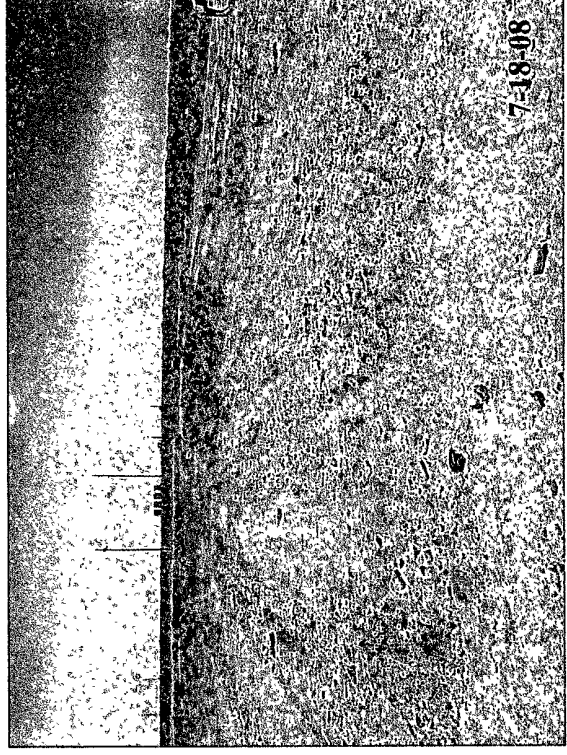
Site after backfill and seeding with BLM Seed #2.
