SUBJECT: Remediation Closure Report for the QPQASU Tank Battery #1 Release (1RP-5122), Lea County, New Mexico

On behalf of Mewbourne Oil Company, Souder, Miller & Associates (SMA) has prepared this Remediation Closure Report that describes the remediation of a release of liquids related to oil and gas production activities at the QPQASU Tank Battery #1 site. The site is in Unit M, Section 23, Township 18S, Range 32E, Lea County, New Mexico, on Federal land. Figure 1 illustrates the vicinity and site location on an USGS 7.5-minute quadrangle map.

Regional Vicinity & Wellhead Protection Map
QPQASU Tank Battery #1- Mewbourne

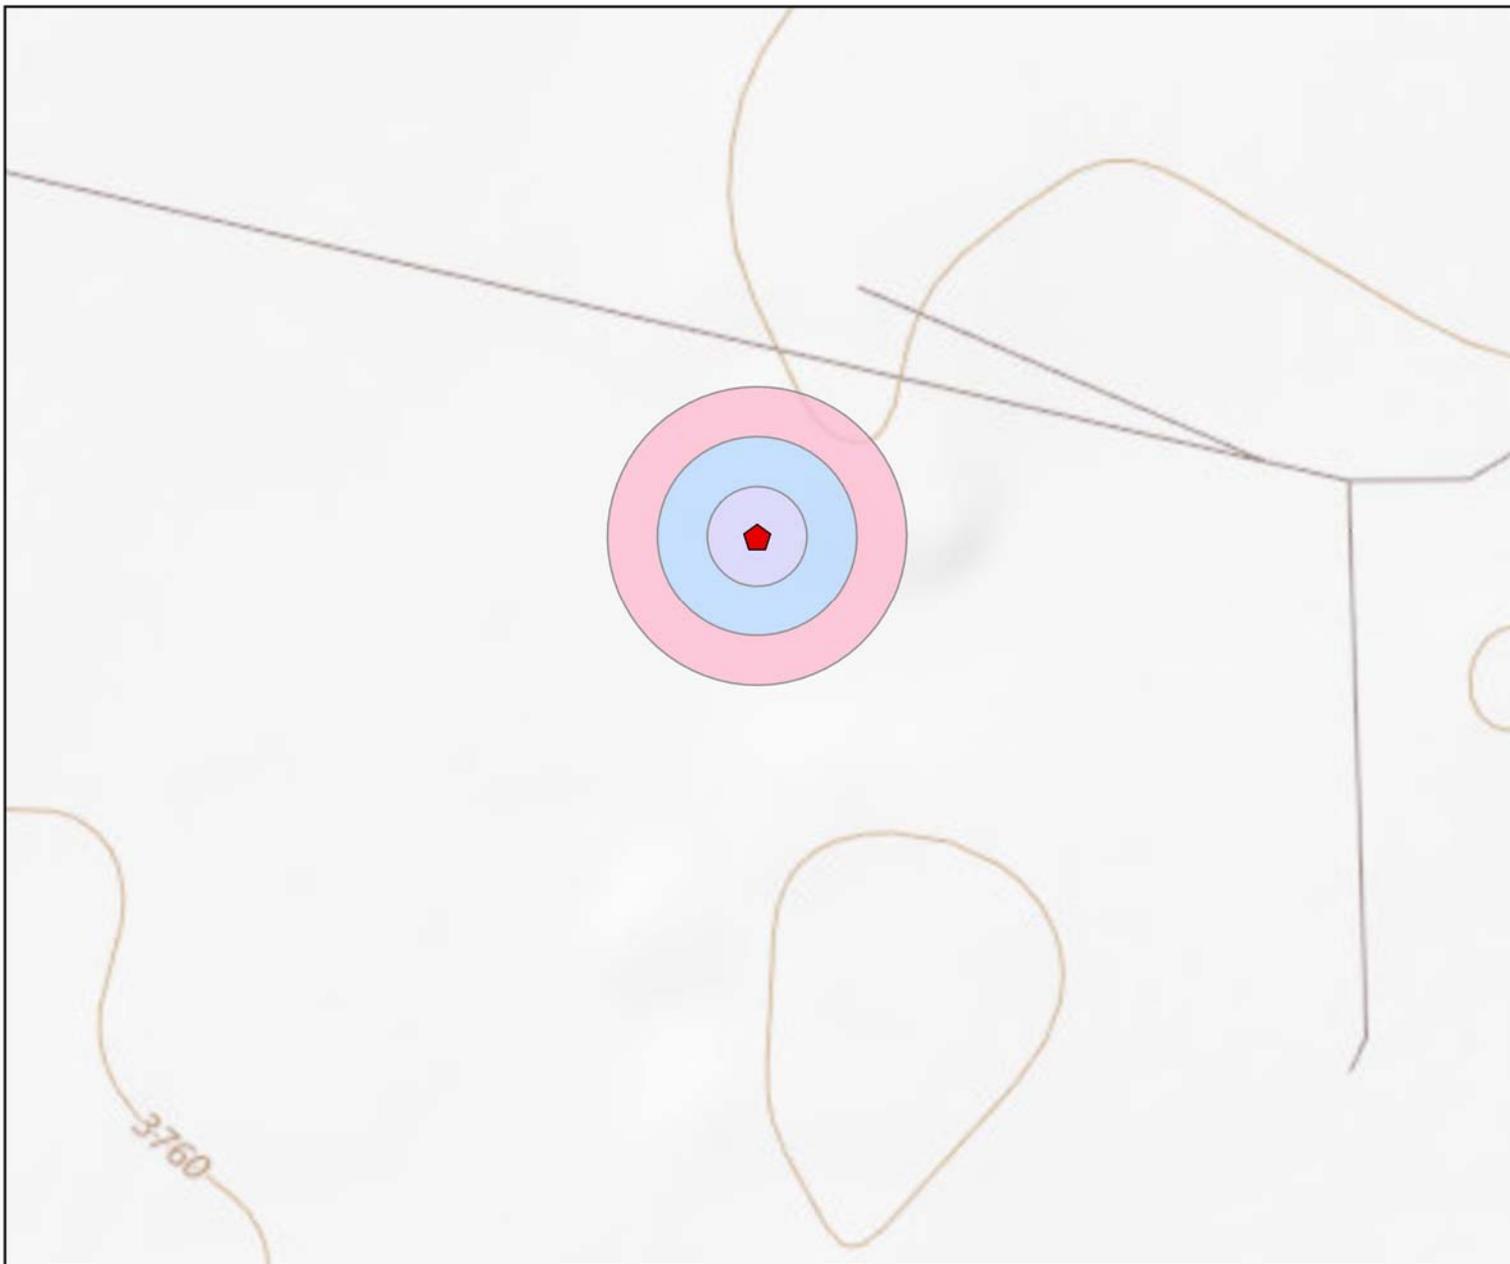
Figure 2

Surface Water Protection Map
 QPQASU Tank Battery #1- Mewbourne
 Lea County, NM

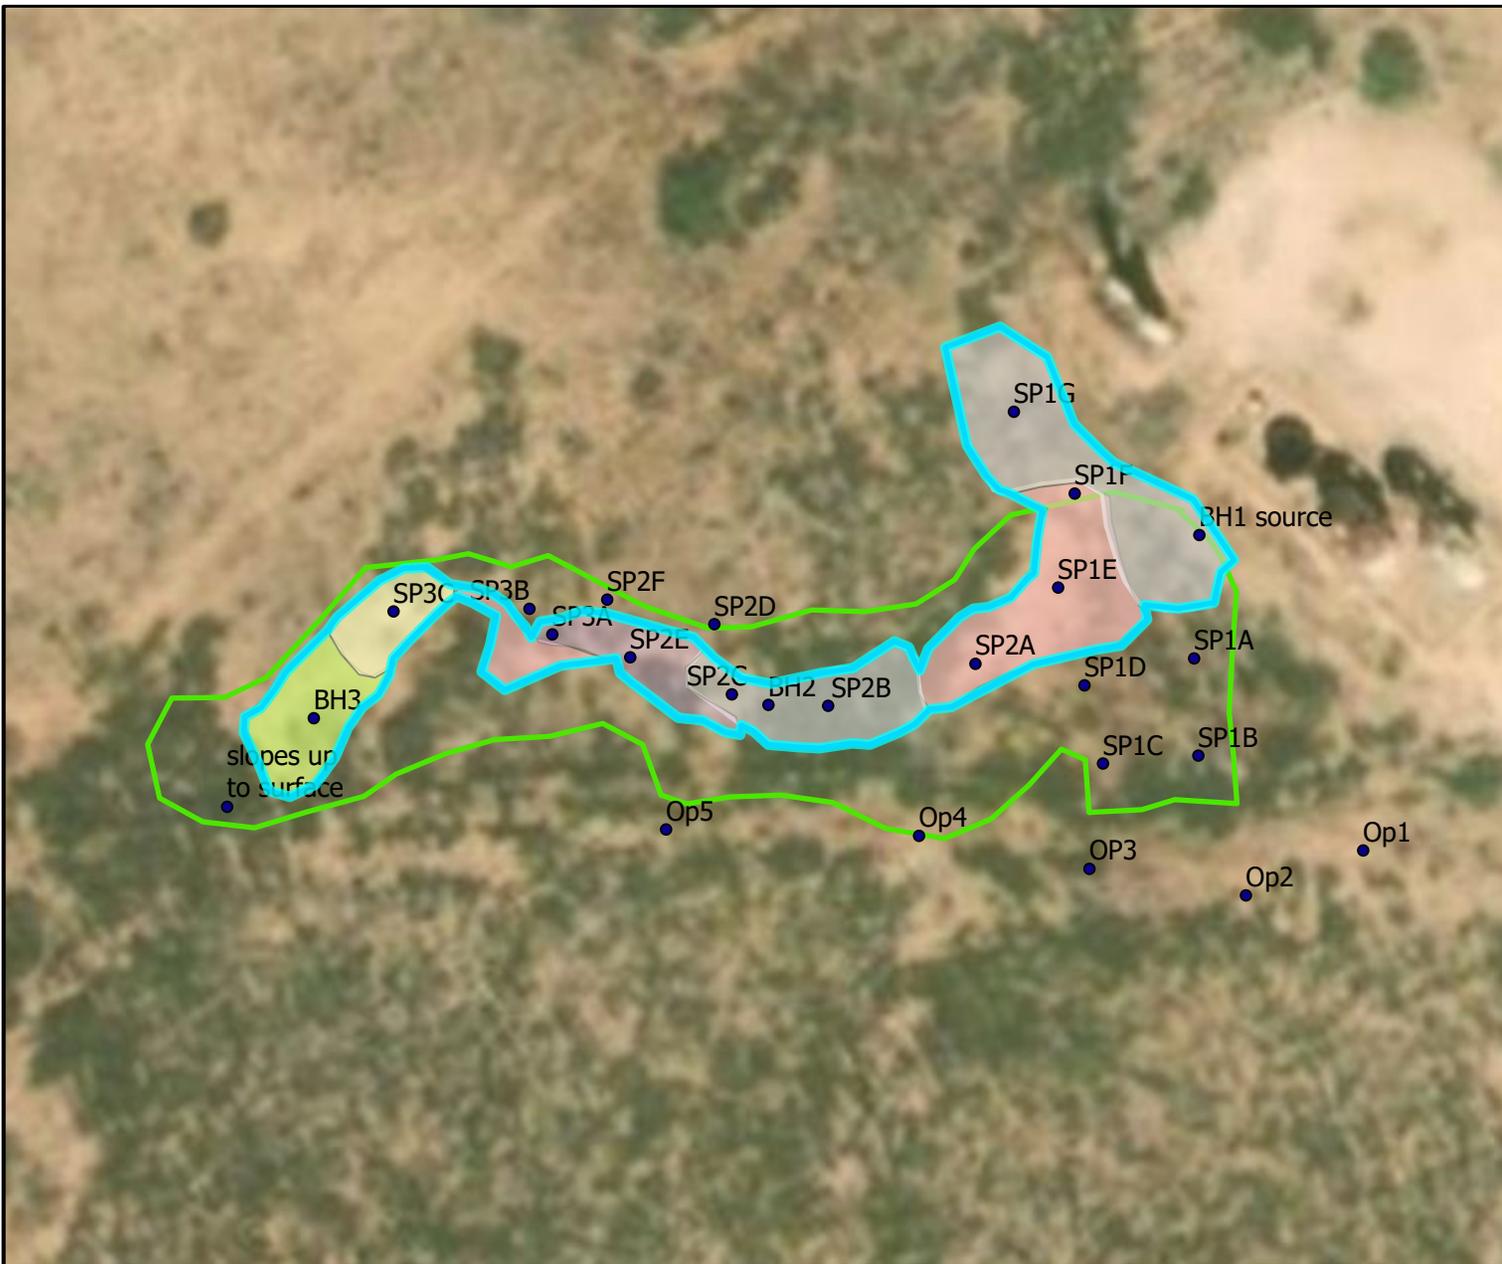
Figure 3A

A total of 29 samples were collected for laboratory analysis for total chloride using EPA Method 300.0; benzene, toluene, ethylbenzene and total xylenes (BTEX) using EPA Method 8021B; and motor, diesel and gasoline range organics (MRO, DRO, and GRO) by EPA Method 8015D. Table 3A itemizes the samples and field-screening results as well as identifying any variances from the typical specification of two samples per boring. Locations for all samples are depicted on Figure 3A.

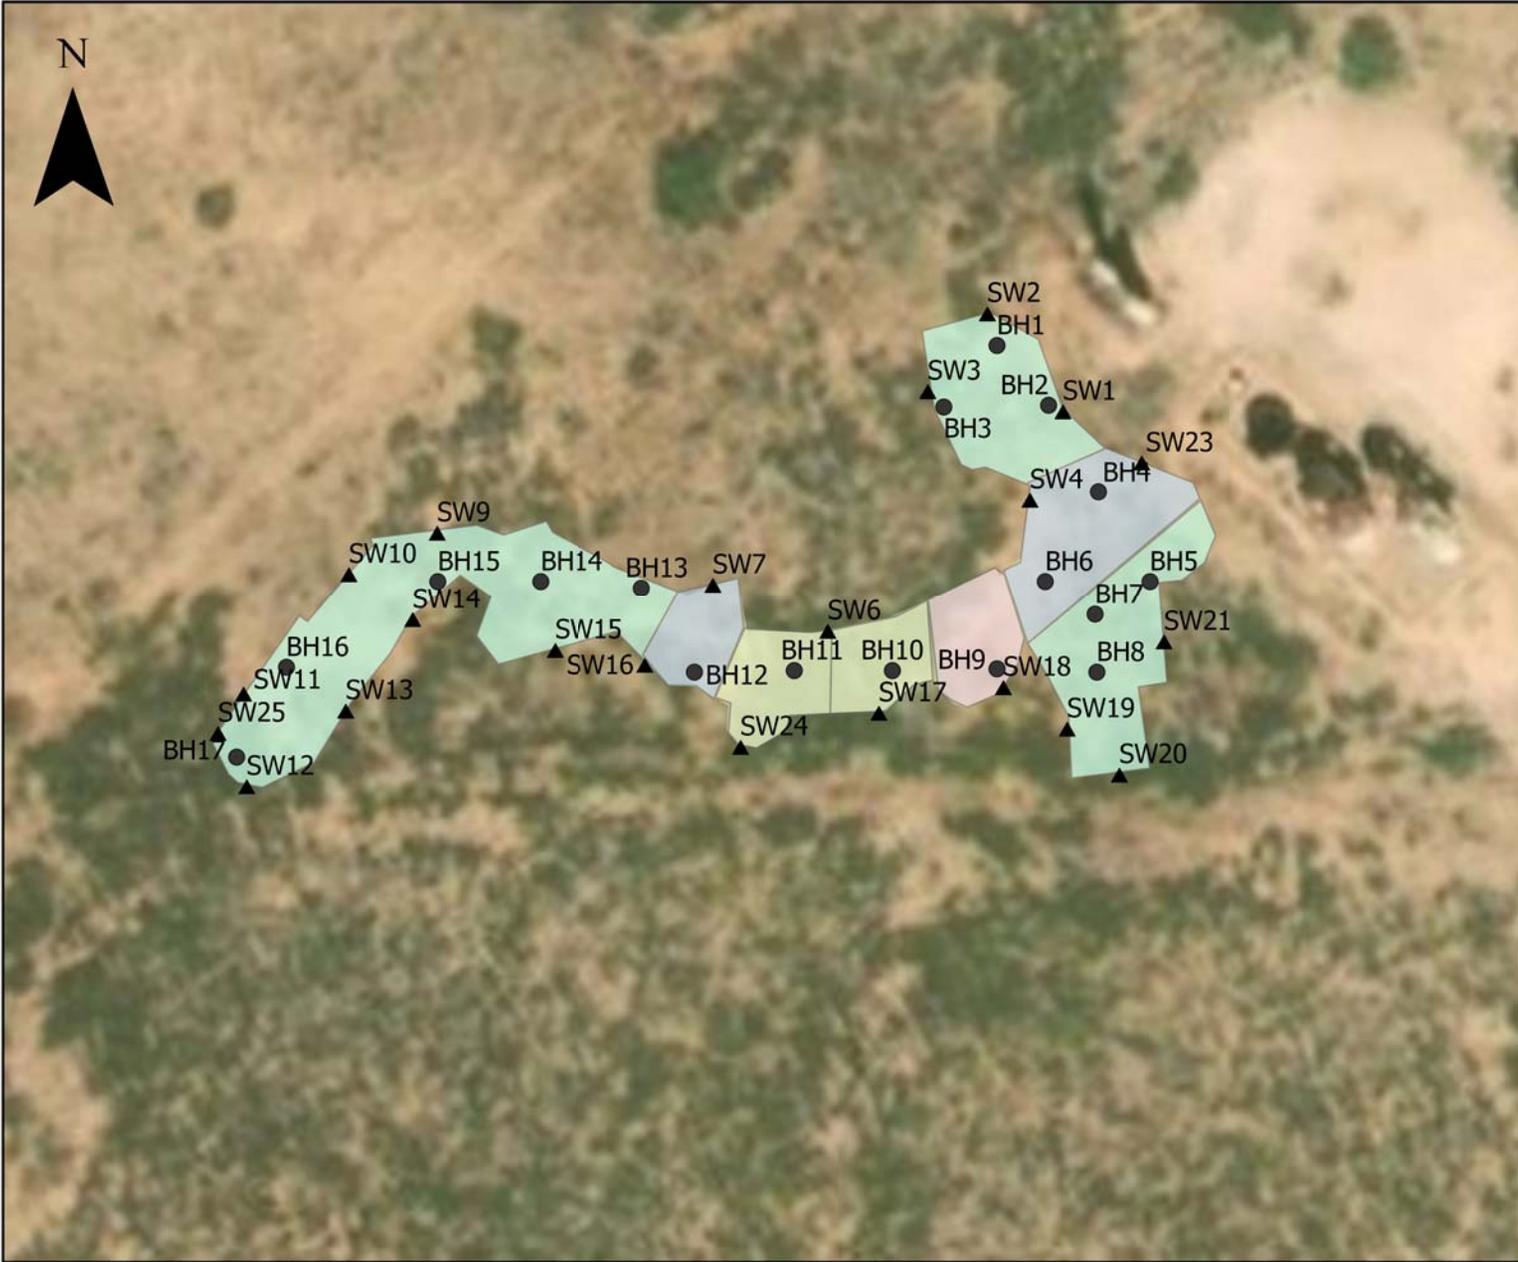
The release area was excavated to depths ranging from 4 to 10 feet bgs. The confirmation samples were collected from within the excavation in accordance with a systematic sampling approach as defined by SW846 using Gilbert, 1987 equation 5.2.3 for Stratified Random Sampling which is detailed in Appendix C. This systematic method meets the EPA's data quality assessment standards (DQA) for composite sampling as defined by (Myers 1997). Confirmation samples were comprised of five-point composites of the base (BH1-B17) and walls (SW1-SW25).

Figure 3 shows the extent of the excavation and sample locations. All field screening and laboratory results are summarized in Table 3. Laboratory reports are included in Appendix D.

Site and Sample location Map
QPQASU Tank Battery #1-Mewbourne

Results demonstrate that the release has been remediated to the Closure Criteria standards in all locations except the eastern sidewall, which borders the QPQASU tank battery location, represented by sample SW23. SMA and Mewbourne are requesting a deferment until site abandonment for this location, as it directly borders multiple pipelines and cannot be further advanced due to health and human safety concerns.

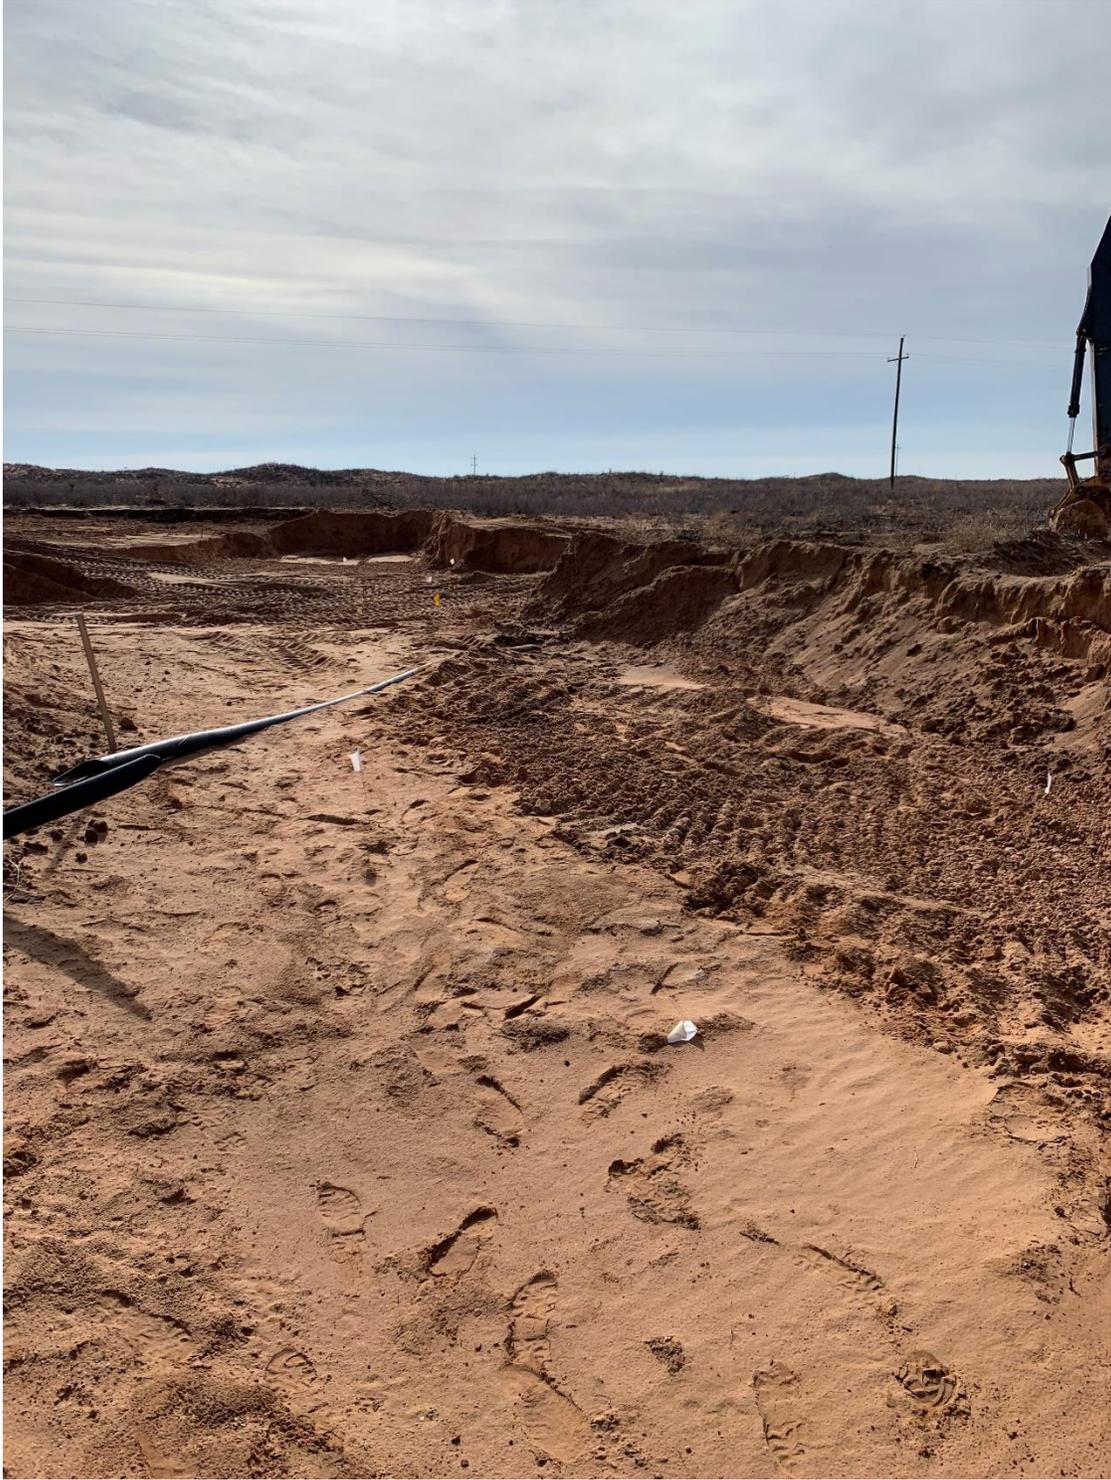
Photo 1: Standing at BH6 looking Southwest.

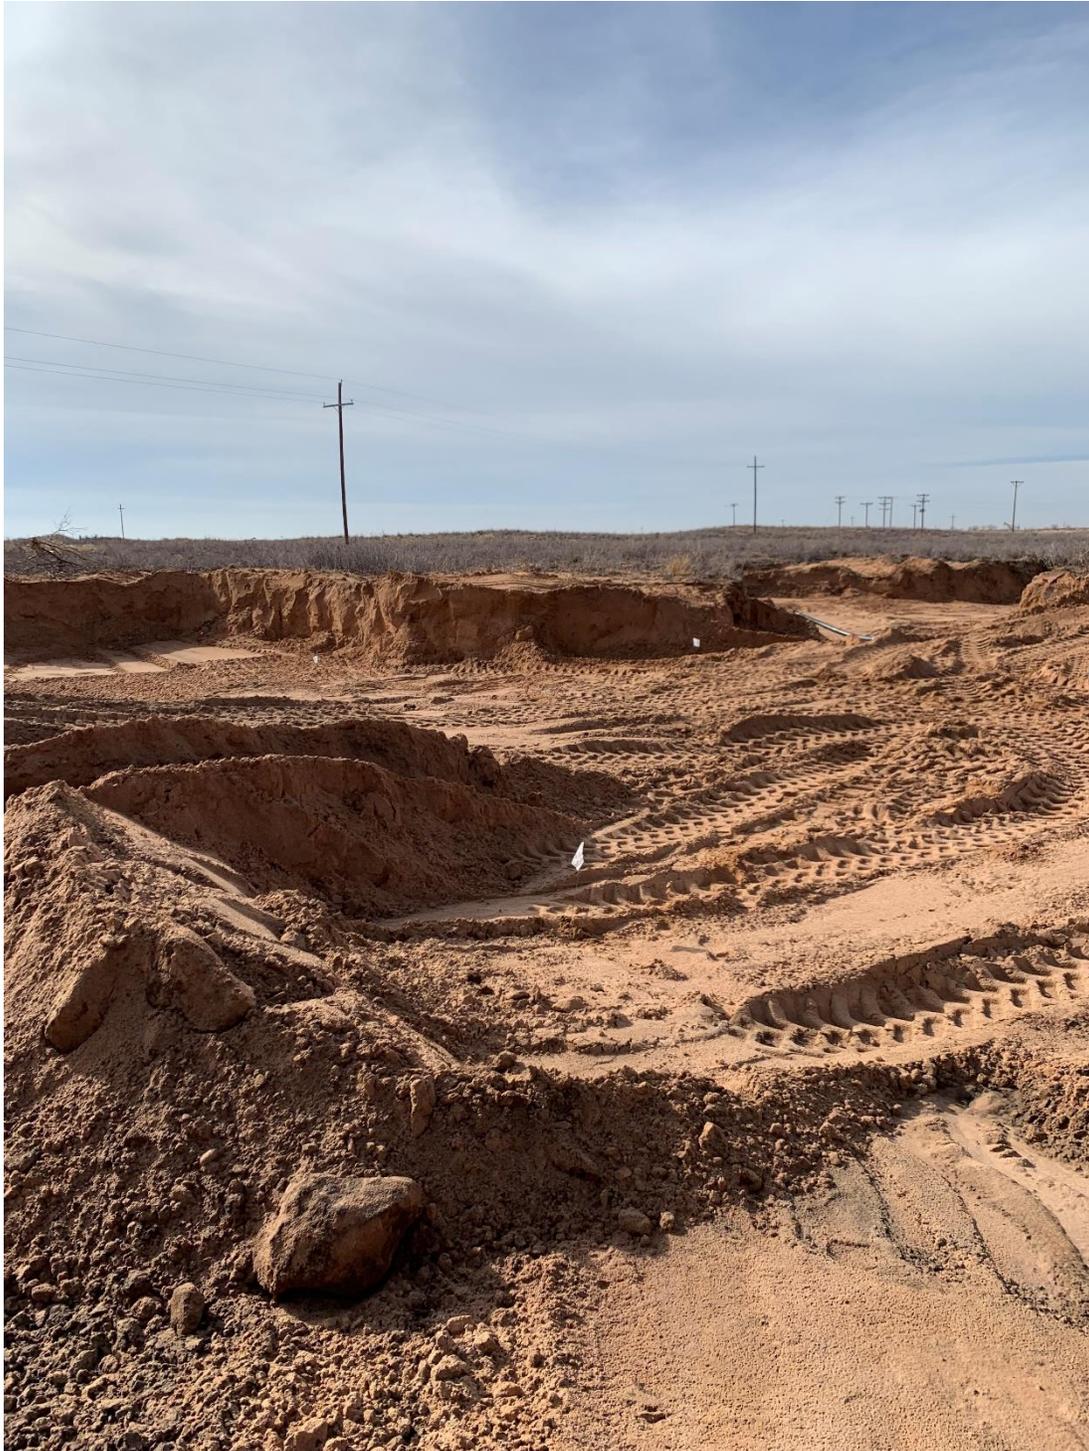
Photo 2: At BH2 looking Southeast.

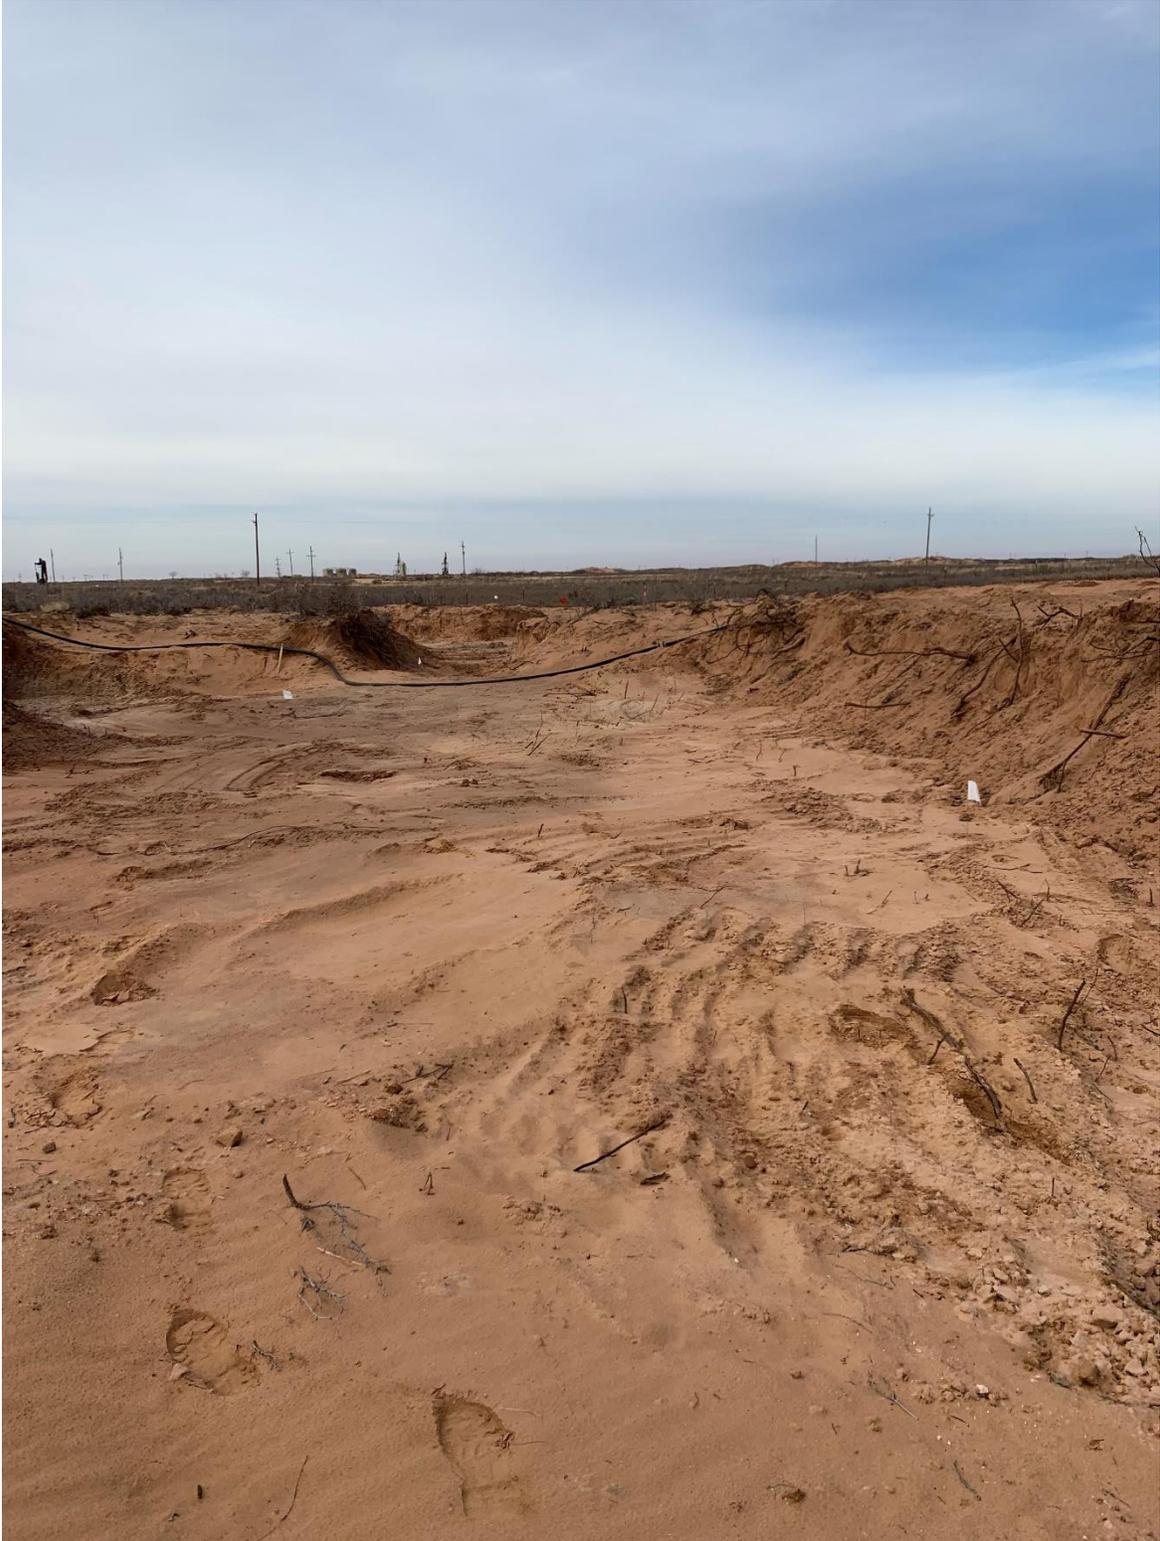
Photo 3: Standing at BH 1 looking West.
