State of New Mexico
Energy Minerals and Natural Resources
Department
Oil Conservation Division
1220 South St. Francis Dr.
Santa Fe, NM 87505

Recycling Facility and/or Recycling Containment

Facility or well name (include API# if associated with a well): Rincon Unit 2706-290

PROJECT DESCRIPTION:
RINCON RECYCLING PIT

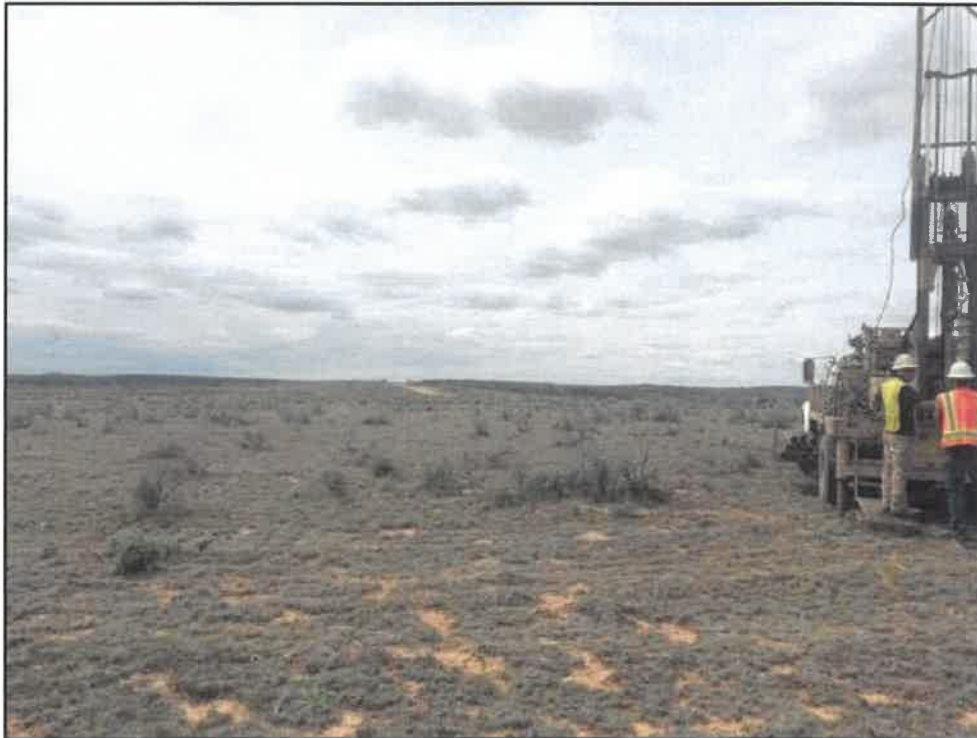
The RNU 2706-290 WRF site is located approximately 30 miles southeast of Bloomfield, New Mexico in Largo Wash. The ground surface across the site of the proposed pond was relatively flat with a slight gradient towards the east. An elevation change of approximately 7 feet occurs from the highest point in the northwest corner of the site to the lowest at the southeast corner of the site. The site had a sparse vegetation of weeds and sagebrush at the time of our exploration. No evidence of prior structural development was noted at the site. The photo below depicts the site conditions at the time of our exploration.

Drill Rig at Boring B-3
View toward the South

All borings were advanced using a CME-55 truck-mounted drill rig with continuous-flight, 7.25-inch O.D. hollow-stem auger. The borings were continuously monitored by a geologist from our office who examined and classified the subsurface materials encountered, obtained representative samples, observed groundwater conditions, and maintained a continuous log of each boring.

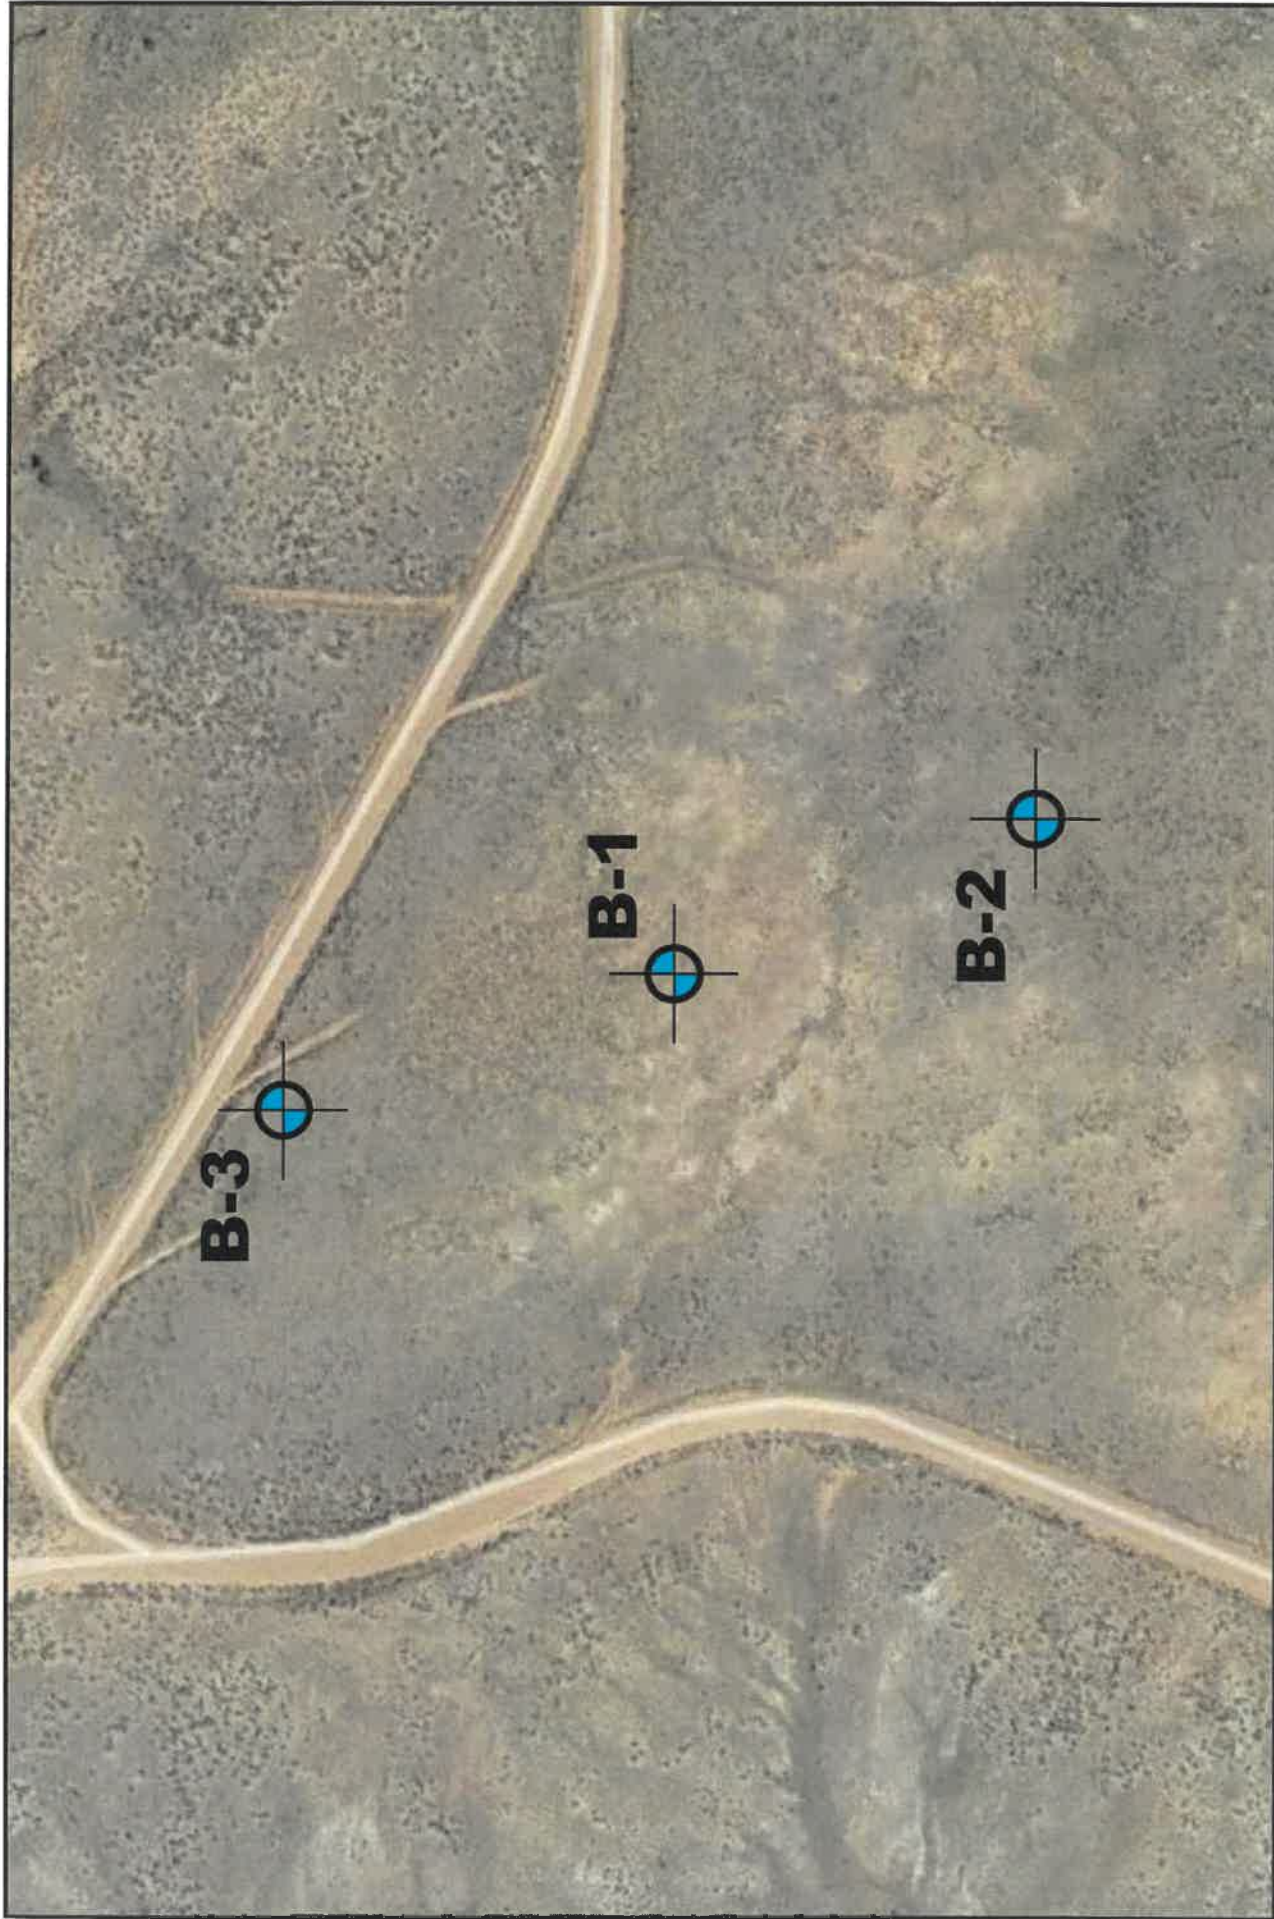
GEOMAT ^{INC.}		PROJECT	
		Rincon Fracking Water Pond III Enduring Resources Rio Arriba County, New Mexico	
SITE PLAN		Boring Locations (approximate)	
		GEOMAT Project No. 192-3247 Date of Exploration: April 24 & 29, 2019	
  Approximate Not to Scale

Subsurface conditions at the Rincon III site were explored over the period April 24 through April 30, 2019 by drilling three exploratory borings, designated B-1 through B-3, at the approximate locations shown on the Site Plan in Appendix A. Boring B-1, was advanced to a depth of approximately 85 feet below existing ground surface (bgs), while borings B-2 and B-3 were drilled to depths of approximately 35 feet bgs.

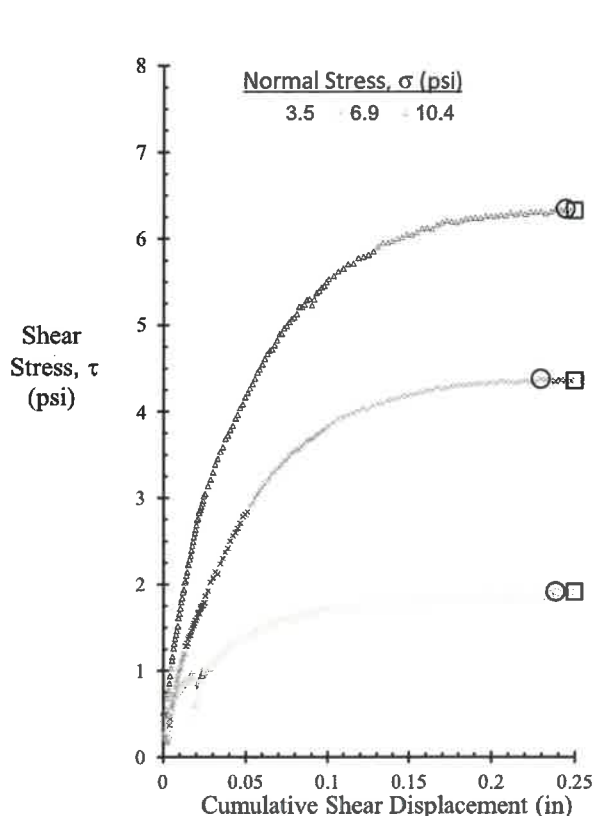
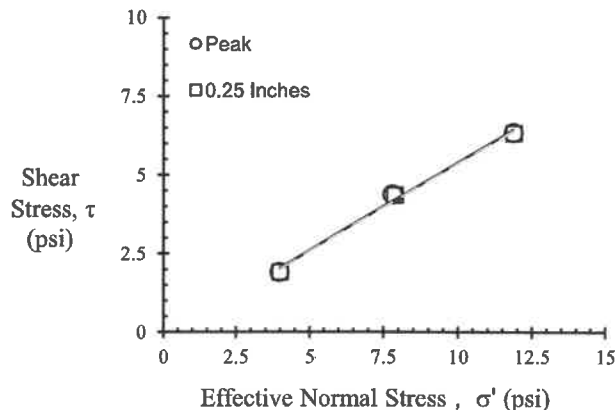
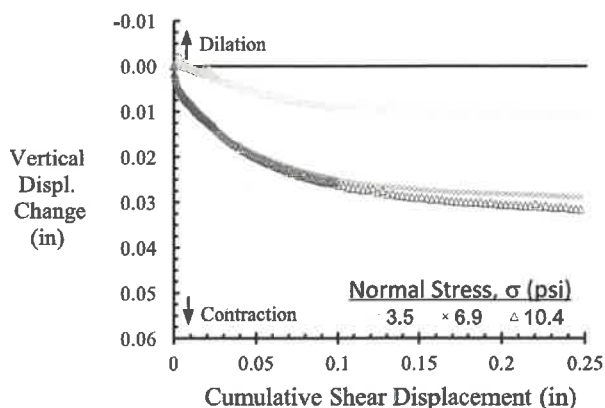
Client: GEOMAT Inc.
 Project: Rincon III
 Sample: Rincon III B3 (10.0-20.0)

TRI Log#: 46478.2
 Test Method: ASTM D3080

Note: The soil was air dried and passed through a No. 8 sieve to eliminate any over sized particles. The soil was moisture conditioned, allowed to equilibrate, and then adjusted according to the target gravimetric moisture content of 16.0% based on an oven dried moisture content. The specimen was then remolded into a known volume to achieve the target dry density of 104.0 pcf. A specific gravity of 2.75 was assumed for weight-volume calculations.

Specimen Number		1	2	3
Initial Condition	Diameter, in	2.50	2.50	2.50
	Height, in (before consol)	1.00	1.00	1.00
	Water Content, %	16.0	16.0	16.0
	Saturation, %	68.1	67.7	68.0
	Dry Density, pcf	104.3	104.0	104.2
	Void Ratio	0.65	0.65	0.65
Consolidation Stress, σ' (psi)		3.5	6.9	10.4
Post-Consol	Height, in (prior to shear)	1.01	1.02	1.06
	Dry Density, pcf	103.0	101.9	98.5
	Void Ratio	0.65	0.67	0.73
Displacement rate (in/min)		3.0E-04		
Final Water Content, %		31.9	28.0	27.1
Peak	Normal Stress, σ' (psi)	3.98	7.81	11.88
	Shear Stress, τ (psi)	1.91	4.38	6.35
	Secant Friction Angle, Degrees	25.7	29.3	28.1
	Displacement (in)	0.24	0.23	0.24
	ϕ'_d , degrees	28.3		
	c'_d , psi	0 (Forced)		
0.25 Inches	Normal Stress, σ' (psi)	4.00	7.89	11.90
	Shear Stress, τ (psi)	1.91	4.36	6.33
	Secant Friction Angle, Degrees	25.5	28.9	28.0
	ϕ'_d , degrees	28.1		
	c'_d , psi	0 (Forced)

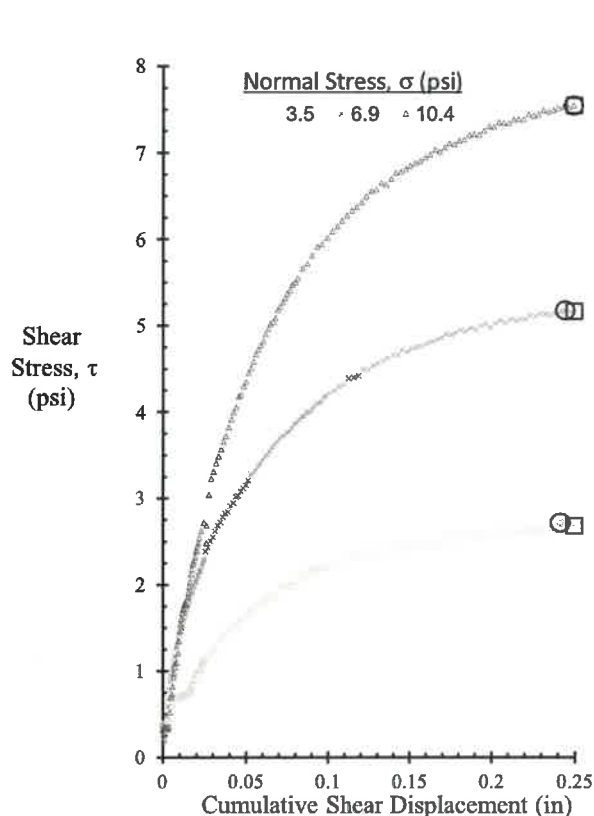
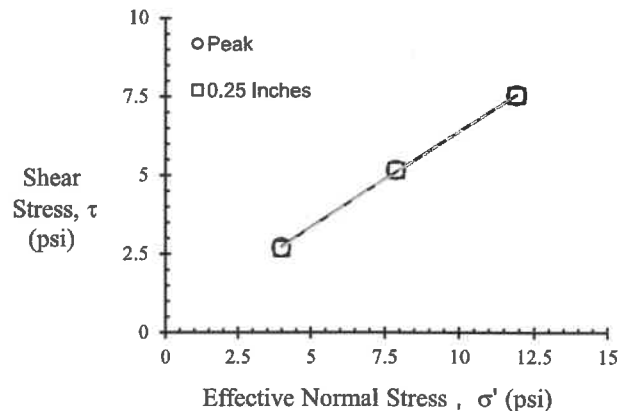
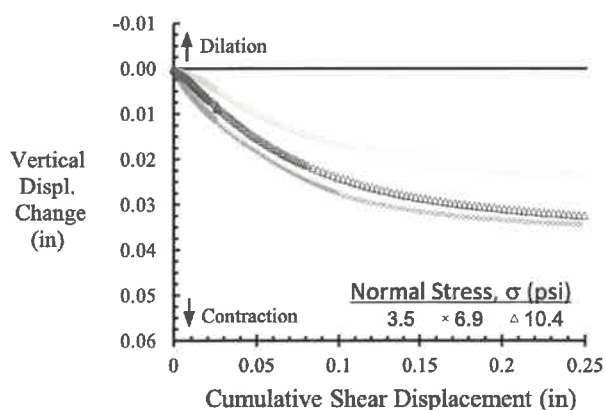
Client: GEOMAT Inc.
 Project: Rincon III
 Sample: Rincon III B3 High Side (0.0-15.0)

TRI Log#: 46478.1
 Test Method: ASTM D3080

Note: The soil was air dried and passed through a No. 8 sieve to eliminate any over sized particles. The soil was moisture conditioned, allowed to equilibrate, and then adjusted according to the target gravimetric moisture content of 16.0% based on an oven dried moisture content. The specimen was then remolded into a known volume to achieve the target dry density of 104.0 pcf. A specific gravity of 2.75 was assumed for weight-volume calculations.

Specimen Number		1	2	3
Initial Condition	Diameter, in	2.50	2.50	2.50
	Height, in (before consol)	1.00	1.00	1.00
	Water Content, %	16.1	16.1	16.1
	Saturation, %	68.4	67.6	67.5
	Dry Density, pcf	104.2	103.7	103.6
	Void Ratio	0.65	0.66	0.66
Consolidation Stress, σ' (psi)		3.5	6.9	10.4
Post-Consol	Height, in (prior to shear)	0.97	0.94	0.92
	Dry Density, pcf	107.1	109.7	112.5
	Void Ratio	0.59	0.55	0.51
Displacement rate (in/min)		3.0E-03		
Final Water Content, %		24.0	28.9	24.3
Peak	Normal Stress, σ' (psi)	3.99	7.88	11.91
	Shear Stress, τ (psi)	2.71	5.17	7.54
	Secant Friction Angle, Degrees	34.2	33.3	32.3
	Displacement (in)	0.24	0.24	0.25
	ϕ'_d , degrees	31.4		
	c'_d , psi	0.3		
0.25 Inches	Normal Stress, σ' (psi)	4.00	7.89	11.91
	Shear Stress, τ (psi)	2.67	5.16	7.54
	Secant Friction Angle, Degrees	33.7	33.2	32.3
	ϕ'_d , degrees	31.6		
	c'_d , psi	0.2

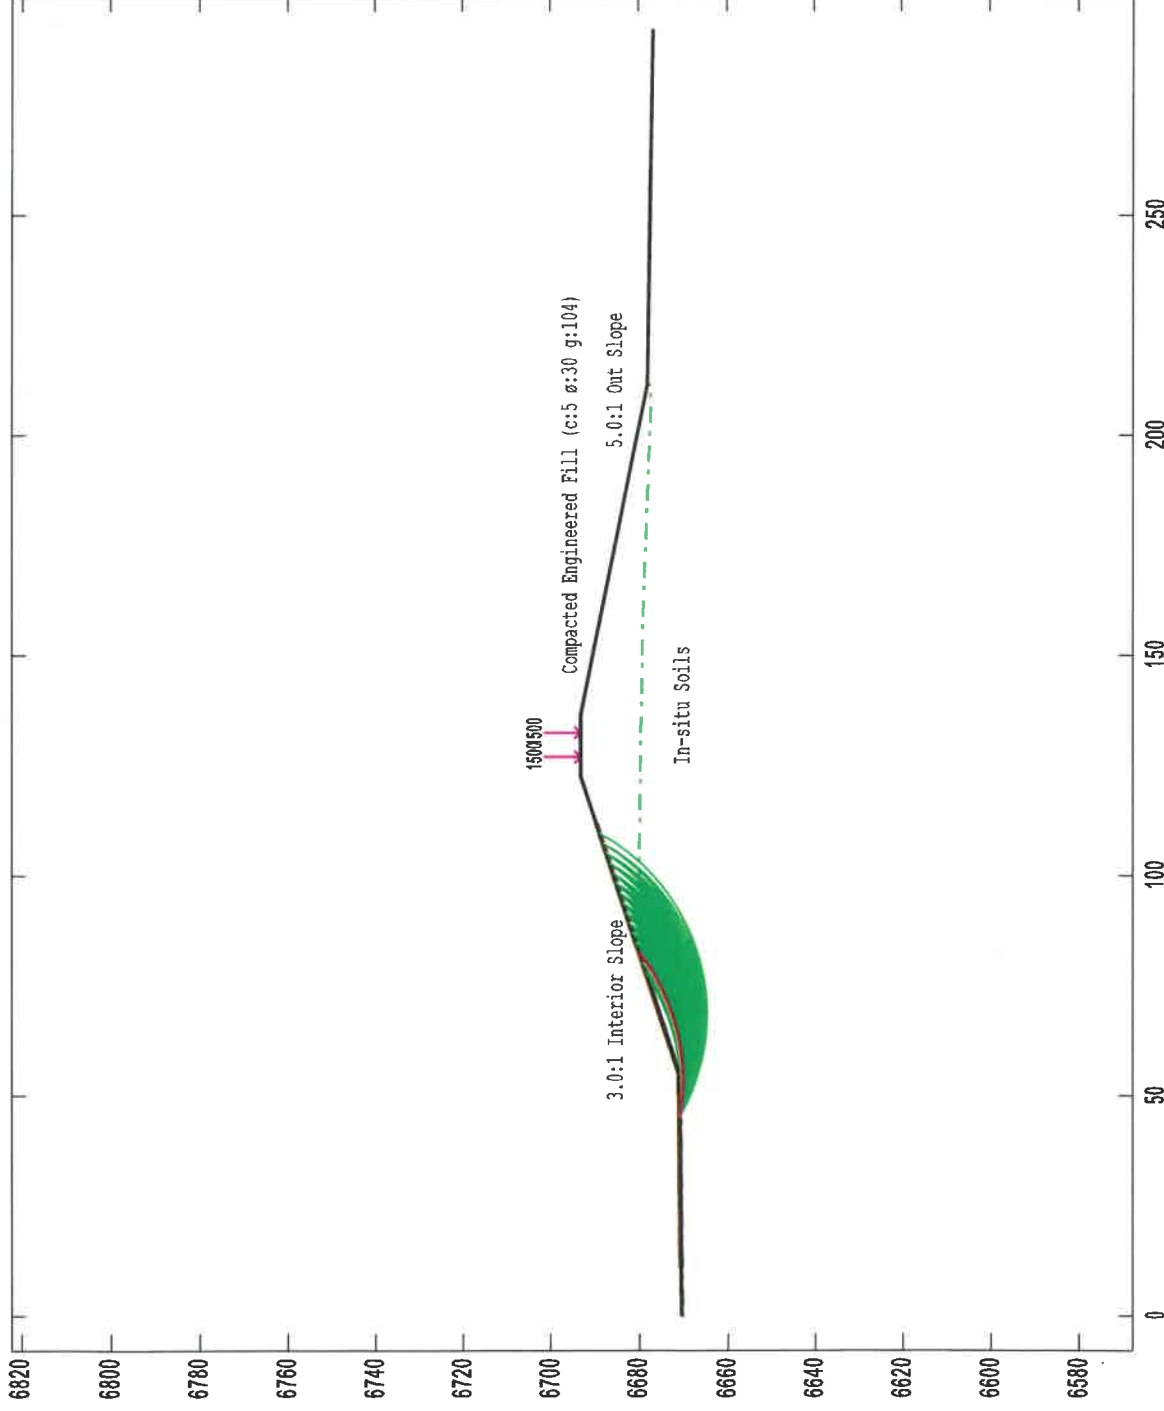
Project 192-3247 Rincon III Pond INSIDE Berm

Enduring Rincon Pond - 3.0:1 INSIDE

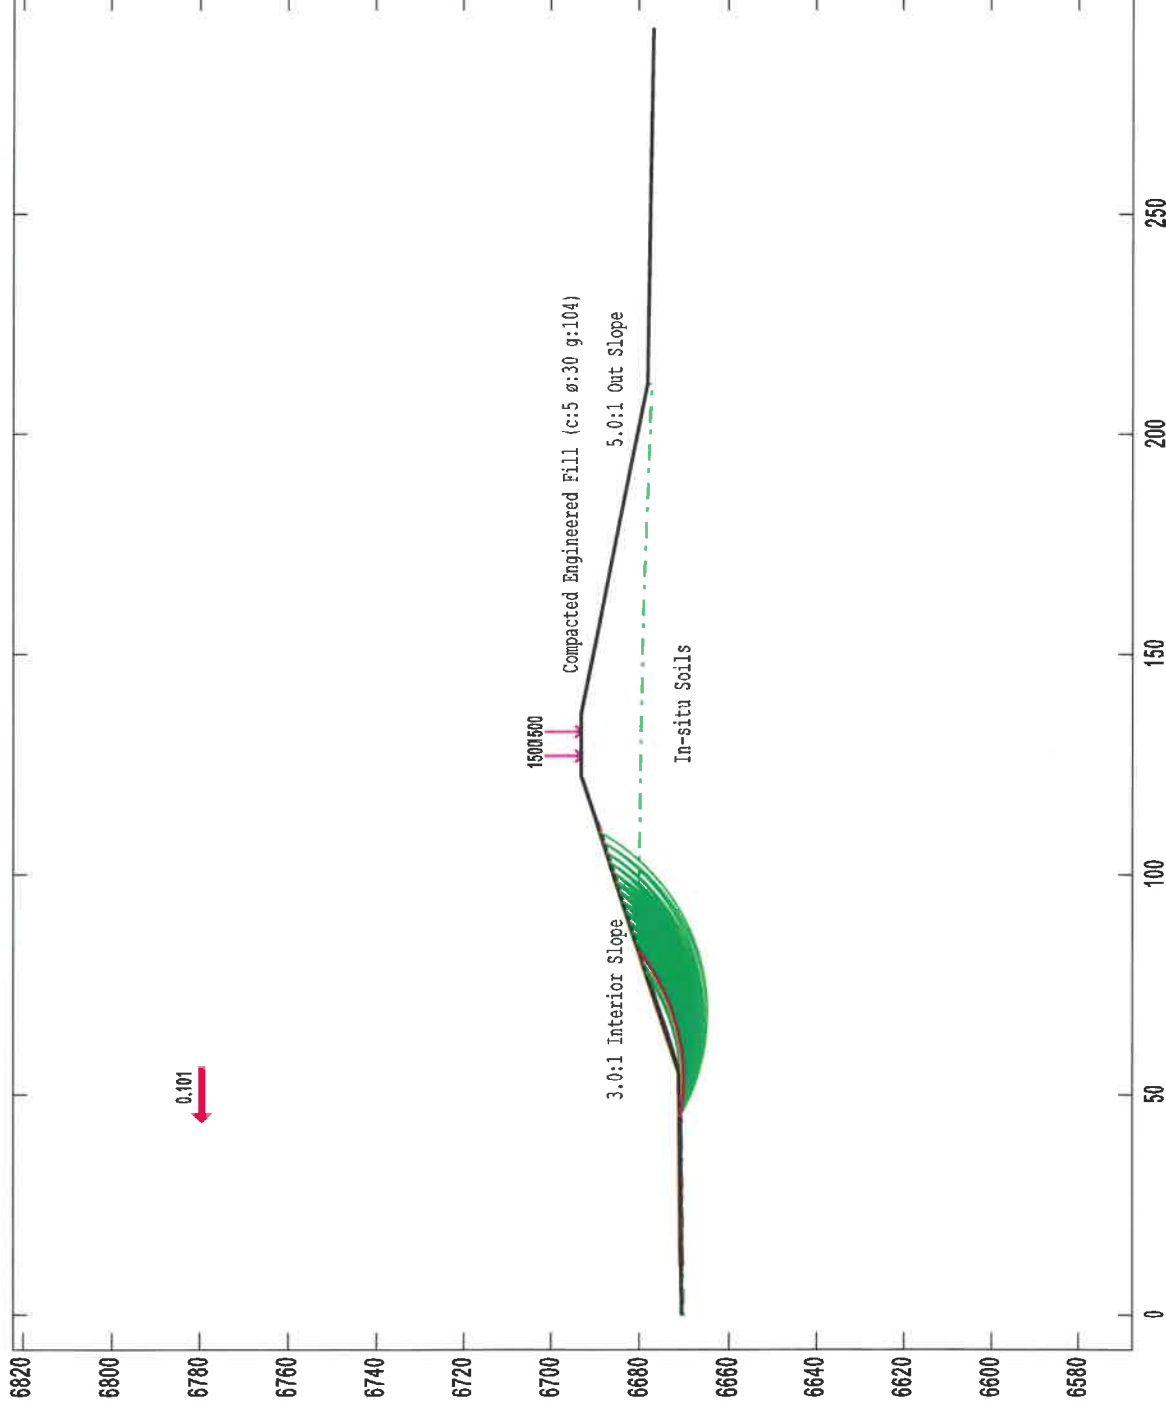
Project 192-3247 Rincon III Pond INSIDE Berm

Enduring Rincon Pond - 3.0:1 INSIDE w/Seismic
