## Release Notification

Site Name: Rosa Unit 312	Site Type: Wellsite
Date Release Discovered: 9/6/19	API# (if applicable) 30-039-25058

Re: nCS1929540332  
Rosa Unit 312 Remediation Activity  
30-039-25058  
SEC. 28, T31N AND R04W  
Rio Arriba County, NM

LOGOS Operating, LLC – Rosa Unit 312  
API 30-039-25058  
Scaled Site Map  
Unit L, Section 28, T31N, R4W  
Rio Arriba County, NM

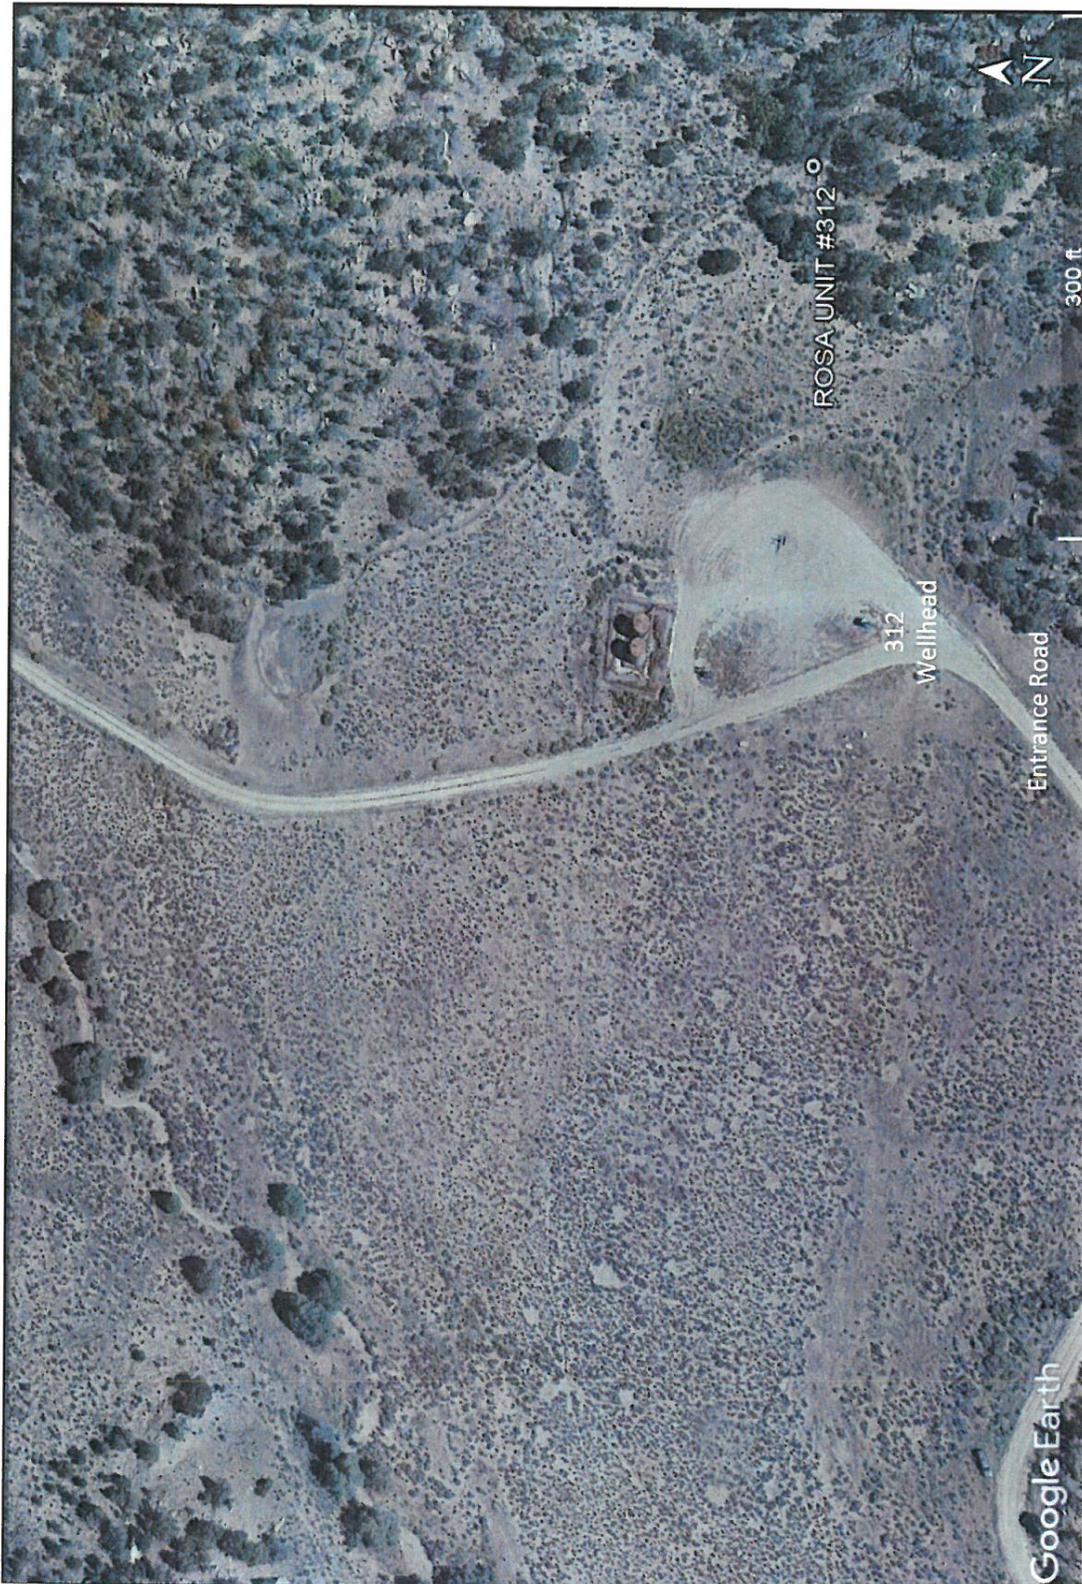
Impacted Area
