Release Notification Responsible Party

Site Name: GALLEGOS CANYON UNIT #505	Site Type: Natural Gas Production Well Pad
Date Release Discovered: March 6, 2019	API#: 30-045-28235

Variance Request: Gallegos Canyon Unit 505

SITING AND HYDRO-GEOLOGICAL REPORT FOR GALLEGOS CANYON UNIT 505

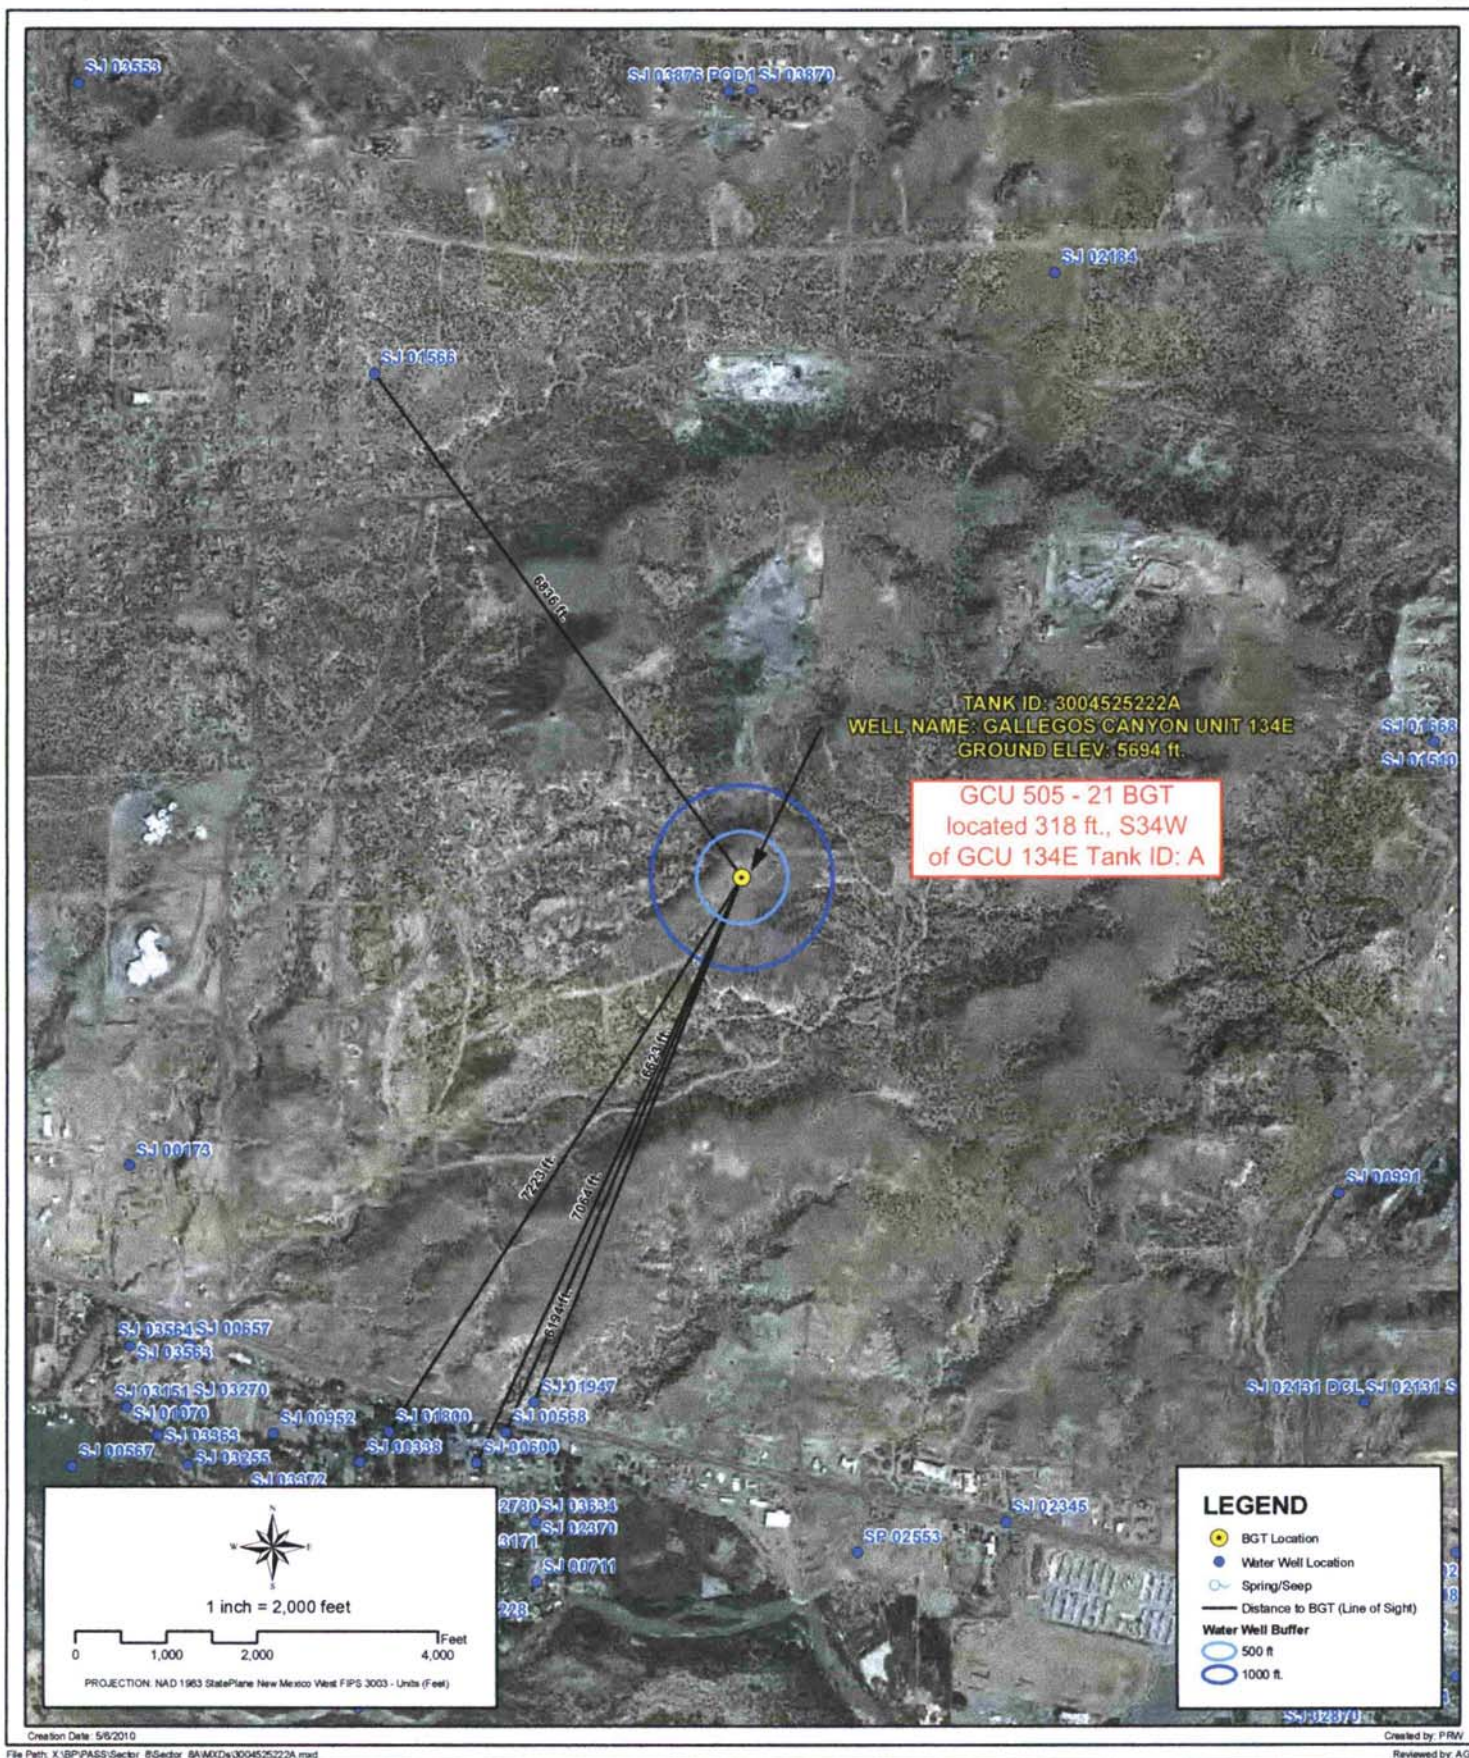
FIGURE
1

Depth to groundwater at the site is estimated to be greater than 100 feet (ft.) below grade (b.g.). This estimation is based on data from Stone and others (1983) and depth to groundwater data obtained from water wells permitted by the New Mexico State Engineer's Office (NMOSE). Local topography and proximity to adjacent water features were also considered. Figure 1, utilized from the adjacent well site's (GCU 134E) 95 barrel bgt permit, and an aerial map provided as Figure 1A, demonstrates that there are no freshwater wells or springs within 200 ft. of the below-grade tank (BGT). A topographic map (Figure 2) demonstrates that the BGT is not within 100 ft. of any continuously flowing watercourse or any other significant watercourse, lakebed, sinkhole or playa lake as measured from the ordinary high water mark. Figure 3, also utilized from the GCU 134E bgt permit, demonstrates that the BGT is not within 500 ft. of a wetland. Figure 4, once again utilized from the GCU 134E bgt permit, demonstrates that the BGT is not within the mapped FEMA 100-year floodplain. The BGT locations from both the GCU 134E and GCU 505 are within 320 ft. of each other.

PROXIMITY TO WATER WELLS

WELL NAME: GALLEGOS CANYON UNIT 134E

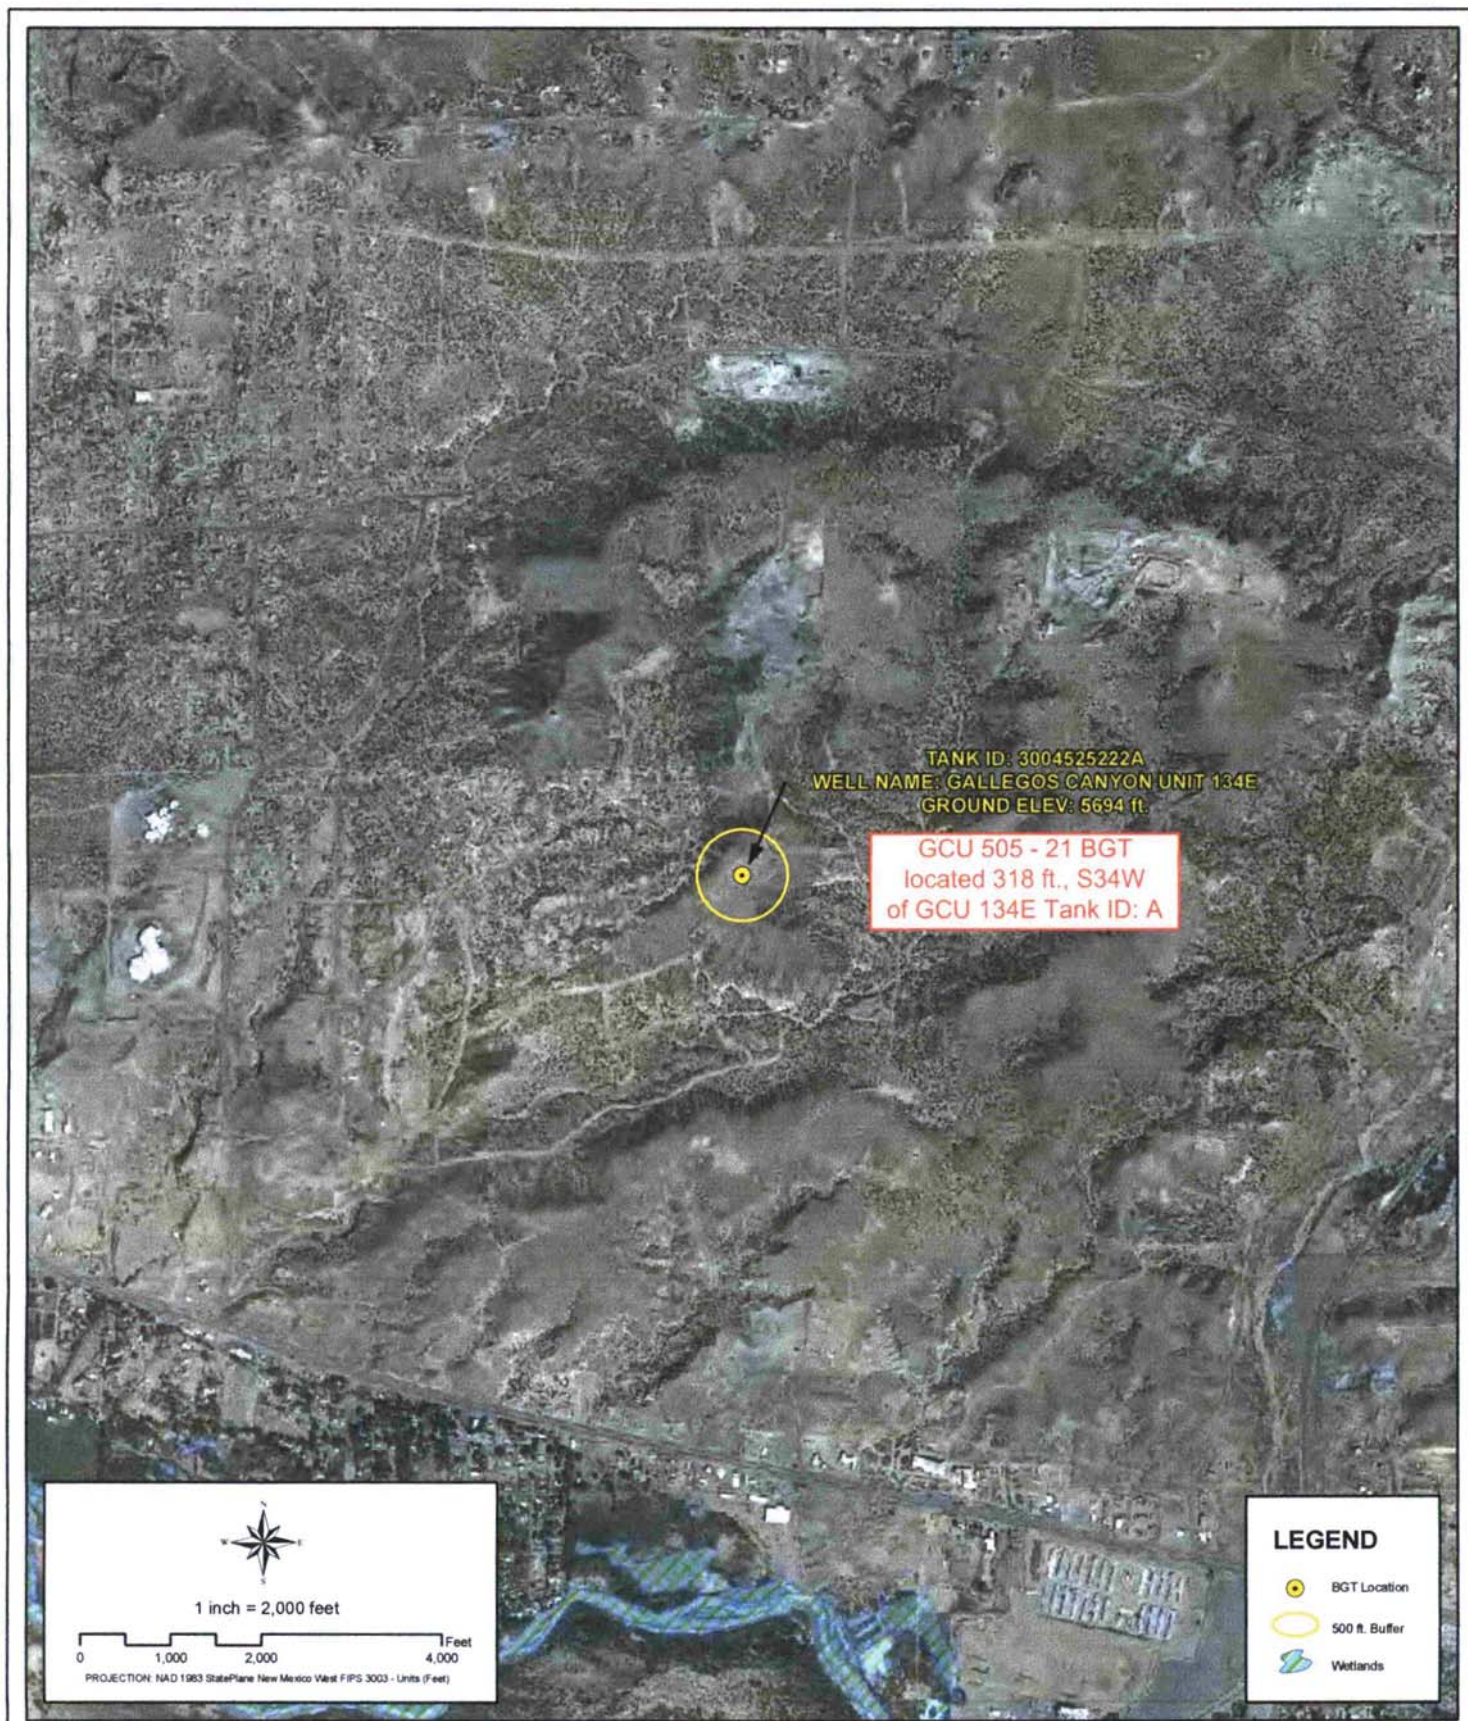
FIGURE
3

PROXIMITY TO WETLANDS
WELL NAME: GALLEGOS CANYON UNIT 134E
API NUMBER: 3004525222 TANK ID: 3004525222A
SECTION 17, TOWNSHIP 29.0N, RANGE 12W, P.M. NM23

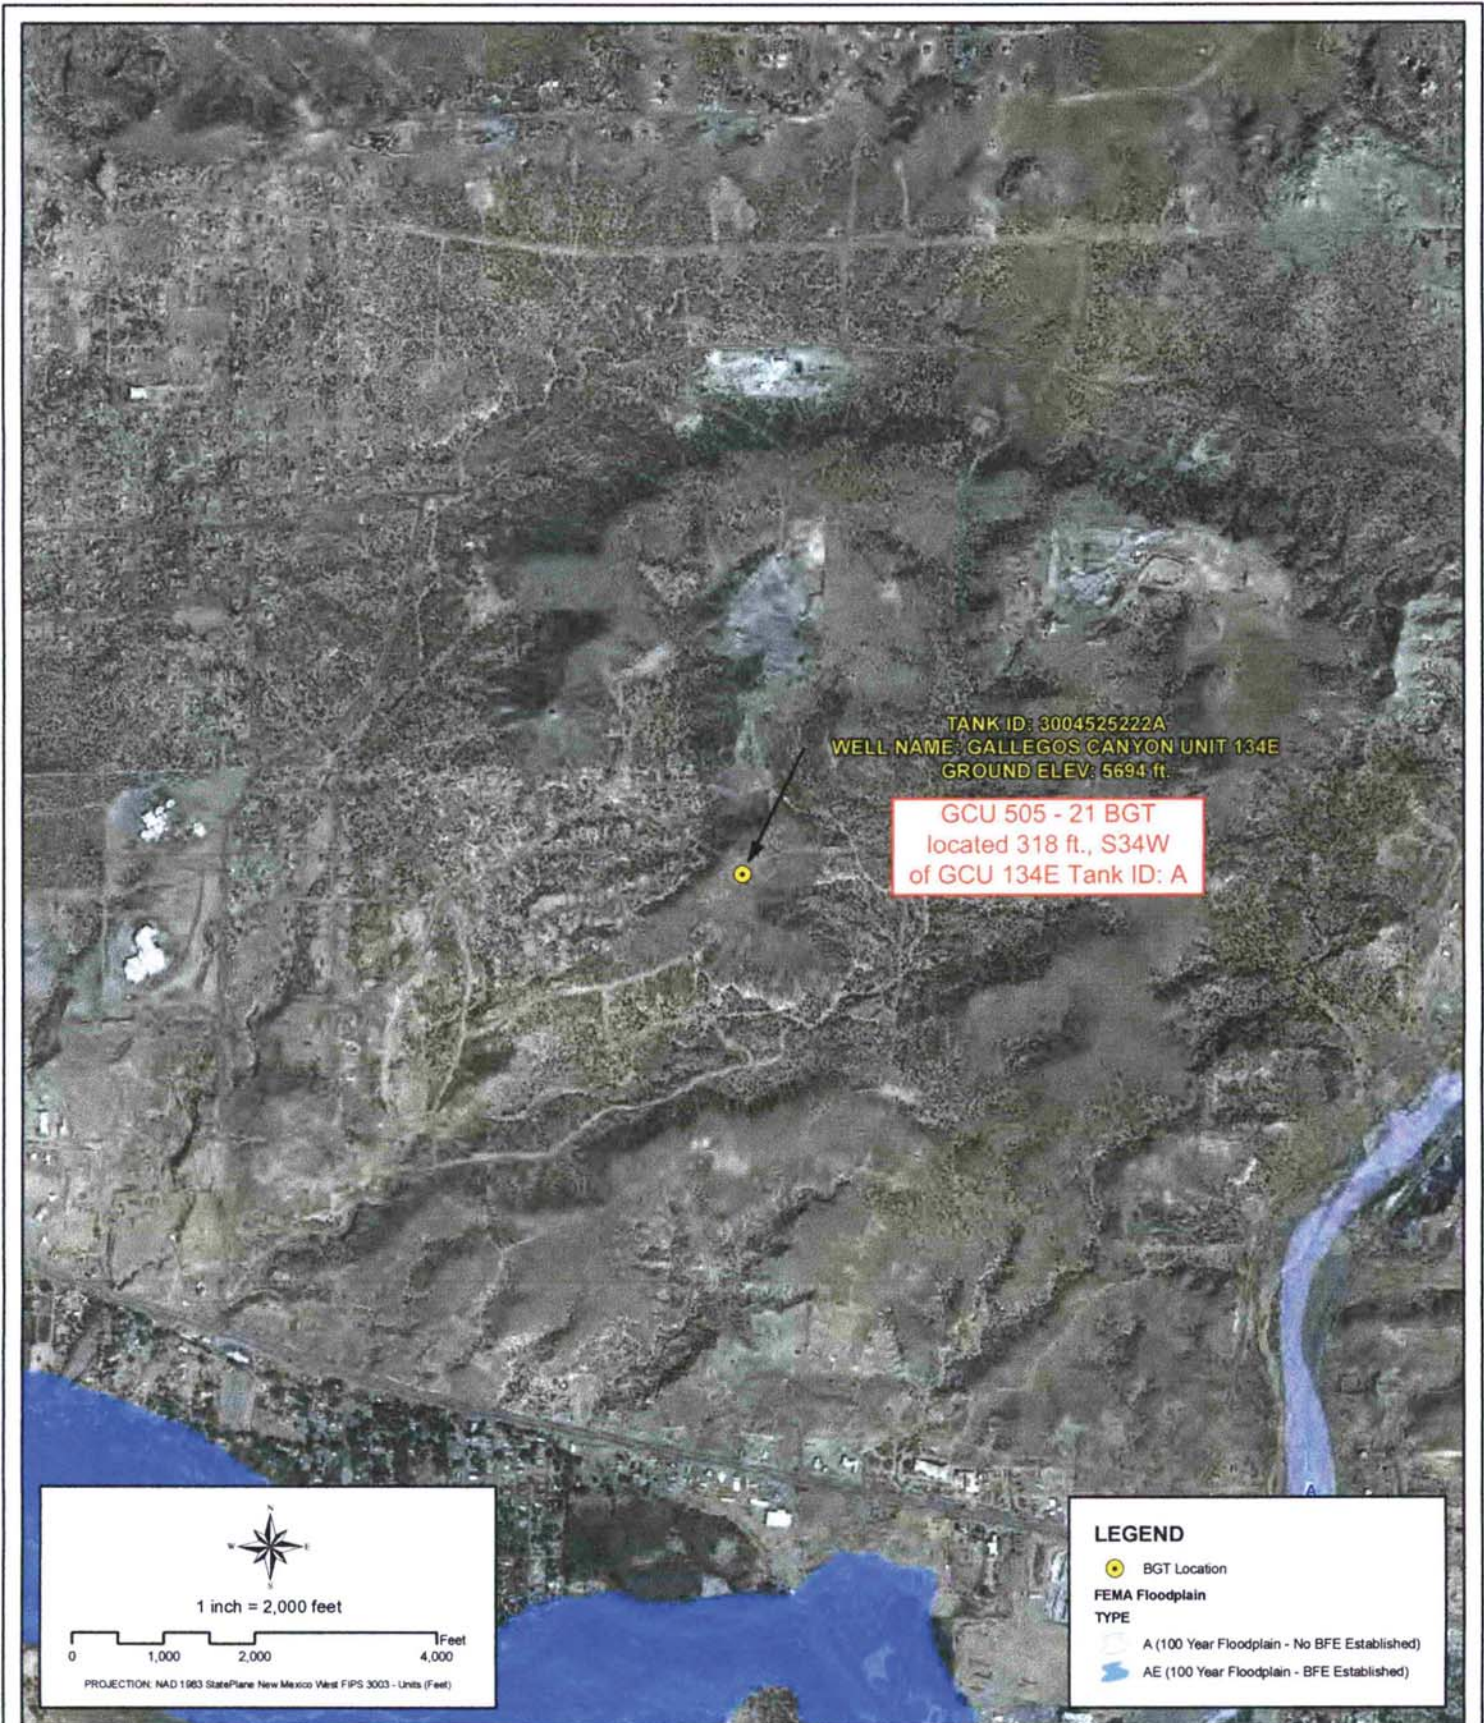
4

PROXIMITY TO FLOODPLAIN

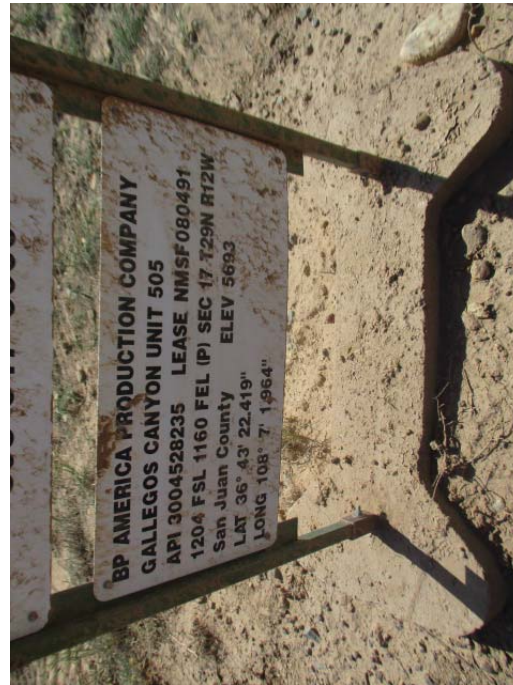
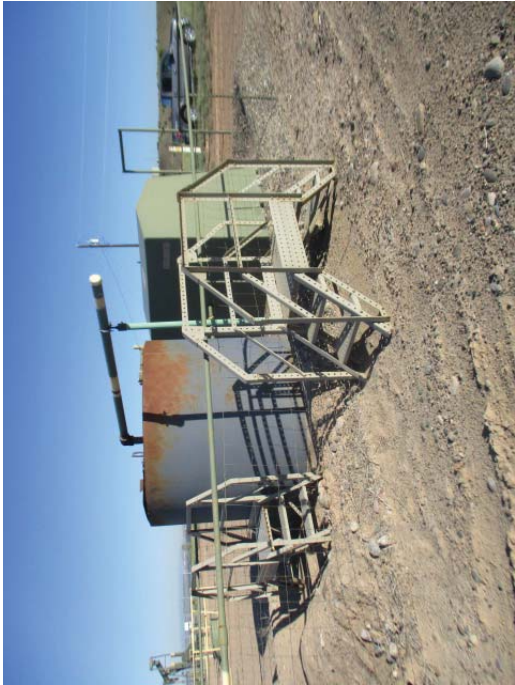
March 6, 2019 Conduct closure sampling for the 21 BGT. At an unknown prior date the BGT had been removed and replaced with a 45 barrel above grade tank at the same location. The 45 AGT was set aside and soil samples were collected at the prior bedding depth of the 21 BGT (3' below grade). During this sampling there was no visual evidence of impacts to the soil.

2'-4' Composite
CL-: Field Test = 388 ppm,
Lab Test = 143 ppm

2'-4' Composite
CL-: Field Test = 1,380 ppm
