Release Notification

REMEDIATION WORK PLAN

**FRPC 4-1
SAN JUAN COUNTY, NEW MEXICO
NCS1929541151**

Project Number: 017820013

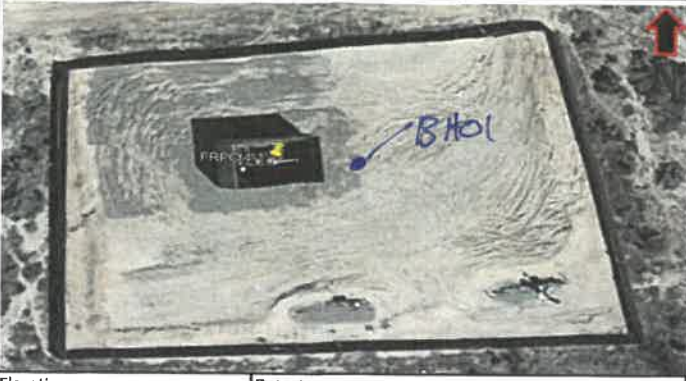
A proud member of WSP	
		BORING LOG/MONITORING WELL COMPLETION DIAGRAM	
Boring/Well Number: BH01		Project: FRPL 4-1	
Date: 4-16-20		Project Number:	
Logged By: JA		Drilled By: Mo-Te	
Elevation:	Detector: PID/Quantab	Drilling Method: hallow-stem	Sampling Method: continuous
Gravel Pack: 10-20 Silica Sand		Seal: Hydrated Bentonite Chips NA	Grout: Bentonite-Cement Slurry NA
Casing Type: Schedule 40 PVC NA	Diameter: 2"	Length:	Hole Diameter: 6"
Screen Type: Schedule 40 PVC	Slot: 0.010"	Diameter: 2"	Length:
		Total Depth: 20'	Depth to Liquid: NA
		Depth to Water: NA

Qtab (ppm)	Moisture Content	Vapor (ppm)	HC Staining?/ Chloride (ppm)	Sample #	Depth (ft. bgs.)	Sample Run	Recovery	Soil/Rock Type	Lithology/Remarks	Well Completion
					0				NR (0-2.5')	
					1				light brown poorly graded sand w/ silt low cohesion low plasticity	
					2					
568	DRY	0.0	NO	BH01 @ 2.5-5' 0950	3	0.5'	Impervious	SW-sm		
					4					
					5					
					6				NR	
					7					
					8	5-10	Impervious	SW-sm	SAA	
568	DRY	0.3	NO		9					
					10		Impervious	ML	brown silt w/sand	
					11				NR	
					12					
					13	10-15	Impervious	SW-sm	light brown poorly graded sand w/ silt	
1028	DRY	3.5	NO	BH01 @ 12.5-15' 0955	14					
					15

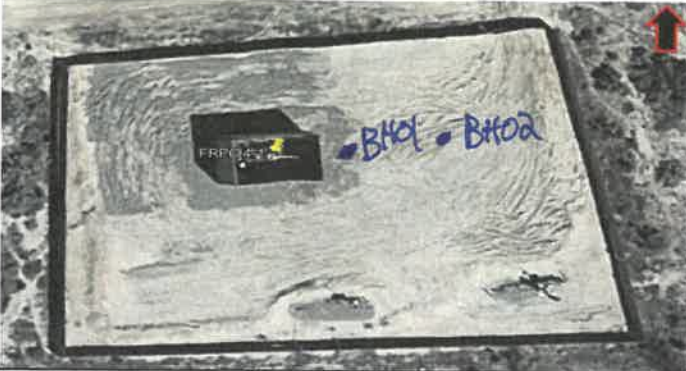
Qtab (ppm)	Moisture Content	Vapor (ppm)	HC Staining?/ Chloride ppm	Sample #	Depth (ft. bgs.)	Sample Run	Recovery	Soil/Rock Type	Lithology/Remarks	Well Completion
					0				NR	
					1					
					2					
428	Dry	0.7	NO		3				poorly graded sand w/ silt	
					4			SP-SM		
					5					
					6				NR	
					7					
428	Dry	0.0	NO	BHO2 C 75-10 1035	8				SAF	
					9					
					10			ML	silt w/ sand high cohesion high plas.	
					11				NR	
					12					
428	Dry	0.0	NO	BHO2 C 125-15 1040	13				poorly graded sand w/ silt some gravel	
					14			SP-SM		
					15

Boring/Well #	BH02	
										Project:		
										Project #		
										Date	4-16-20	
Qtab (ppm)	Moisture Content	Vapor (ppm)	Staining	Sample #	Depth (ft. bgs.)	Sample Run	Recovery	Soil/Rock Type	Lithology/Remarks	Well Completion		
					15							
					16							
					17							
					18							
128	Dry	0.0	NO	BH02 Q 17.5-20' 1045	19			SP	poorly graded sand			
					20							
					21							
					22							
					23							
					24							
					25							
					26							
					27							
					28							
					29							
					30							
					31							
					32							
					33							
					34							
					35							
					36							
					37

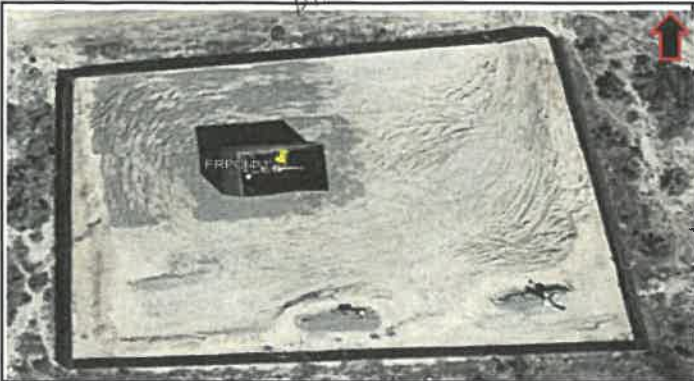
Qtab (ppm)	Moisture Content	Vapor (ppm)	HC Staining?/ Chloride ppm	Sample #	Depth (ft. bgs.)	Sample Run	Recovery	Soil/Rock Type	Lithology/Remarks	Well Completion	
NS	dry	0.0	NO		0			SM	Brown silty sand, low cohesion low plasticity		
					1						
					2						
424 ppm	dry	0.0	NO	BA08 5' @ 1285	3			SP-SM	light brown poorly graded sand w/ silt		
					4						
					5						
NS	dry	0.1	NO		6			SP-SM	SAA		
					7						
					8						
424	dry	0.0	NO		9			SP-SM	SAA		
					10						
					11						
NS	dry	0.0	NO		12			SP	brown silty sand		
					13						
186	dry	0.0	NO		14			SP-SM	poorly graded sand w/ silt some gravel		
					15

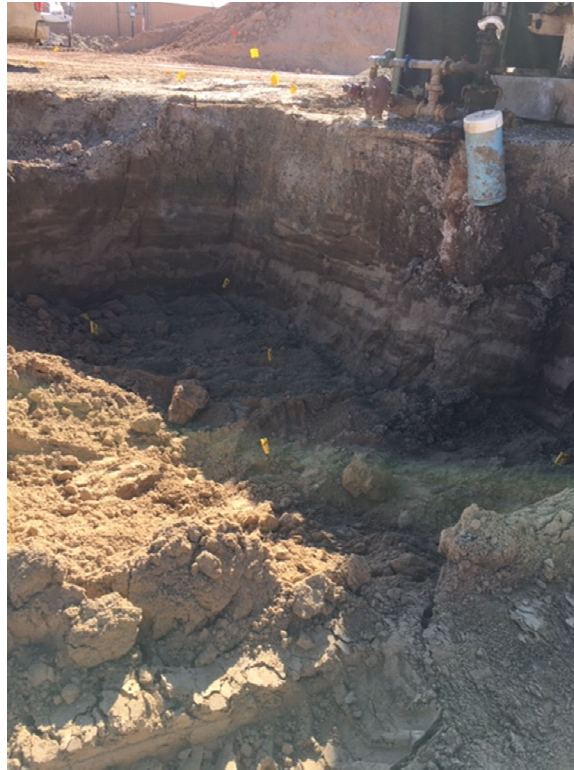
Photograph 1: Release location near well head, excavation 8 feet deep.

Hilcorp excavated approximately 258 cubic yards (yds³) of impacted soil at the Site in order to make repairs to the water transfer line and to remove impacted soil. During the excavation activities Hilcorp personnel collected various soil samples that confirmed the presence of elevated chloride concentrations as a result of produced water impact to soil at the Site. Due to the sampling results and existing size of the excavation, Hilcorp opted to stop the excavation.

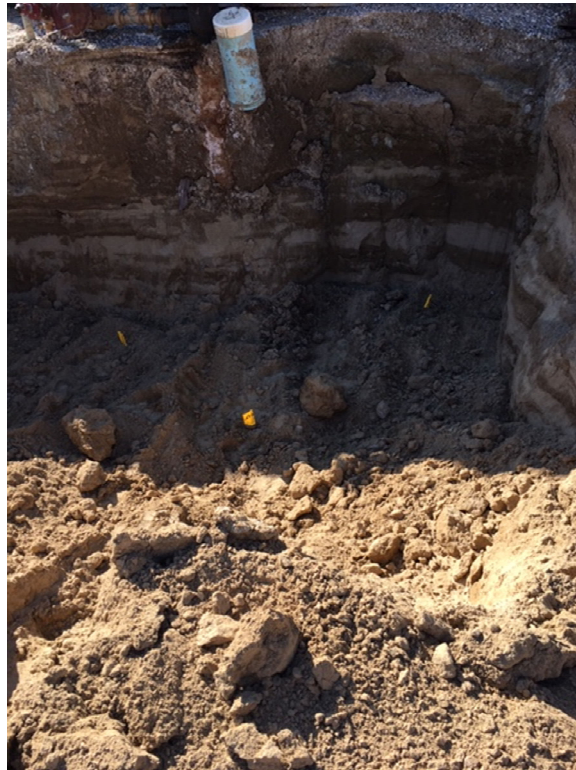
Photograph 2: Release location.
