**Lateral L-11 Valve Release:
Release Assessment and Final Remediation Report**

Latitude 36.333375°, Longitude -107.213957°
Section 1, T24N, R4W
Rio Arriba County, New Mexico

January 6, 2020

**January 6, 2020
SMA #5127965 BG14**

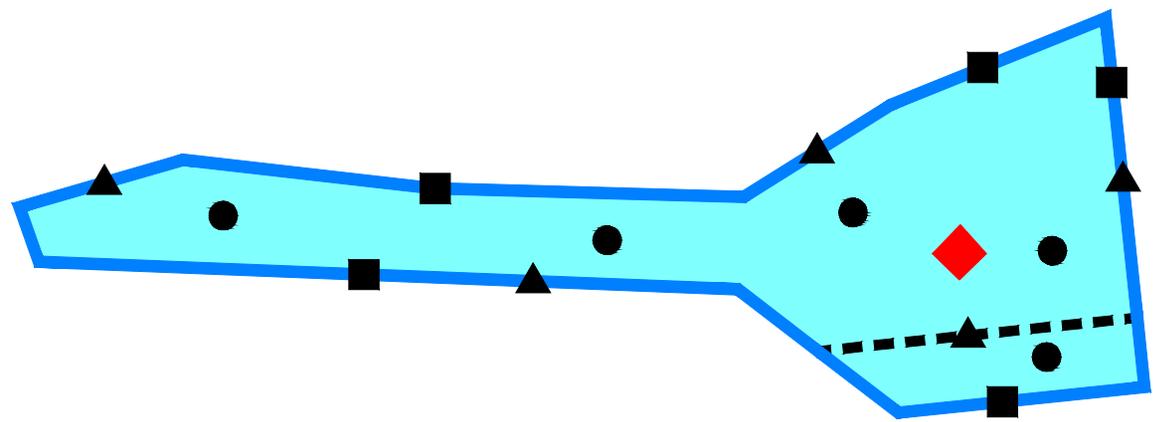
Figure 3
 Scale: Horiz: 1"=5'
 Vert: N/A
 Date: August 2019
 THIS DRAWING IS INCOMPLETE AND NOT TO BE USED FOR CONSTRUCTION UNLESS IT IS STAMPED, SIGNED AND DATED

- FORMER EXTENT OF EXCAVATION
- ◆ RELEASE LOCATION
- SC-1 (BASE COMPOSITE SAMPLE)
- ▲ SC-2 (SIDE WALL COMPOSITE SAMPLE)
- SC-3 (SIDE WALL COMPOSITE SAMPLE)

Sample ID	Sample Date	Sample Location	Depth (feet bgs)	BTEX mg/Kg	Benzene mg/Kg	GRO mg/Kg	DRO mg/Kg	MRO mg/Kg	Total TPH mg/Kg	Cl- mg/Kg
NMOCD Closure Criteria				50	10				100	600
SC-1	5/31/2019	Base Composite	1-5	<0.185	<0.021	<4.1	20	<49	20	79
SC-2*	5/31/2019	Sidewalls Composite	1-5	<0.245	<0.027	<5.4	51	61	112	310
SC-3	6/4/2019	Sidewalls Composite	1-5	<0.228	<0.026	<5.1	38	<48	38	65

On May 31, 2019 and June 4, 2019, SMA conducted confirmation sampling of the excavation, which measured, at the widest points, approximately 26 feet by 12 feet and ranged in depth from 1 foot to 5 feet in depth.

Confirmation samples were comprised of five-point composites of the excavated area. The base of the excavation measured 197 ft². The sidewalls ranged in depth from 1 to 5 feet with a total surface area measurement of 167 ft². Sample SC-1 was collected from the base of the excavation and sample SC-2 was collected from the sidewalls of the excavation. Analytical results demonstrated that SC-2, a side wall composite sample, exceeded Closure Criteria and was therefore further excavated and resampled (SC-3).

Figure 3 shows the extent of the excavation and sample locations. Laboratory results are summarized in Table 3. Laboratory reports are included in Appendix E.

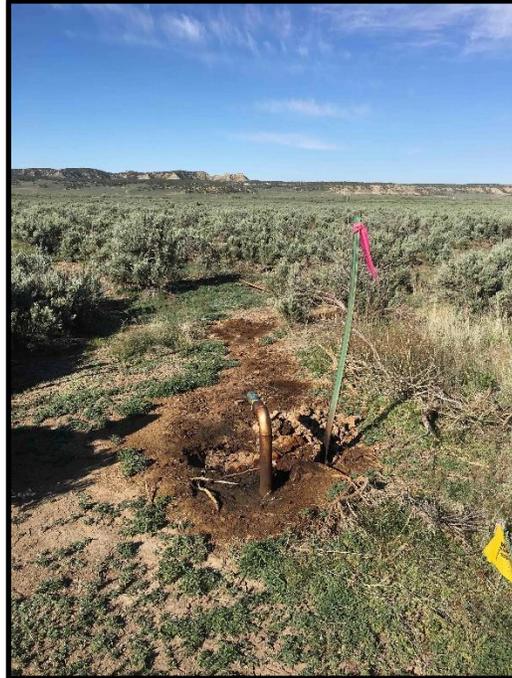
Figure 1. View of surface stained area prior to excavation.

On May 13, 2019, surface staining was discovered at a valve associated with the Lateral L-11 pipeline. Initial response activities were conducted by Enterprise, and included

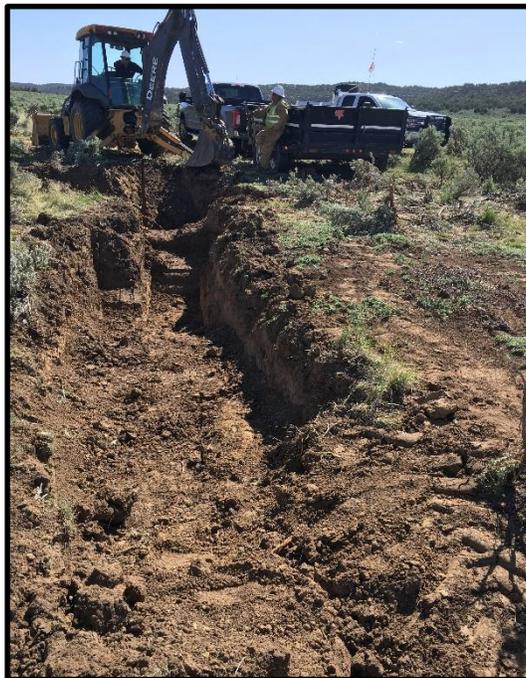
Figure 2. View facing north of final excavation.

Contaminated soils were removed and replaced with clean backfill material to return the surface to previous contours. Twenty-eight (28) cubic yards of contaminated soil was transported and disposed of at Envirotech Landfarm, Bloomfield, New Mexico, an NMOCD permitted disposal facility.
