General Description of Remedial Action : A soil sample was obtained from the center bottom of the pit at a depth of 6 feet utilizing U.S.E.P.A. protocol and evaluated for GRO/DRO analysis.  
The sample was tested and provided concentrations below NMOCD guidelines.  
\_\_\_\_\_  
\_\_\_\_\_  
\_\_\_\_\_

| <b>Location:</b> <u>SJ 29-6 # 24 MV</u> | | |
| <b>Pit:</b> <u>abandoned pit 2</u> | | |

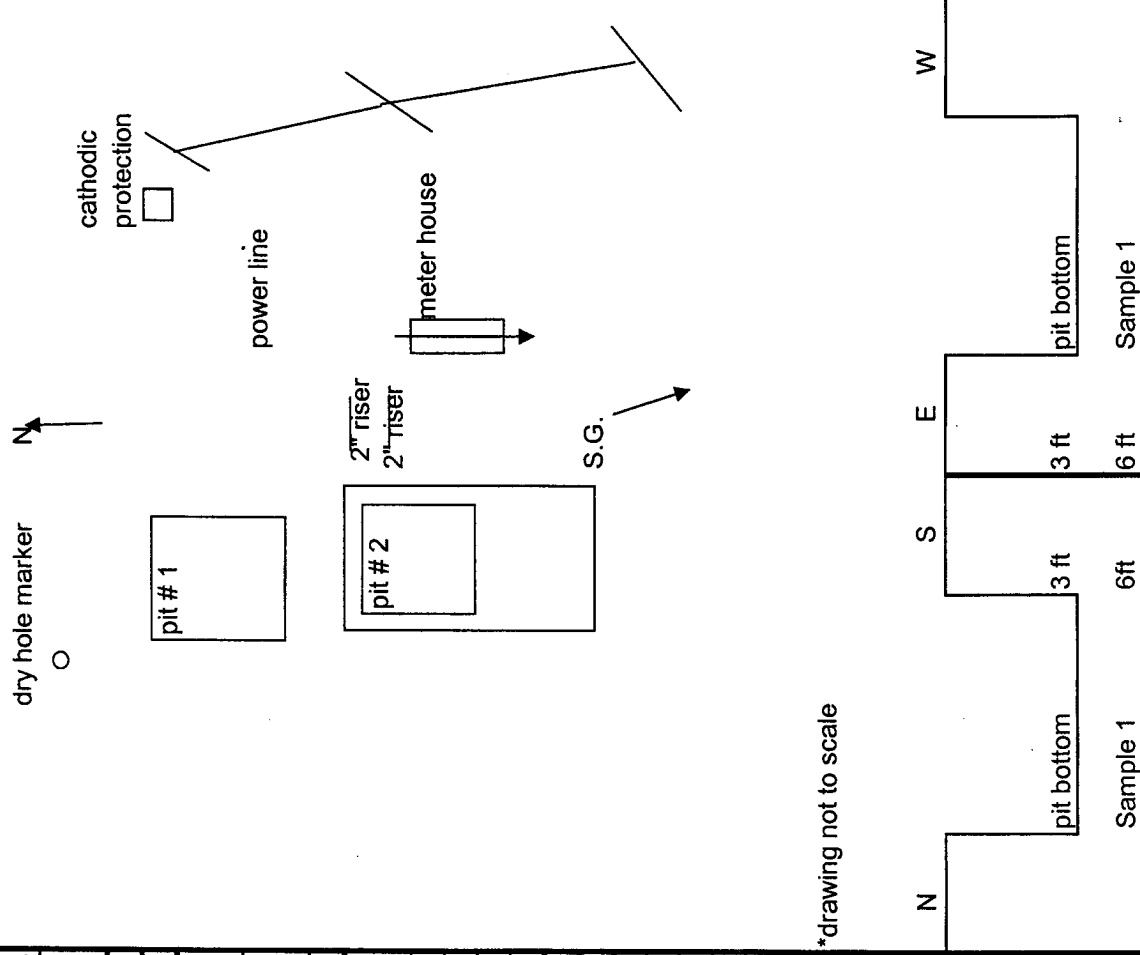
Site Diagram:

| <b>Pit Reference from Wellhead:</b> | | |
| <u>60° S 12 degrees E</u> | | |
| Initial size: | <u>15' x 20' x 3' deep</u> | |
| Topography is sagebrush flats Soil is sandy clay loam | | |
| No hydrocarbon staining or odor was noticed. Sample was | | |
| extracted from 6 ft below surface (3 ft below pit bottom). | | |
