Pit, Below-Grade Tank, or
Proposed Alternative Method Permit or Closure Plan Application

1.
Operator: Burlington Resources Oil & Gas Company LP OGRID #: 14538
Address: PO BOX 4289, Farmington, NM 87499
Facility or well name: San Juan 30-6 Unit 126
API Number: 30-039-26003 OCD Permit Number: _____
U/L or Qtr/Qtr P (SESE) Section 15 Township 30N Range 6W County: Rio Arriba
Center of Proposed Design: Latitude 36.80853000 °N Longitude -107.44343000 °W NAD: ☒ 1927 ☐ 1983
Surface Owner: ☒ Federal ☐ State ☐ Private ☐ Tribal Trust or Indian Allotment

Burlington Resources Oil Gas Company, LP
San Juan Basin
Below Grade Tank Closure Report

Lease Name: SJ 30-6 Unit 126

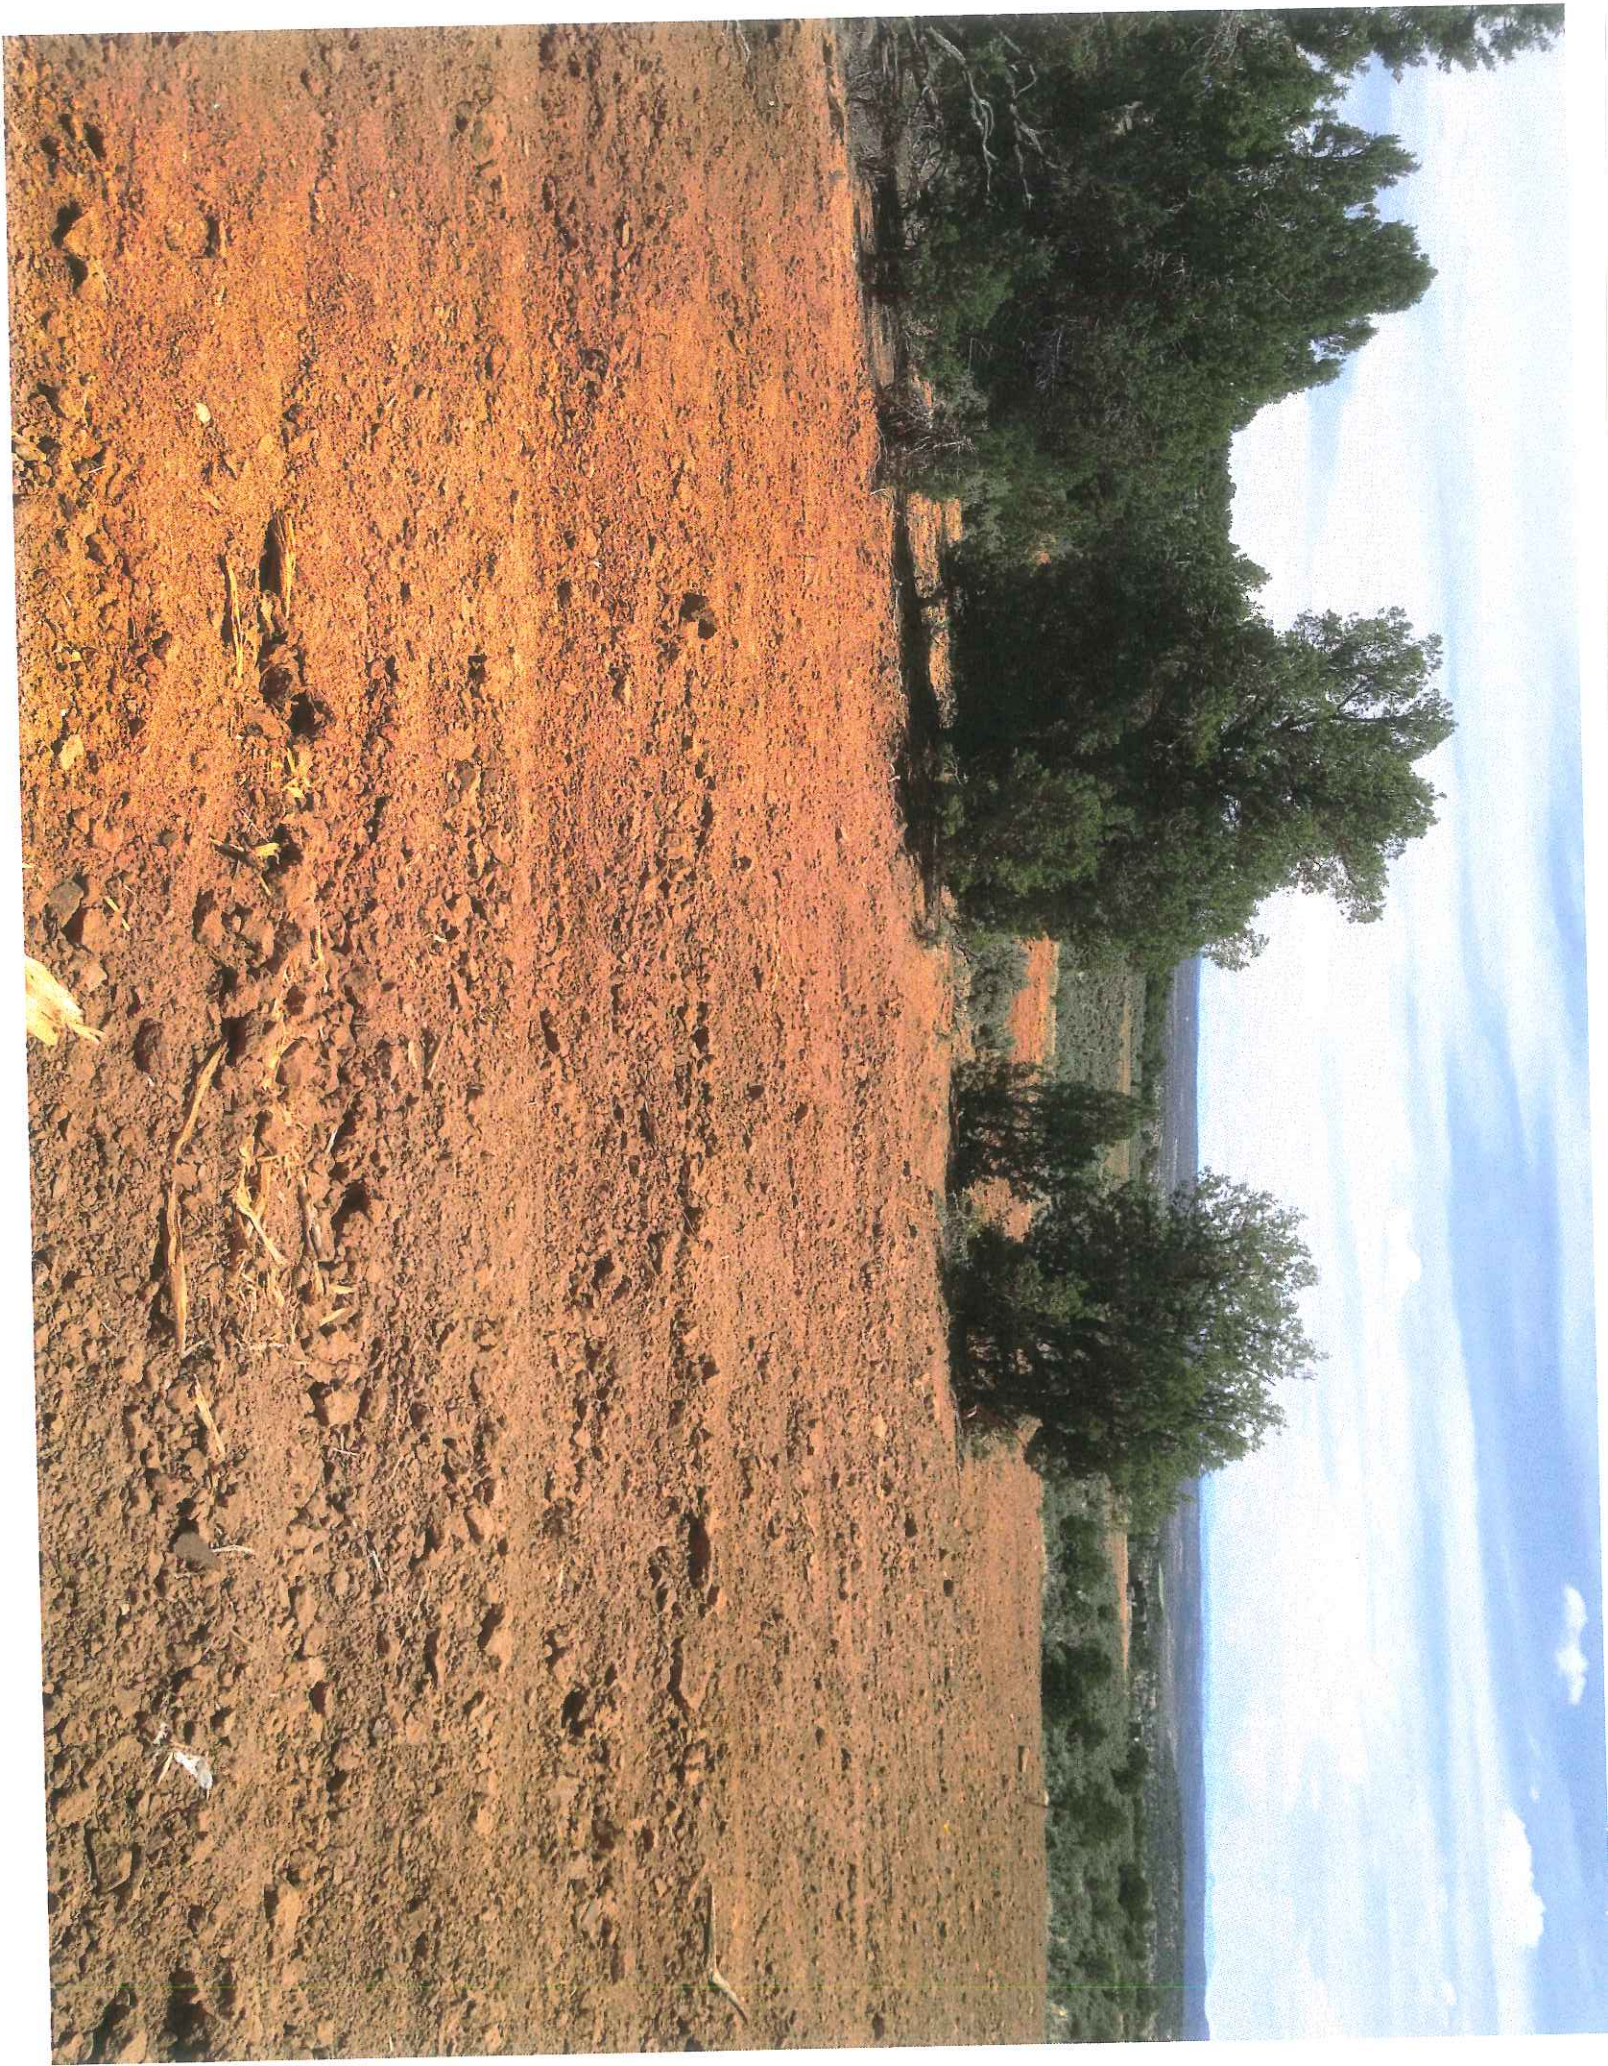
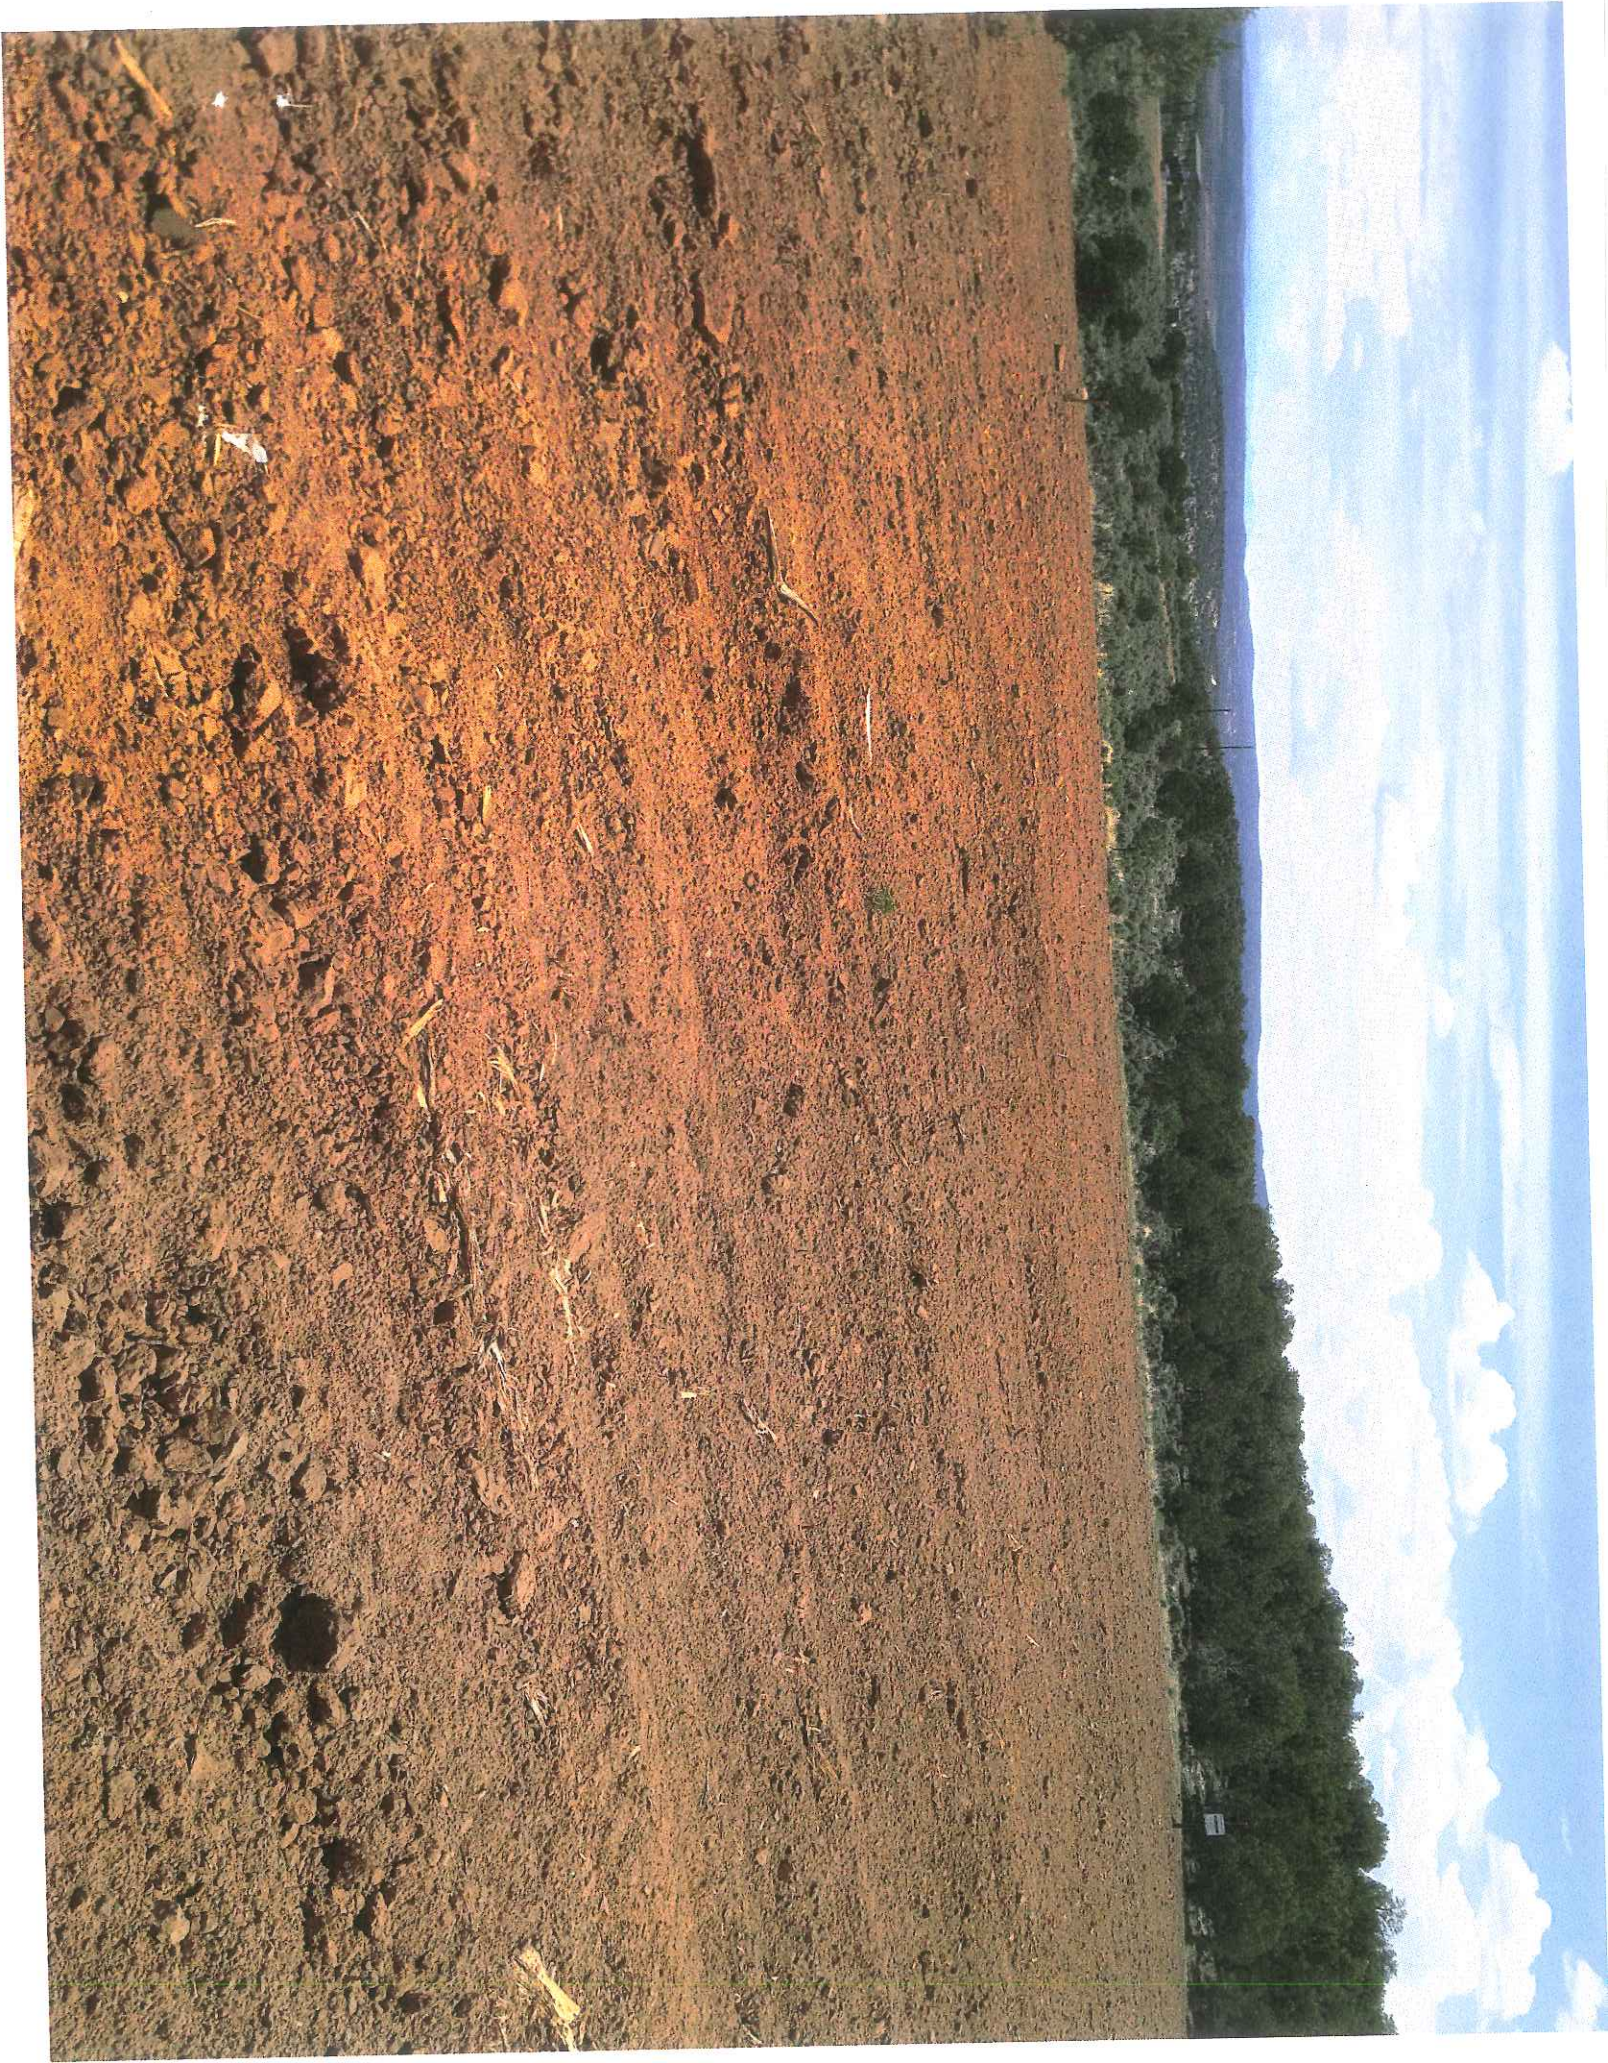
ConocoPhillips 1190' FSL 790' FEL
SEC. 15 T030N R006W
LEASE NO. SF-080713B ELEV. 6410
API NO. 30-039-26003
CA NO. NMNM99472
RIO ARriba COUNTY, NEW MEXICO
EMERGENCY NUMBER (505) 324-5170
