Pit, Below-Grade Tank, or
Proposed Alternative Method Permit or Closure Plan Application

1.
Operator: Burlington Resources Oil & Gas Company LP OGRID #: 14538
Address: PO BOX 4289, Farmington, NM 87499
Facility or well name: San Juan 28-4 Unit 30
API Number: 30-039-20078 OCD Permit Number: _____
U/L or Qtr/Qtr G (SWNE) Section 31 Township 28N Range 4W County: Rio Arriba
Center of Proposed Design: Latitude 36.61924000 °N Longitude -107.28871000 °W NAD: 1927 1983
Surface Owner: Federal State Private Tribal Trust or Indian Allotment

Burlington Resources Oil Gas Company, LP
San Juan Basin
Below Grade Tank Closure Report

Lease Name: San Juan 28-4 Unit 30
API No.: 30-039-20078

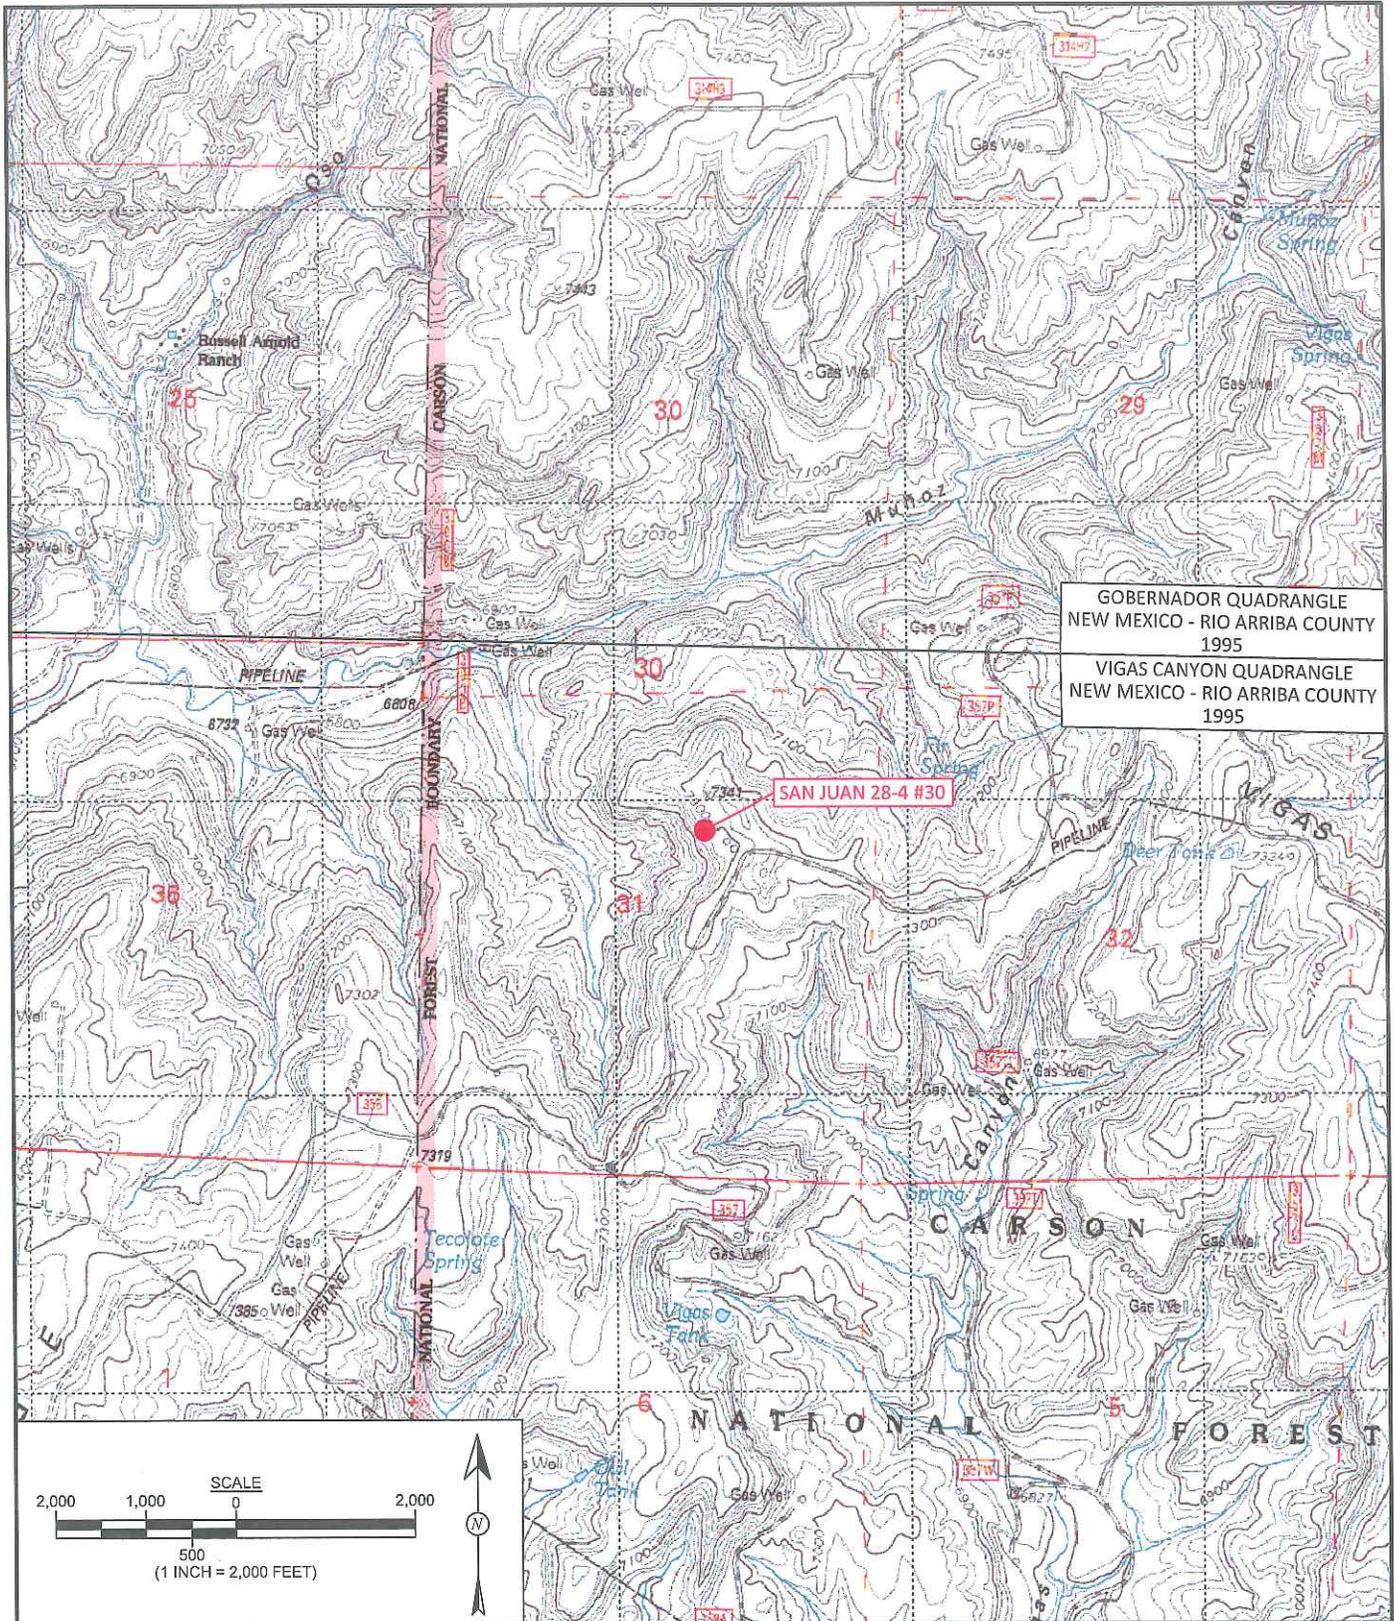
FIGURE 1

SAN JUAN 28-4 #30

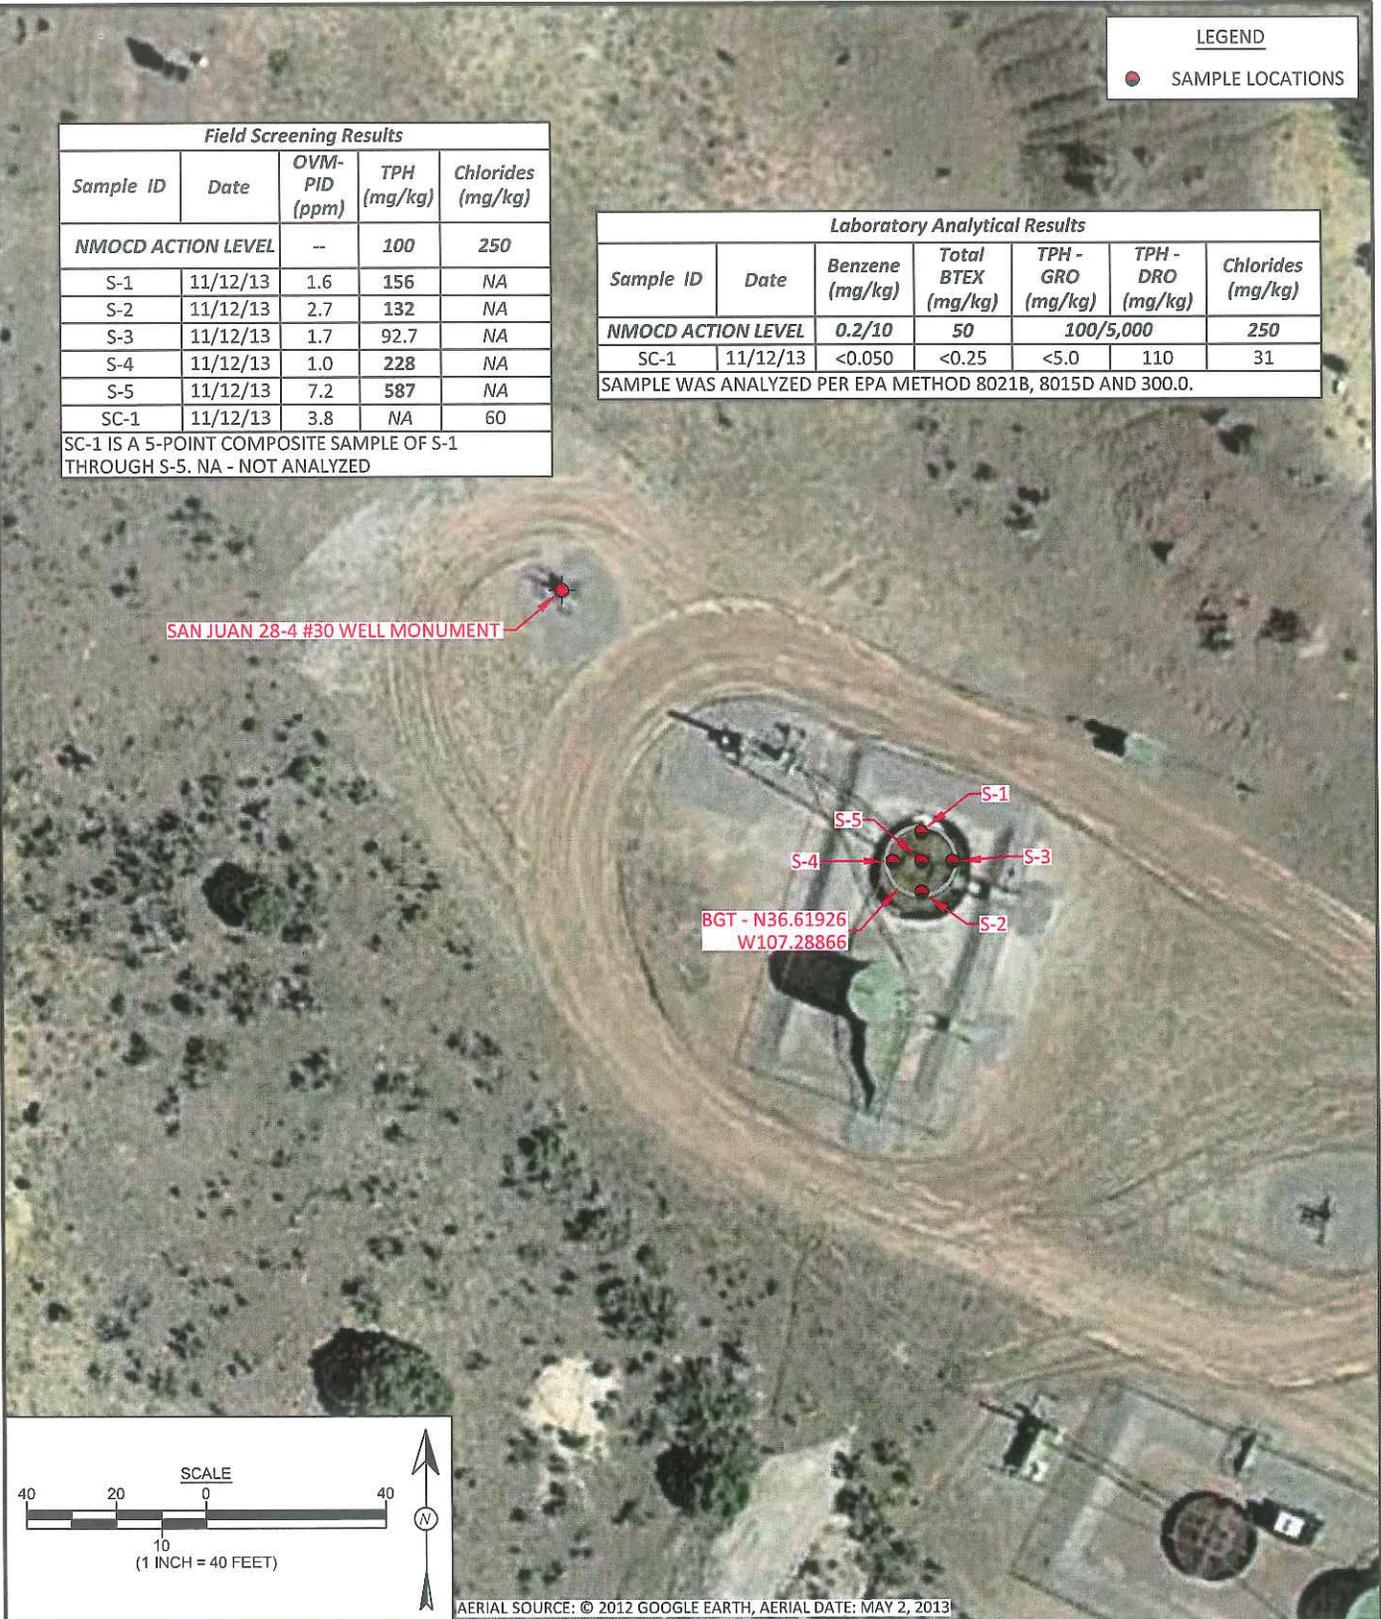
Laboratory Analytical Results						
Sample ID	Date	Benzene (mg/kg)	Total BTEX (mg/kg)	TPH - GRO (mg/kg)	TPH - DRO (mg/kg)	Chlorides (mg/kg)
NMOC D ACTION LEVEL		0.2/10	50	100/5,000		250
SC-1	11/12/13	<0.050	<0.25	<5.0	110	31

SAMPLE WAS ANALYZED PER EPA METHOD 8021B, 8015D AND 300.0.

Action levels for releases are determined by the NMOCD ranking score per *NMOCD Guidelines for Remediation of Leaks, Spills, and Releases* (August 1993), and the site was assigned a rank of 0. Benzene and total BTEX concentrations in SC-1 were below the NMOCD action levels of 10 mg/kg and 50 mg/kg, respectively. TPH concentrations as GRO/DRO in SC-1 were reported below the NMOCD action level of 5,000 mg/kg. Soil laboratory analyses showed that benzene, total BTEX, TPH and chloride concentrations were below the NMOCD action levels for SC-1. Release notification should follow the
