Form C-144 Revised June 6, 2013

Burlington Resources Oil Gas Company, LP San Juan Basin Below Grade Tank Closure Report

Lease Name: Cundiff A 2R API No.: 3004531790

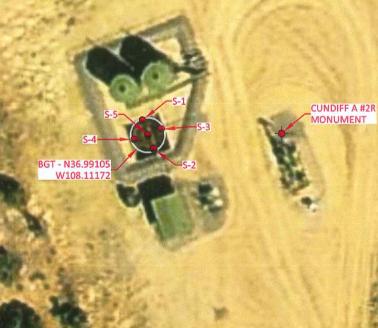
SAMPLE LOCATIONS

| | | Laborato | ry Analytica | al Results | | |
|---|---|---|---|---|---|---|
| SC-1 | 10/19/12 | <0.050 | <0.25 | <5.0 | <10 | 47 |
| SAMPLE WAS | ANALYZED | PER EPA M | ETHOD 802 | 1B. 8015B A | ND 300.0. | |

AERIAL SOURCE: © 2012 PICTOMETRY INTERNATIONAL CORP. ONLINE, AERIAL TAKEN: APRIL 12, 2011
