Pit, Below-Grade Tank, or
Proposed Alternative Method Permit or Closure Plan Application

Burlington Resources Oil Gas Company, LP
San Juan Basin
Below Grade Tank Closure Report

Lease Name: SJ 28-6 Unit 136

API No.: 3003920038

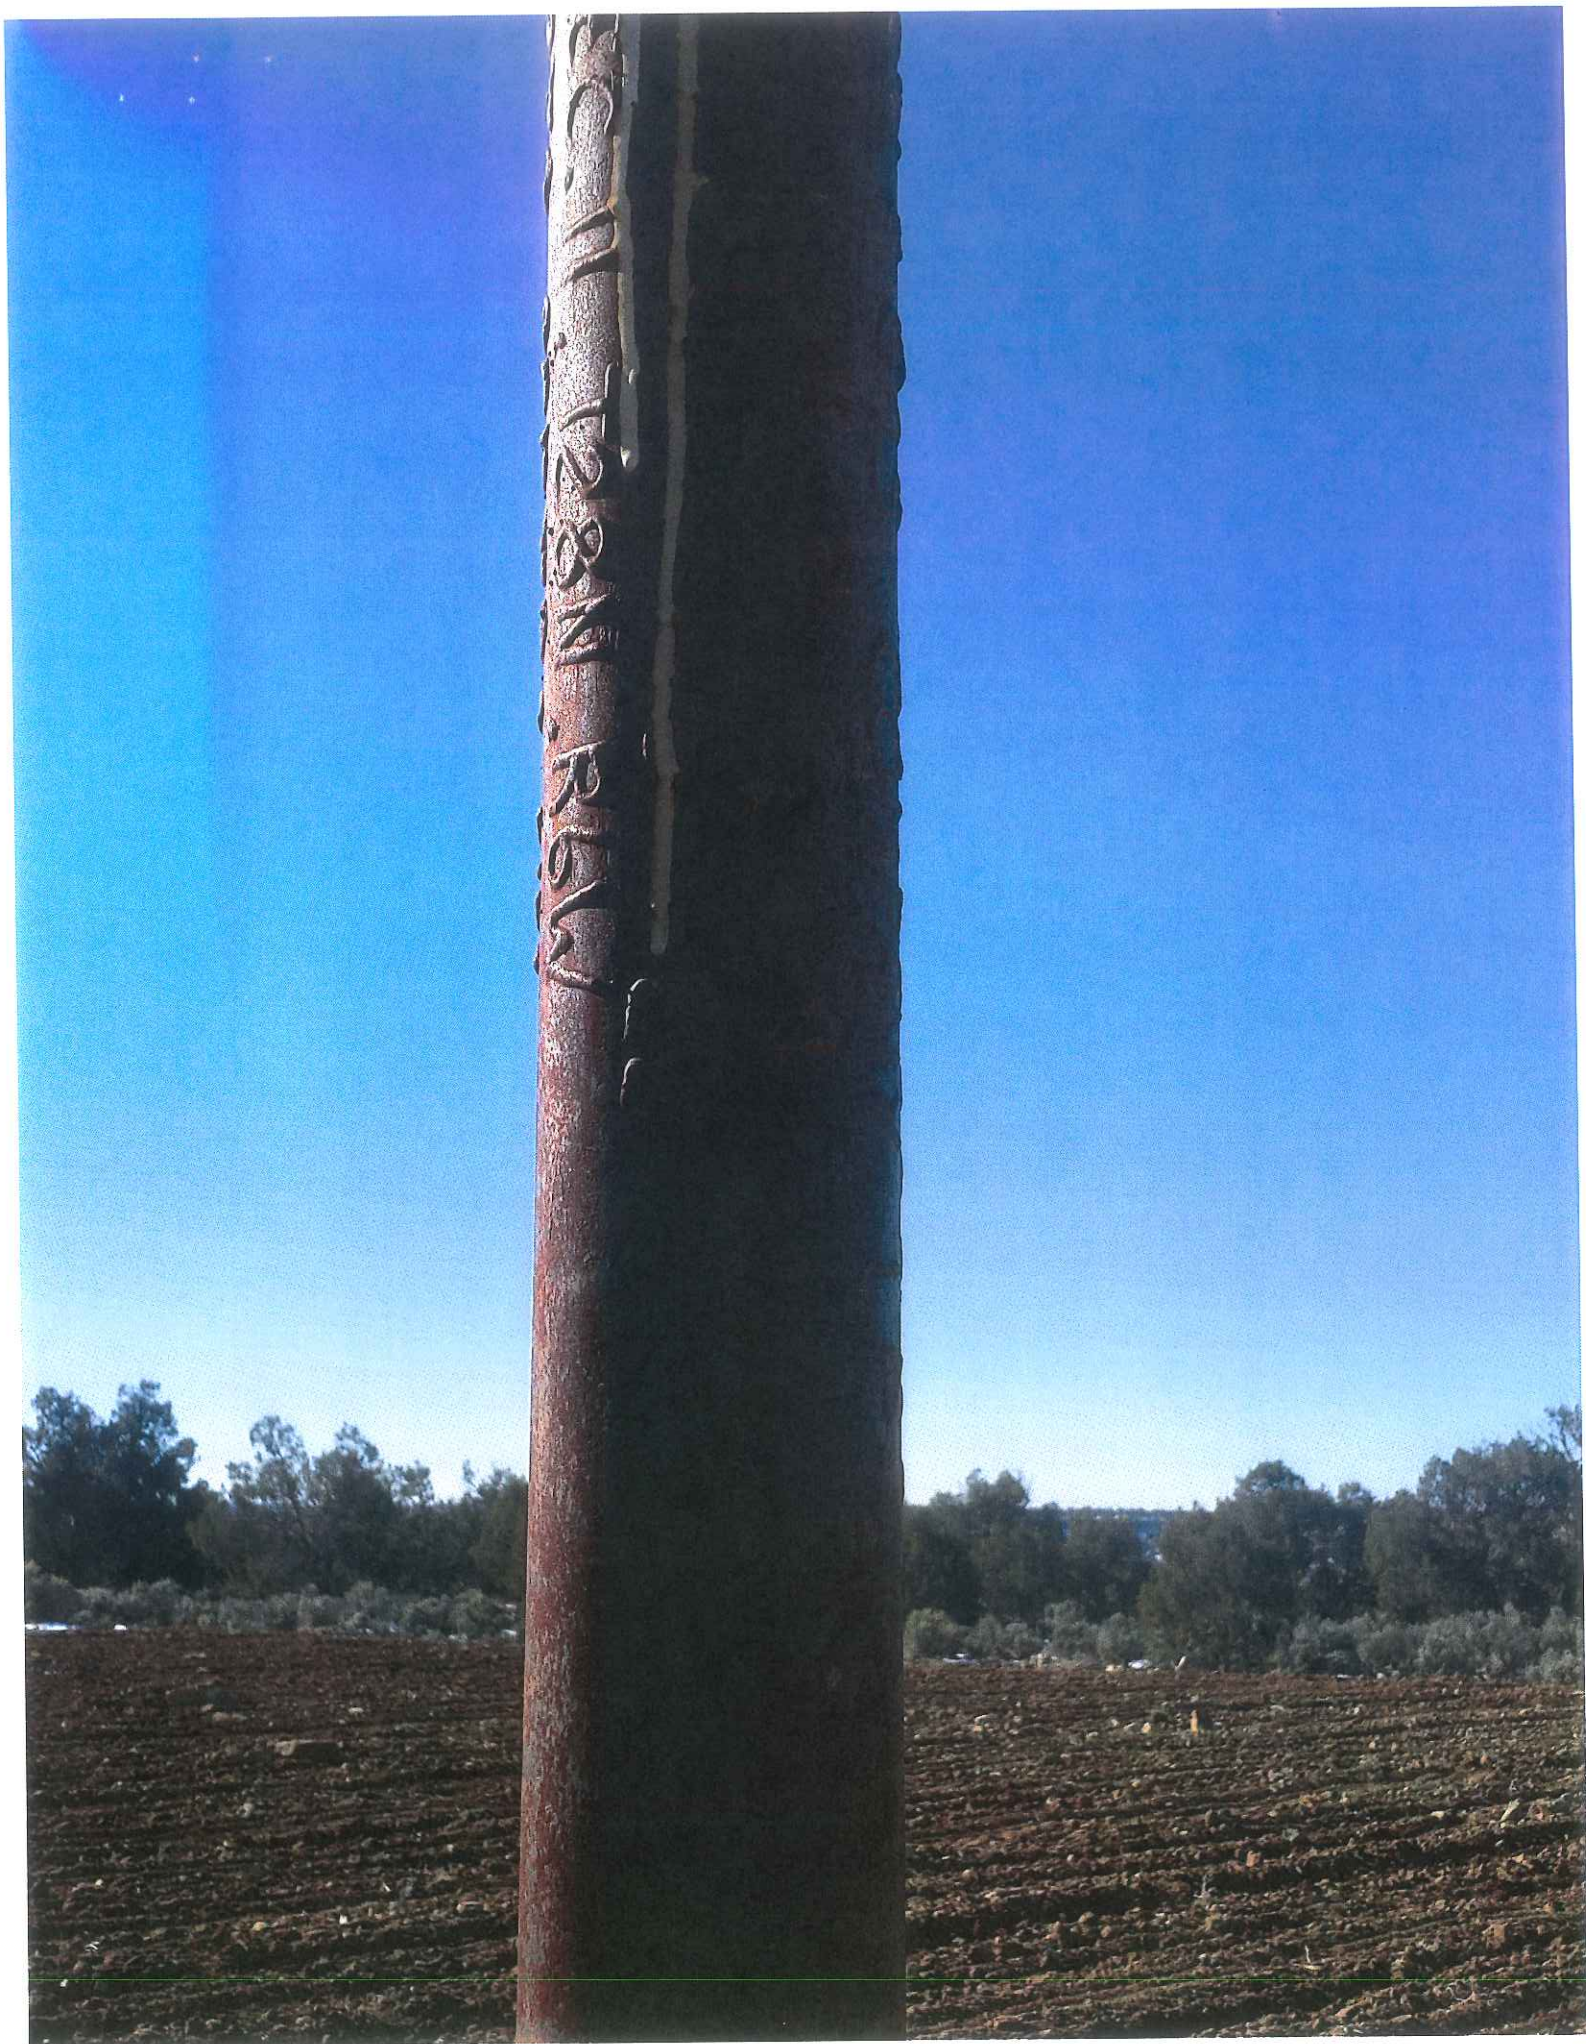
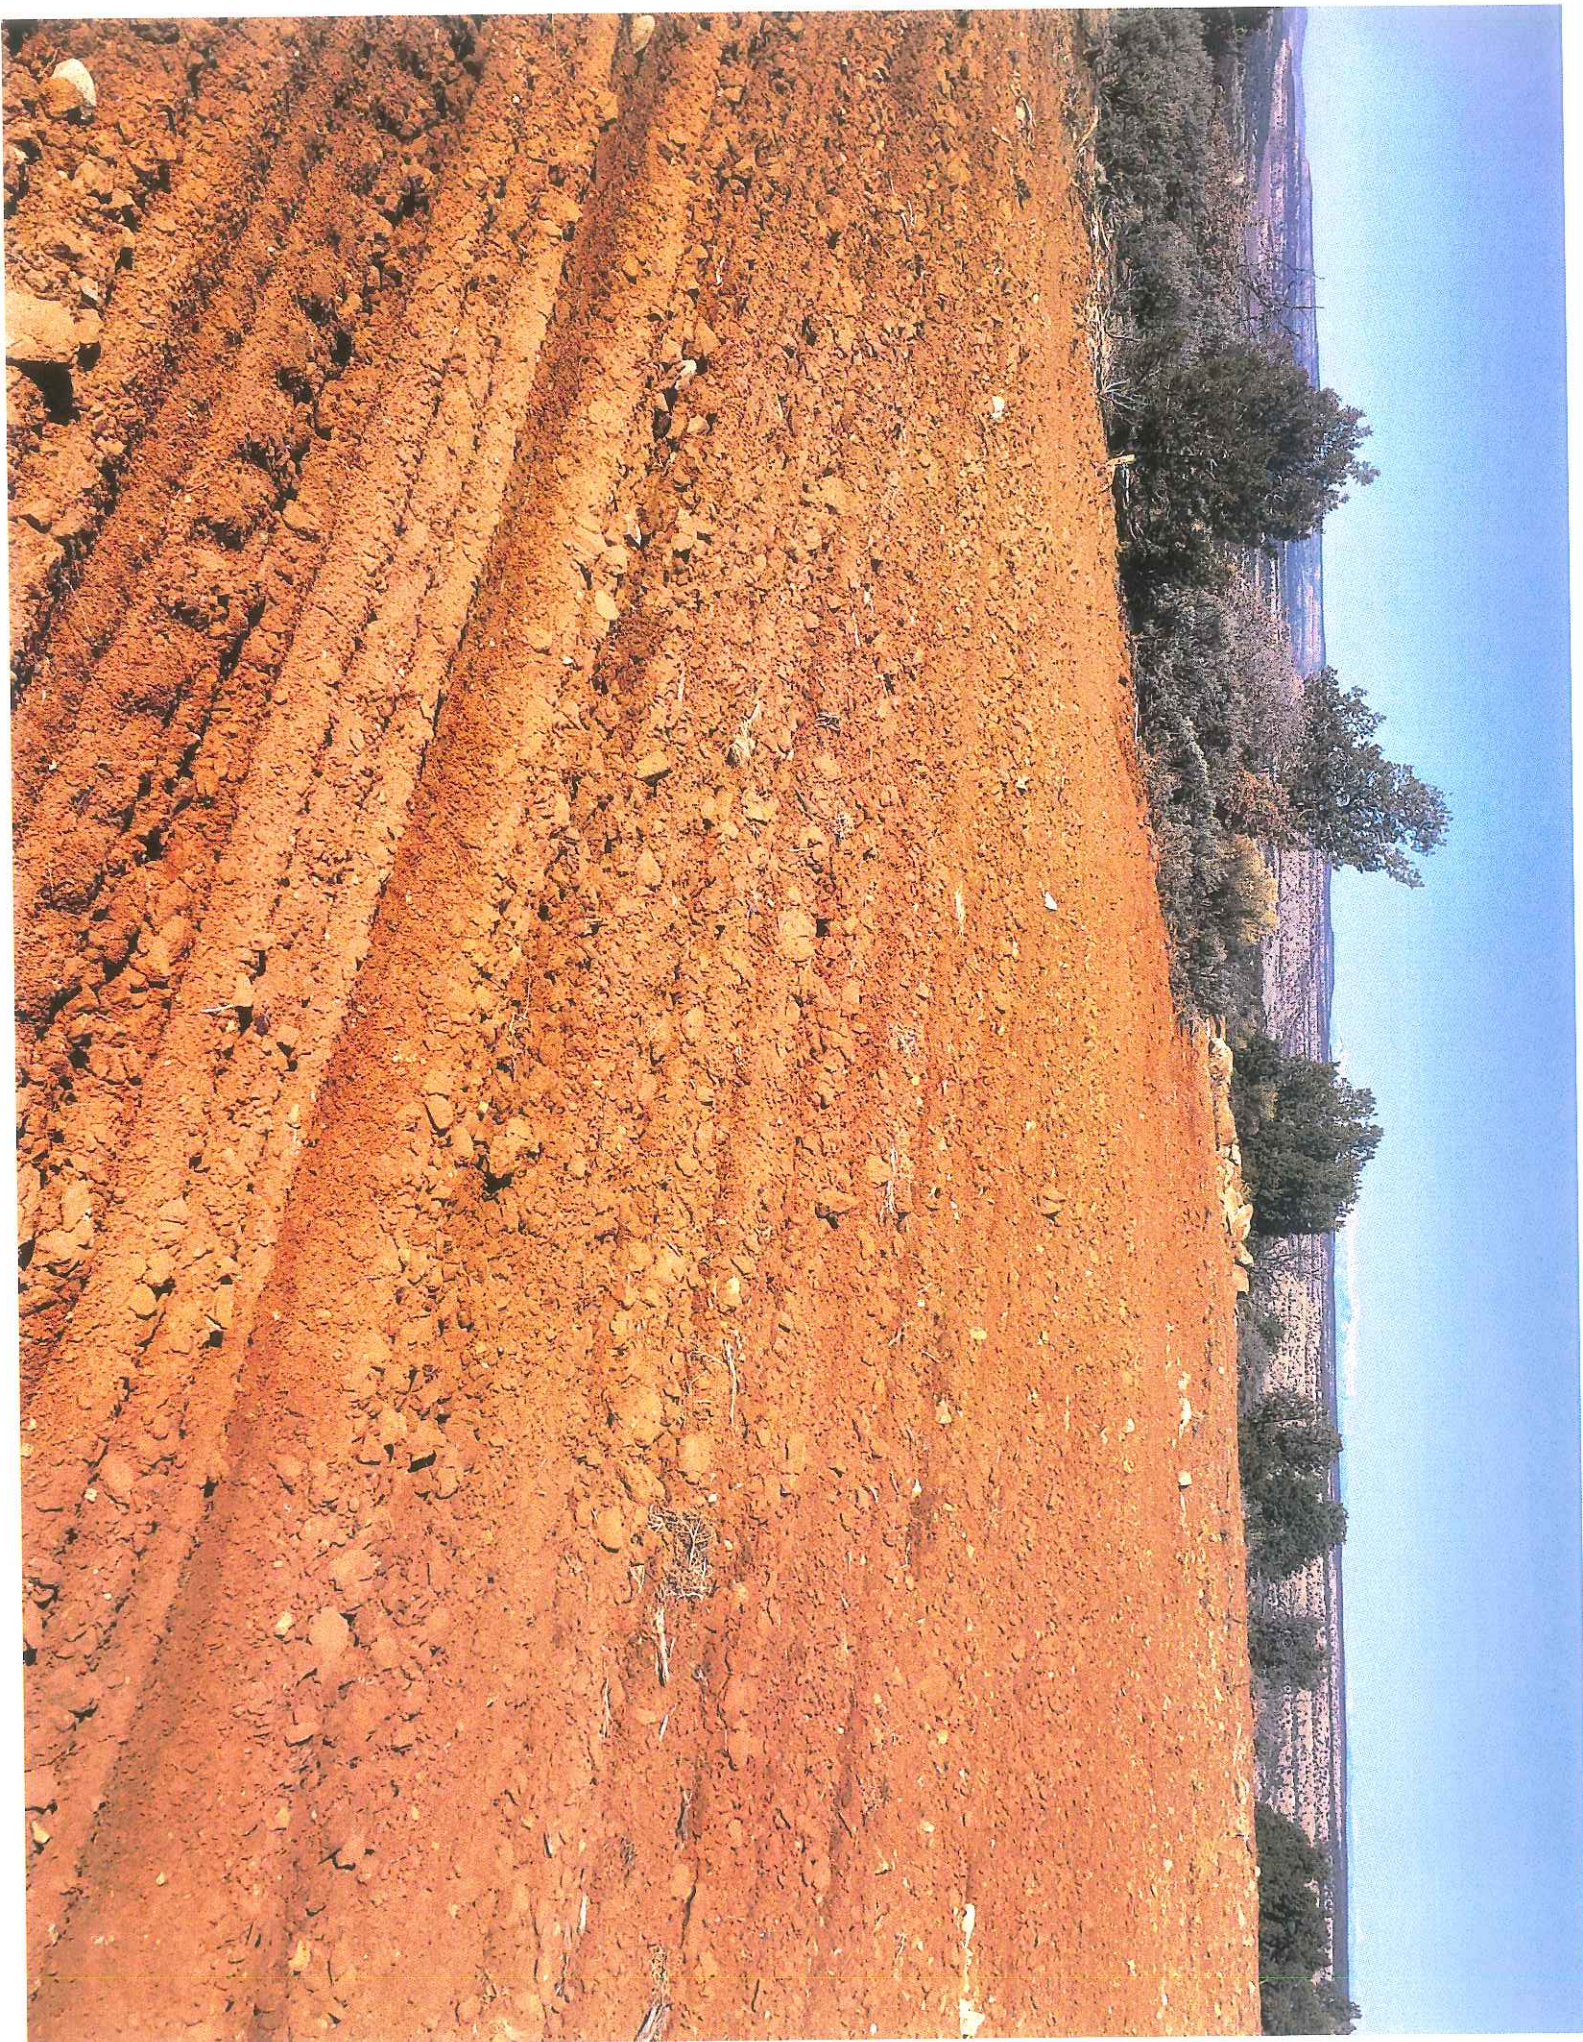
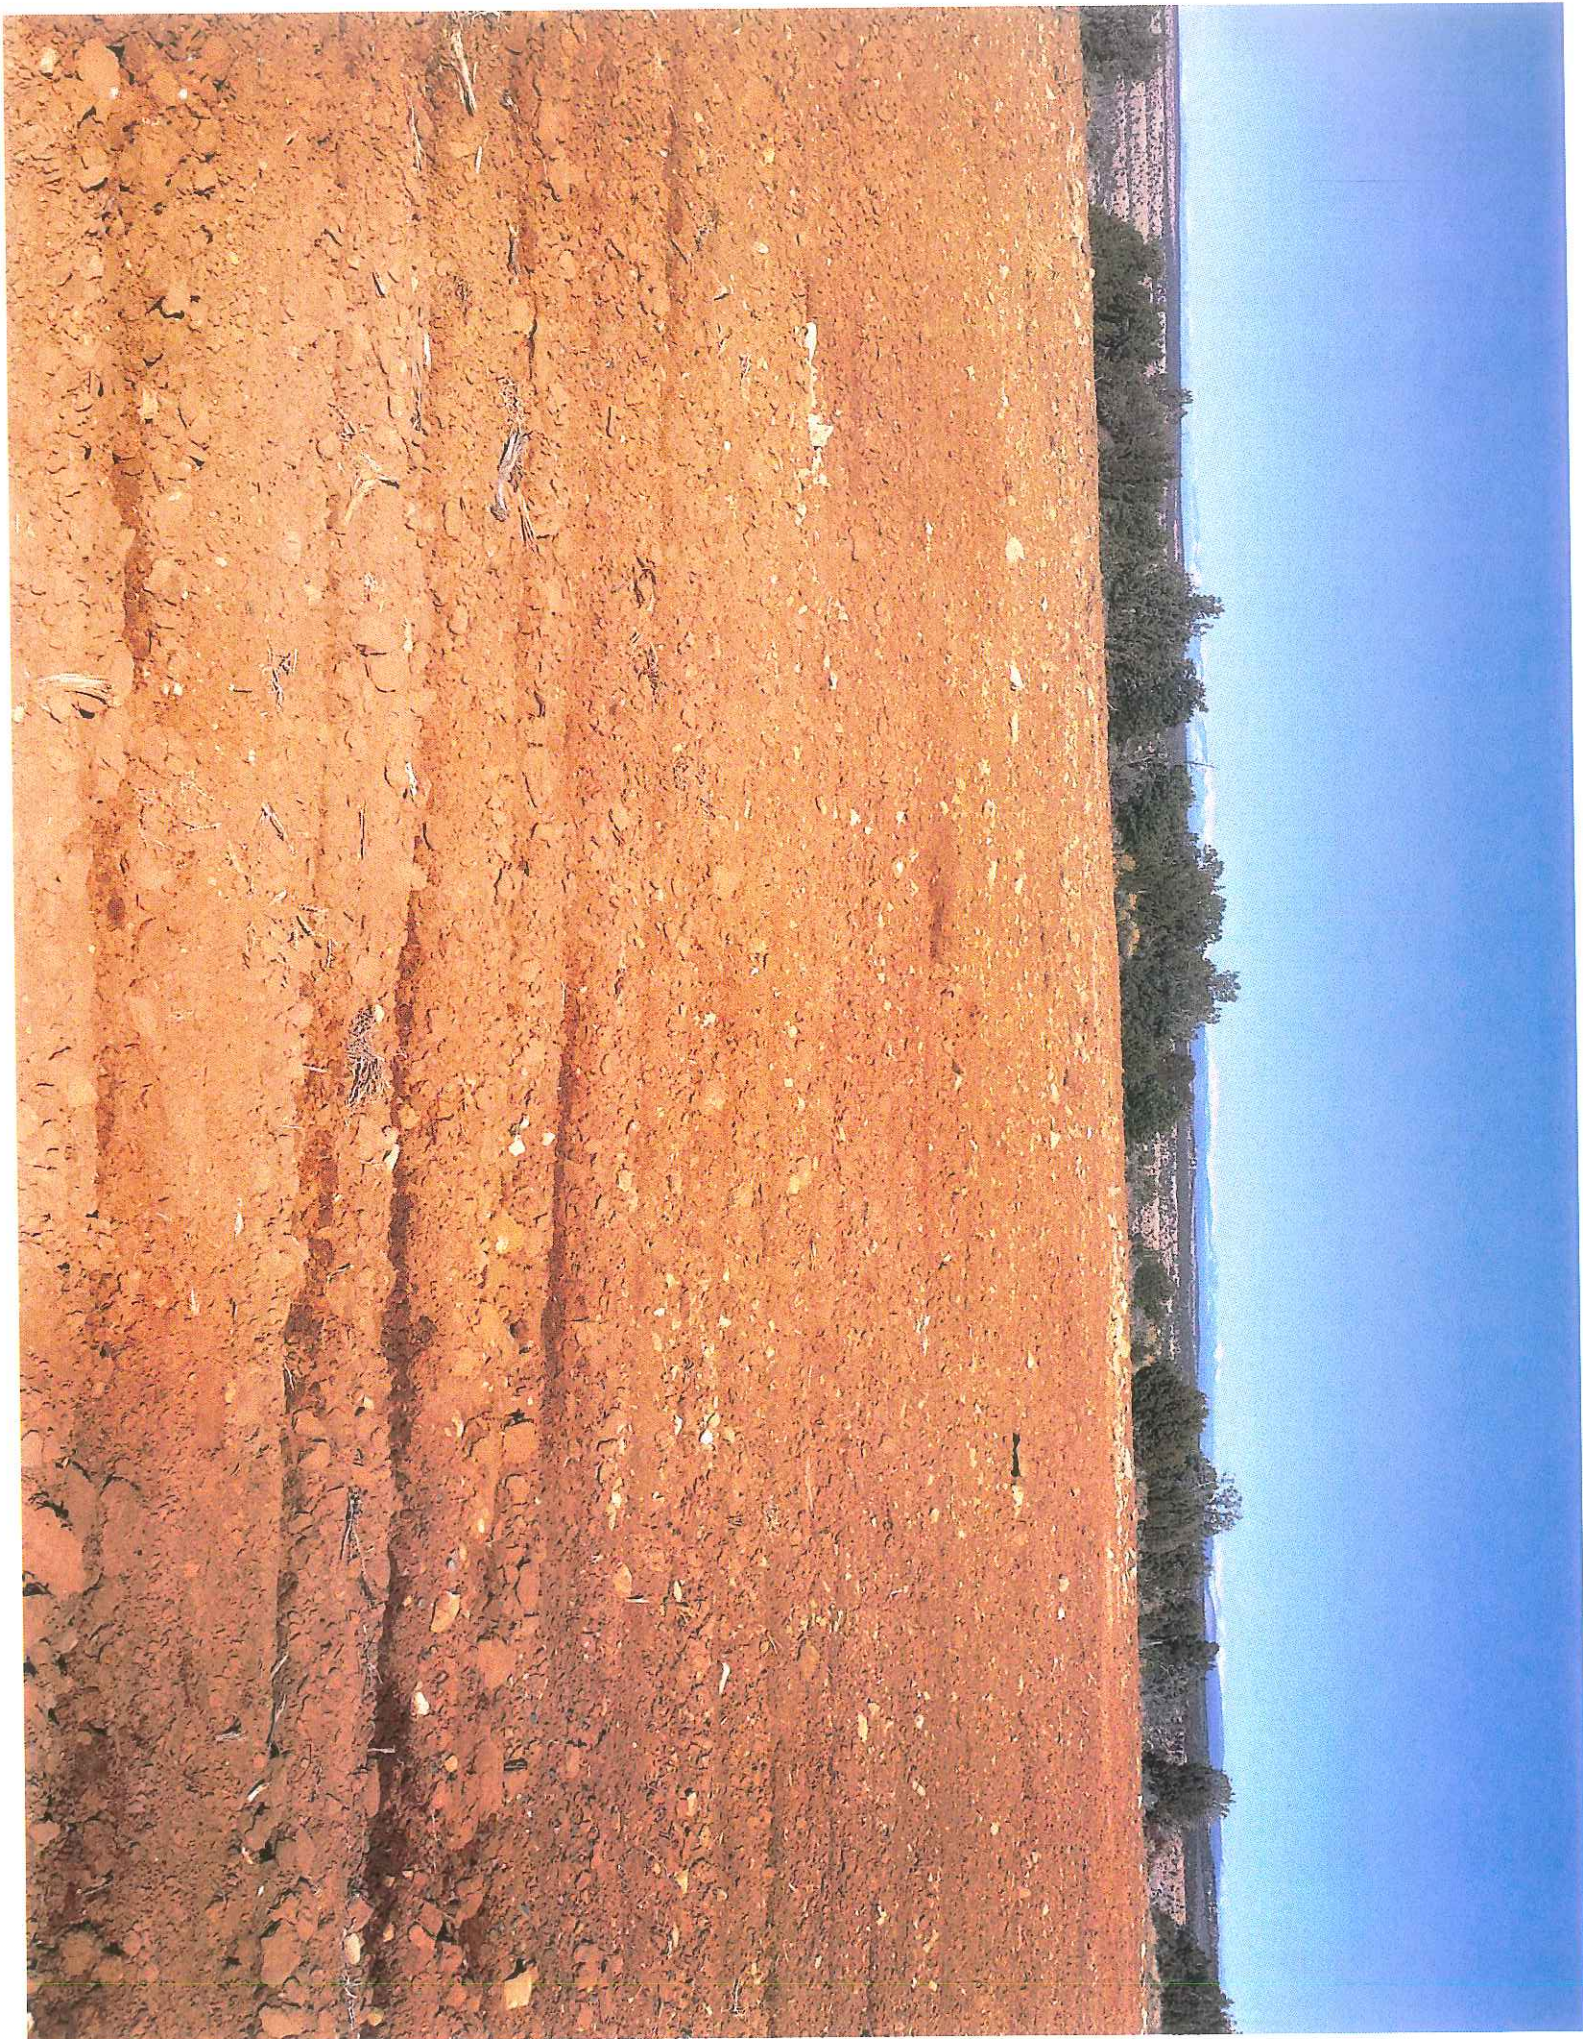
- ☒ Proof of Closure Notice (surface owner and division)
- ☐ Proof of Deed Notice (required for on-site closure for private land only)
- ☐ Plot Plan (for on-site closures and temporary pits)
- ☒ Confirmation Sampling Analytical Results (if applicable)
- ☐ Waste Material Sampling Analytical Results (required for on-site closure)
- ☐ Disposal Facility Name and Permit Number
- ☒ Soil Backfilling and Cover Installation
- ☒ Re-vegetation Application Rates and Seeding Technique
- ☒ Site Reclamation (Photo Documentation)
