Pit, Below-Grade Tank, or  
Proposed Alternative Method Permit or Closure Plan Application

**Burlington Resources Oil Gas Company, LP**  
**San Juan Basin**  
**Below Grade Tank Closure Report**

**Lease Name: SJ 27-4 Unit 77**

**API No.: 3003920886**

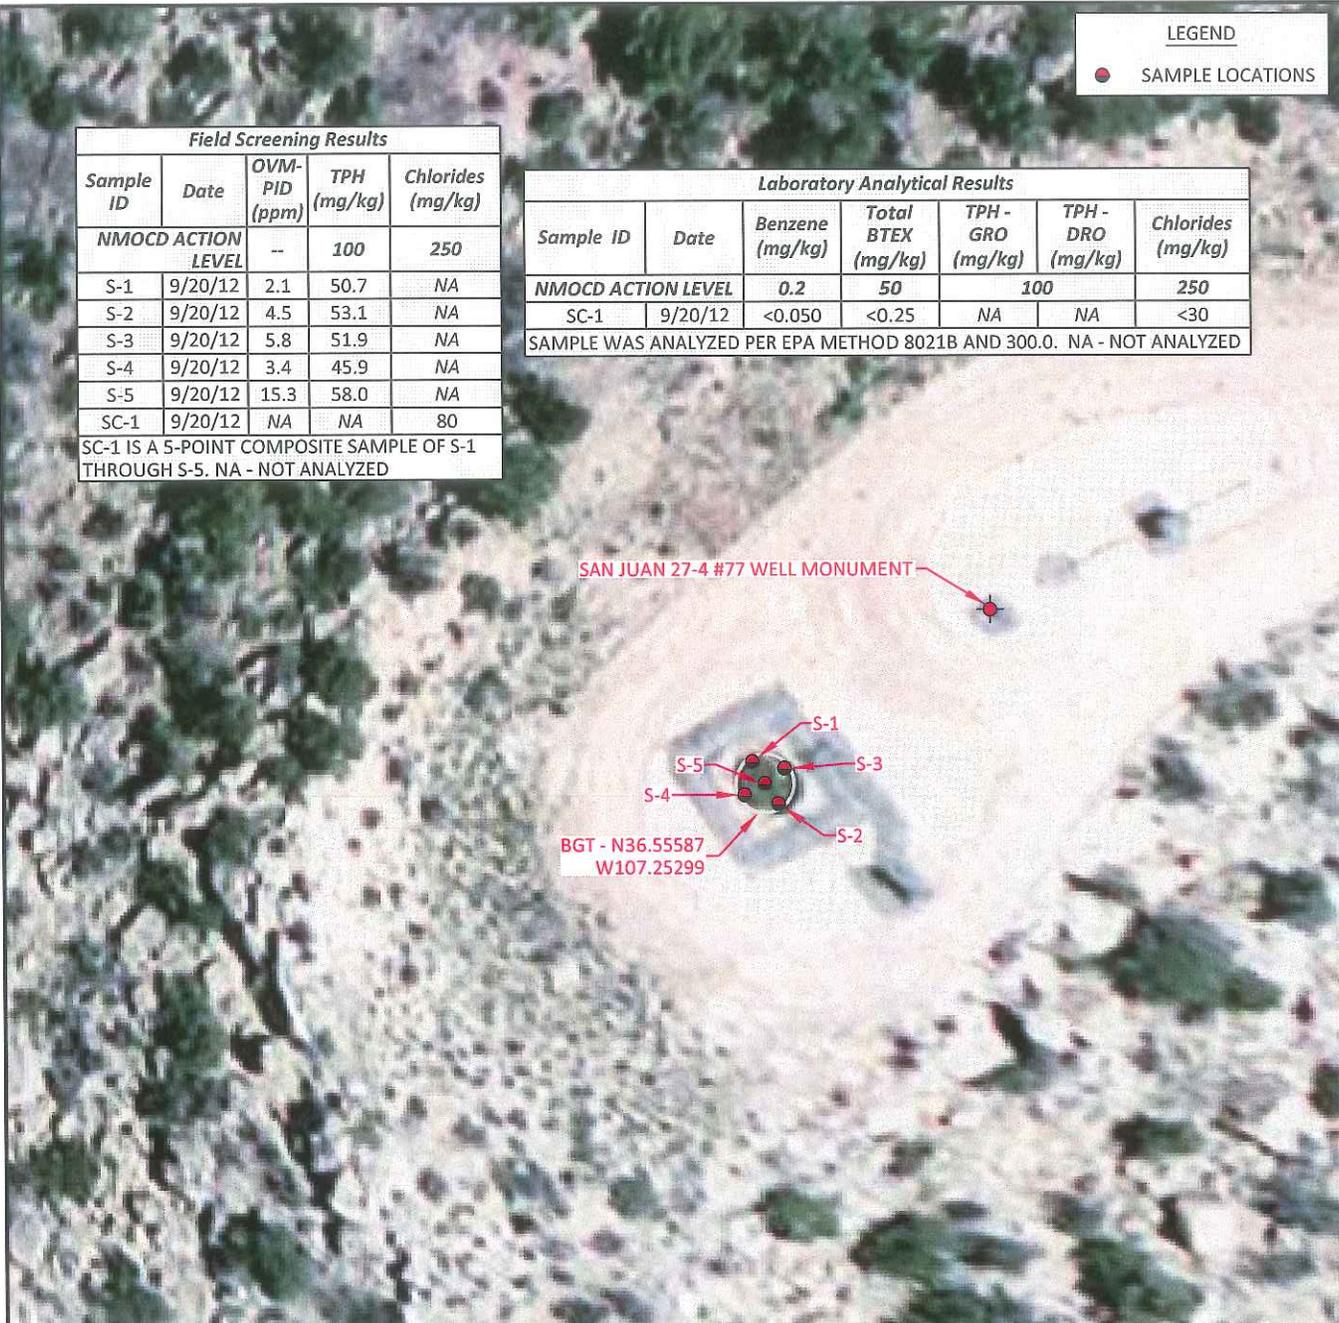
**FIGURE 2**  
**AERIAL SITE MAP**  
**BELOW GRADE TANK CLOSURE**  
**SEPTEMBER 2012**  
ConocoPhillips  
SAN JUAN 27-4 #77  
RIO ARriba COUNTY, NEW MEXICO  
NW¼ SE¼, SECTION 21, T27N, R4W  
N36.55598, W107.25285

AERIAL SOURCE: © 2012 MICROSOFT CORPORATION - AVAILABLE EXCLUSIVELY BY DIGITALGLOBE
