# Burlington Resources Oil Gas Company, LP San Juan Basin Below Grade Tank Closure Report

Lease Name: Cornell B 100 API No.: 30-045-30198

**Below Grade Tank Closure Report**

Cornell B #100

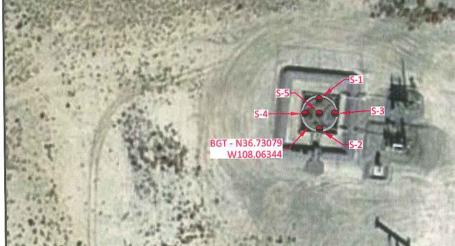
# FIGURE 2

SAMPLE LOCATIONS

Field Screening Results						
Sample ID Date		OVM- PID (ppm)	TPH (mg/kg)	Chlorides (mg/kg)		
NMOCD AC	TION LEVEL		100	250		
S-1	12/31/13	0.0	34.9	NA		
S-2	12/31/13	0.0	<20.0	NA		
S-3	12/31/13	0.0	<20.0	NA		
S-4	12/31/13	0.0	48.4	NA		
S-5	12/31/13	0.0	<20.0	NA		
SC-1	12/31/13	0.0	NA	60

Laborato	ry Analytica	ıl Results		
Sample ID	Date	Benzene (mg/kg)	Total BTEX (mg/kg)	TPH - GRO (mg/kg)	TPH - DRO (mg/kg)	Chlorides (mg/kg)
NMOCD ACTION LEVEL		0.2	50	10	00	250
SC-1	12/31/13	<0.033	<0.166	NA	NA	77

AERIAL SITE MAP BELOW GRADE TANK CLOSURE DECEMBER 2013

On December 31, 2013, AES personnel conducted field screening and collected five soil samples (S-1 through S-5) and one 5-point composite (SC-1) from below the BGT. Soil samples were collected from approximately 0.5 feet below the former BGT for field screening of volatile organic compounds (VOCs) and total petroleum hydrocarbon (TPH). Soil sample SC-1 was field screened for VOCs and chlorides and was submitted for confirmation laboratory analysis. Soil sample locations are included on Figure 2.

Field screening readings for VOCs via OVM were each measured at 0.0 ppm. Field TPH concentrations ranged from less than 20.0 mg/kg in S-2, S-3, and S-5, up to 48.4 mg/kg in S-4. The field chloride concentration in SC-1 was 60 mg/kg. Field screening results are summarized in Table 1 and presented on Figure 2. The AES Field Screening Report is attached.

Laboratory analytical results reported benzene and total BTEX concentrations in SC-1 as less than 0.033 mg/kg and 0.166 mg/kg, respectively. The laboratory chloride concentration was reported at 77 mg/kg. Laboratory analytical results are summarized in Table 2 and included on Figure 2. The laboratory analytical report is attached.
