Pit, Below-Grade Tank, or
Proposed Alternative Method Permit or Closure Plan Application

Burlington Resources Oil Gas Company, LP
San Juan Basin
Below Grade Tank Closure Report
(Without Reclamation)

Lease Name: THURSTON COM 101

API No.: 30-045-34615

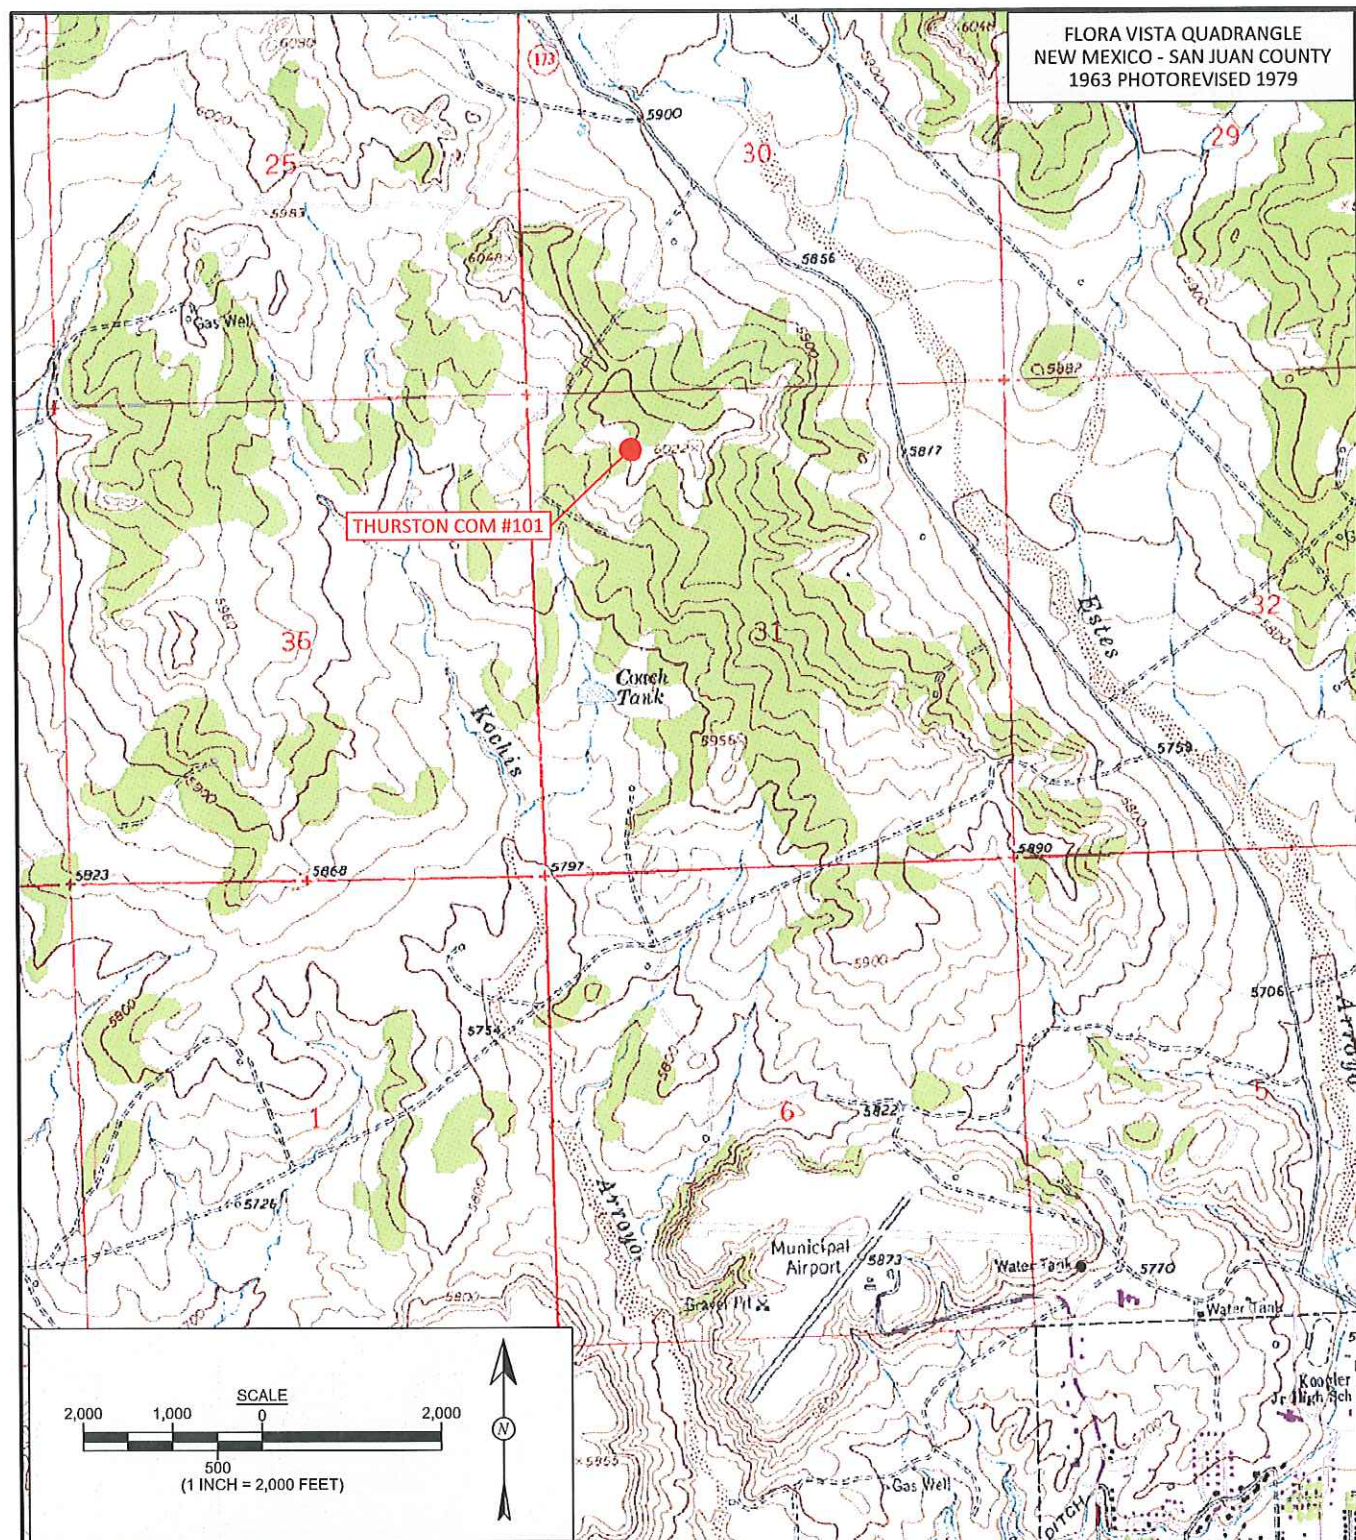
Figure 1. Topographic Site Location Map
Figure 2. Aerial Site Map, January 2013
AES Field Screening Report 011013
Hall Analytical Report 1301370
