Form C-144 Revised June 6, 2013

Burlington Resources Oil Gas Company, LP San Juan Basin Below Grade Tank Closure Report

Lease Name: LLOYD B COM 100 API No.: 30-045-34669

RE: Below Grade Tank Closure Report Llovd B Com #100

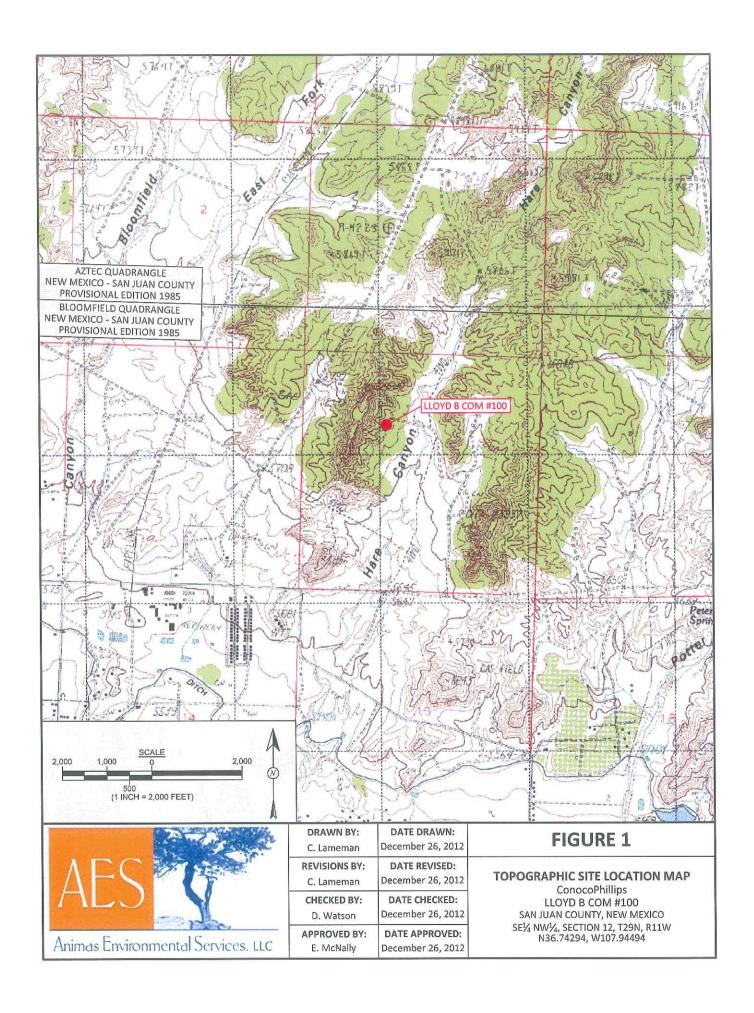
Site Name – Lloyd B Com #100
Legal Description – SE¼ NW¼, Section 12, T29N, R11W, San Juan County, New Mexico
Well Latitude/Longitude – N36.74294 and W107.94494, respectively
BGT Latitude/Longitude – N36.74279 and W107.94473, respectively
Land Jurisdiction – Bureau of Land Management (BLM)
Figure 1. Topographic Site Location Map
Figure 2. Aerial Site Map, December 2012

Figure 1. Topographic Site Location Map Figure 2. Aerial Site Map, December 2012 AES Field Screening Report 121812 Hall Analytical Report 1212831

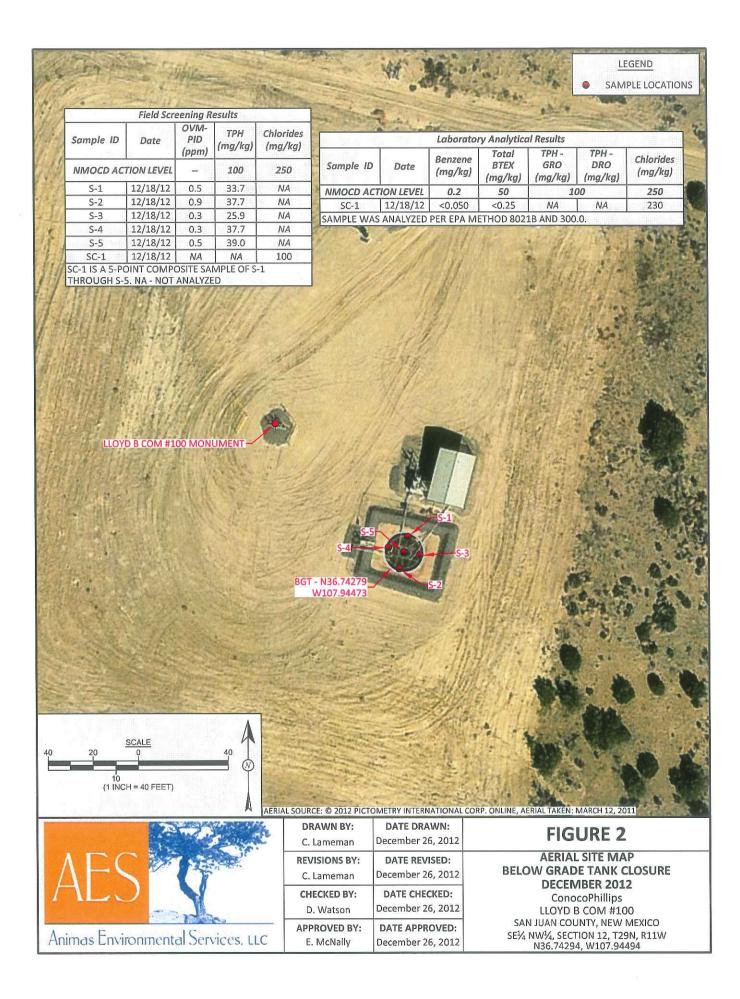
On December 18, 2012, AES personnel conducted field screening and collected five soil samples (S-1 through S-5) and one 5-point composite (SC-1) from below the BGT. Soil samples were collected from approximately 0.5 feet below the former BGT for field screening of volatile organic compounds (VOCs) and total petroleum hydrocarbon (TPH). Soil sample SC-1 was field screened for chloride and was submitted for confirmation laboratory analysis. Soil sample locations are included on Figure 2.

Field screening readings for VOCs via OVM ranged from 0.3 ppm in S-3 and S-4 up to 0.9 ppm in S-2. Field TPH concentrations ranged from 25.9 mg/kg in S-3 up to 39.0 mg/kg in S-5. The field chloride concentration in SC-1 was 100 mg/kg. Field screening results are summarized in Table 1 and presented on Figure 2. The AES Field Screening Report is attached.

Laboratory analytical results reported benzene and total BTEX concentrations in SC-1 as less than 0.050 mg/kg and 0.25 mg/kg, respectively. The laboratory chloride concentration was reported as 230 mg/kg. Laboratory analytical results are summarized in Table 2 and included on Figure 2. Laboratory analytical reports are attached.
