Pit, Below-Grade Tank, or
Proposed Alternative Method Permit or Closure Plan Application

ConocoPhillips Company
San Juan Basin
Below Grade Tank Closure Report

Lease Name: JICARILLA B 13M

API No.: 30-039-25773

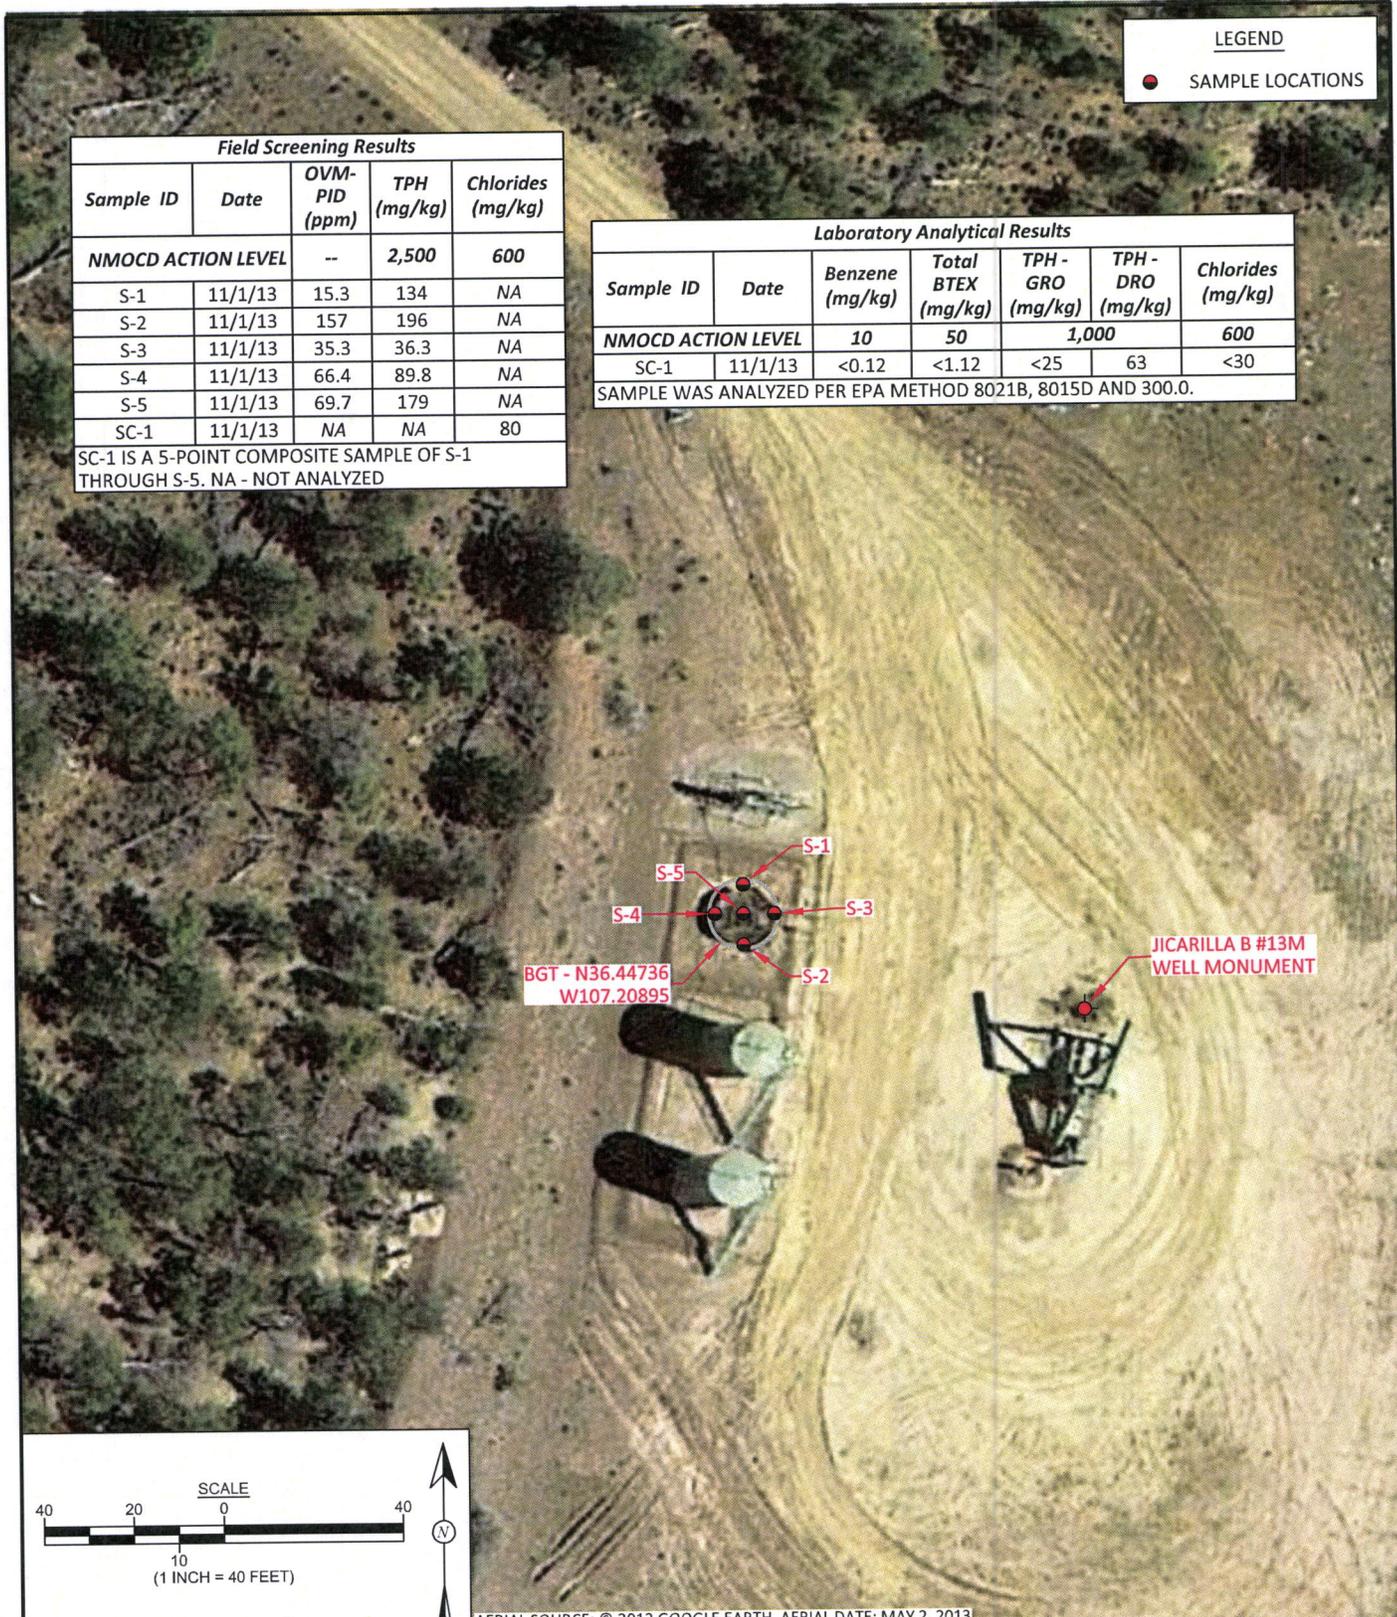
FIGURE 2
AERIAL SITE MAP
BELOW GRADE TANK CLOSURE
NOVEMBER 2013
 ConocoPhillips
 JICARILLA B #13M
 NW¼ NW¼, SECTION 36, T26N, R4W
 RIO ARRIBA COUNTY, NEW MEXICO
 N36.44730, W107.20869

SAMPLE WAS ANALYZED PER EPA METHOD 8021B, 8015D AND 300.0.

SC-1 IS A 5-POINT COMPOSITE SAMPLE OF S-1 THROUGH S-5. NA - NOT ANALYZED
