Pit, Below-Grade Tank, or
Proposed Alternative Method Permit or Closure Plan Application

Burlington Resources Oil & Gas Company, LP
San Juan Basin
Below Grade Tank Closure Report

Lease Name: San Juan 29-7 Unit 101

API No.: 30-039-20082

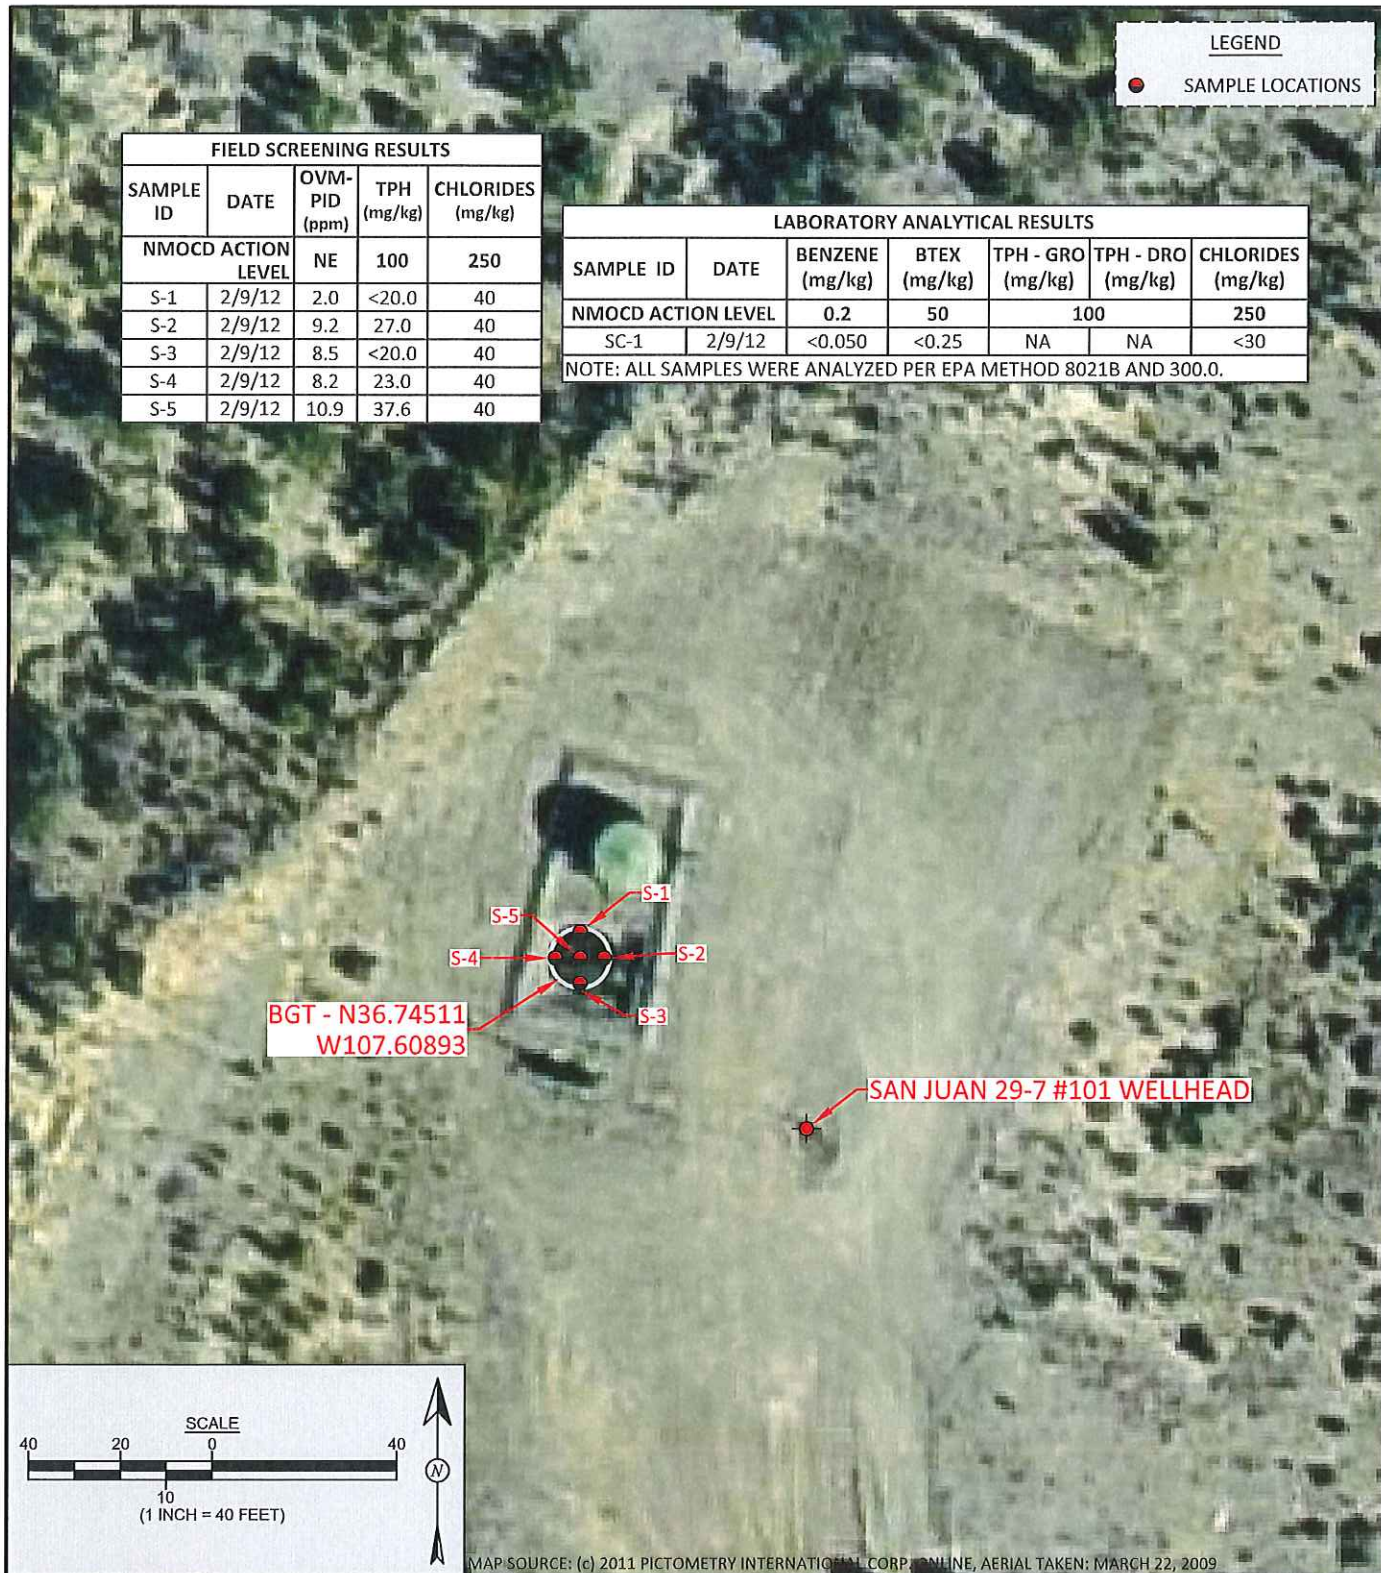
FIGURE 2

LABORATORY ANALYTICAL RESULTS						
SAMPLE ID	DATE	BENZENE (mg/kg)	BTEX (mg/kg)	TPH - GRO (mg/kg)	TPH - DRO (mg/kg)	CHLORIDES (mg/kg)
NMOCD ACTION LEVEL		0.2	50	100		250
SC-1	2/9/12	<0.050	<0.25	NA	NA	<30

GENERAL SITE MAP BELOW GRADE TANK CLOSURE FEBRUARY 2012

ConocoPhillips
SAN JUAN 29-7 #101
RIO ARriba COUNTY, NEW MEXICO
NW¼, NE¼, SECTION 7, T29N, R7W
N36.74502, W107.60880

NMOCD action levels for BGT closures are specified in New Mexico Administrative Code (NMAC) 19.15.17.13E. Benzene concentrations in SC-1 were below the laboratory detection limit of 0.050 mg/kg, and total BTEX concentrations were below the NMOCD action level of 50 mg/kg in SC-1. Field TPH concentrations were below the NMOCD action level of 100 mg/kg in all samples. Chloride concentrations for all samples were below the NMOCD action level of 250 mg/kg. Based on field screening and laboratory analytical results for benzene, BTEX, TPH, and chlorides, no further work is recommended.
