Pit, Below-Grade Tank, or
Proposed Alternative Method Permit or Closure Plan Application

Facility or well name: Canyon Largo Unit 6

Burlington Resources Oil & Gas Company, LP
San Juan Basin
Below Grade Tank Closure Report

Lease Name: Canyon Largo Unit 6
API No.: 3003921371

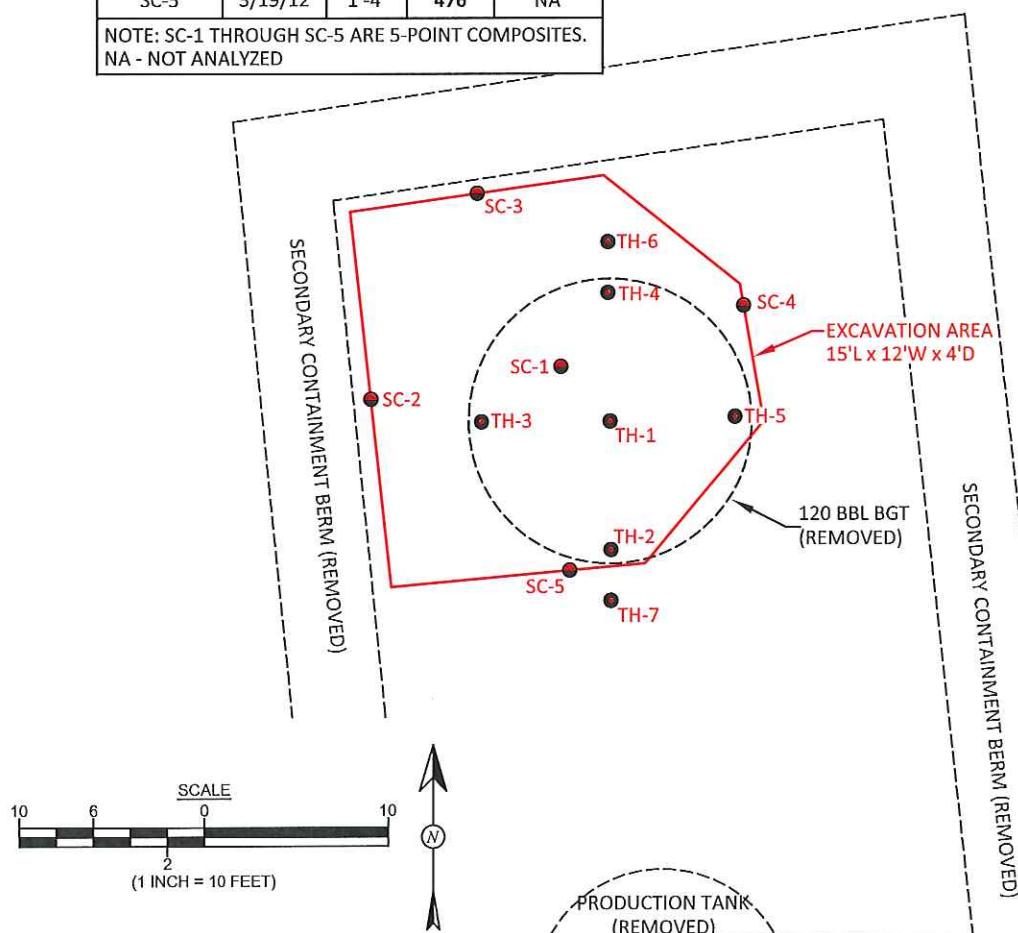
SAMPLE LOCATIONS

Field Screening Results			
Sample ID	Date	OVM-PID (ppm)	TPH (mg/kg)
NMOCD Action Level		NE	100
BGT SC-1	3/16/12	946	17,200
NOTE: SC-1 IS A 5-POINT COMPOSITE COLLECTED FROM BGT FOOTPRINT.

NOTE: ALL SAMPLES WERE ANALYZED PER EPA METHOD 8021B.

LEGEND	
●	TEST HOLE LOCATIONS
●	SAMPLE LOCATIONS

5. Soil laboratory analytical results showed that benzene and BTEX concentrations were below the NMOCD action levels for S-1, S-3, S-4, and S-5. Based on confirmation field screening and laboratory analytical results from March 16 and 19, 2012, no further work is recommended.
