Pit, Below-Grade Tank, or  
Proposed Alternative Method Permit or Closure Plan Application

Facility or well name: SAN JUAN 30-6 UNIT 481S

**Burlington Resources Oil & Gas Company, LP**  
**San Juan Basin**  
**Below Grade Tank Closure Report**

**Lease Name: San Juan 30-6 Unit 481S**

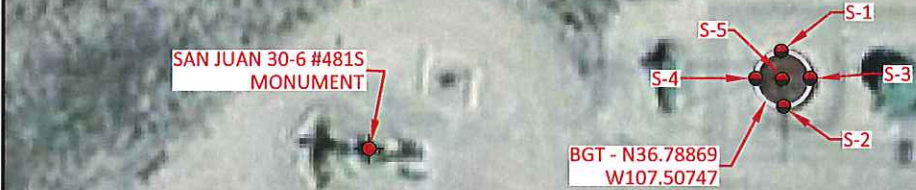
| Laboratory Analytical Results | | | | | | |
|---|---|---|---|---|---|---|
| SC-1 | 3/7/13 | <0.050 | <0.25 | NA | NA | <30 |
| SAMPLE WAS ANALYZED PER EPA METHOD 8260B AND 300.0. NA- NOT ANALYZED | | | | | | |
