Burlington Resources Oil & Gas Company San Juan Basin: New Mexico Assets

Below Grade Tank Closure Report

Lease Name: Southeast Cha Cha 38

API No.: 30-045-24816

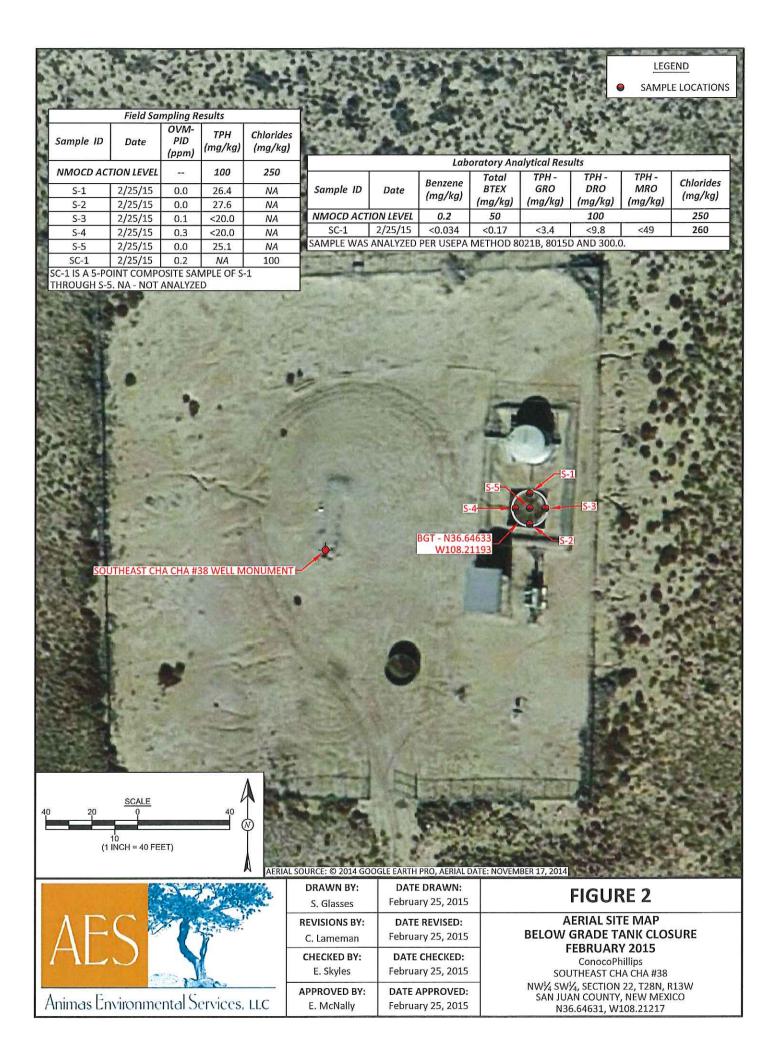
Figure 2. Aerial Site Map, February 2015

On February 25, 2015, AES personnel conducted field sampling and collected five soil samples (S-1 through S-5) and one 5-point composite (SC-1) from below the BGT. Soil samples were collected from approximately 0.5 feet below the former BGT for field screening of volatile organic compounds (VOCs) and total petroleum hydrocarbon (TPH). Soil sample SC-1 was field screened for VOCs and chloride and was submitted for confirmation laboratory analysis. Soil sample locations are included on Figure 2.

Field screening readings for VOCs via OVM ranged from 0.0 ppm in S-1, S-2, and S-5 up to 0.3 ppm in S-4. Field TPH concentrations ranged from less than 20.0 mg/kg in S-3 and S-4 up to 27.6 mg/kg in S-2. The field chloride concentration in SC-1 was 100 mg/kg. Field sampling results are summarized in Table 1 and presented on Figure 2. The AES Field Sampling Report is attached.

Laboratory analytical results reported benzene and total BTEX concentrations in SC-1 as less than 0.034 mg/kg and less than 0.170 mg/kg, respectively. TPH concentrations as GRO, DRO, and MRO were reported at less than 3.4 mg/kg, less than 9.8 mg/kg, and less than 49 mg/kg, respectively. The laboratory chloride concentration was reported at 260 mg/kg. Laboratory analytical results are summarized in Table 2 and included on Figure 2. The laboratory analytical report is attached.
