Pit, Below-Grade Tank, or
Proposed Alternative Method Permit or Closure Plan Application

Burlington Resources Oil & Gas Company, LP
San Juan Basin
Below Grade Tank Closure Report

Lease Name: SAN JUAN 32-9 UNIT 35

API No.: 30-045-10929

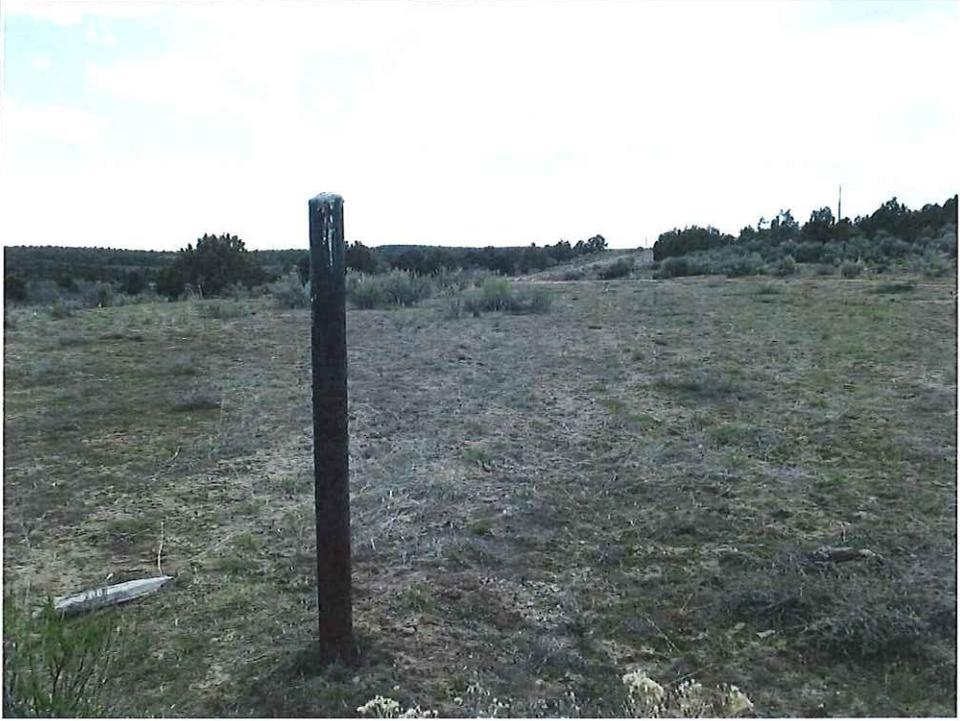
Photo #1

Client: ConocoPhillips	
Project Name: San Juan 32-9 Unit 35 San Juan County, NM	
Date Photo Taken: April 21, 2016	
BGT GPS and Location: 36.91534, -107.76442 SW¼ NE¼, Section 10, T31N, R9W	
Taken by: Sam Glasses, AES

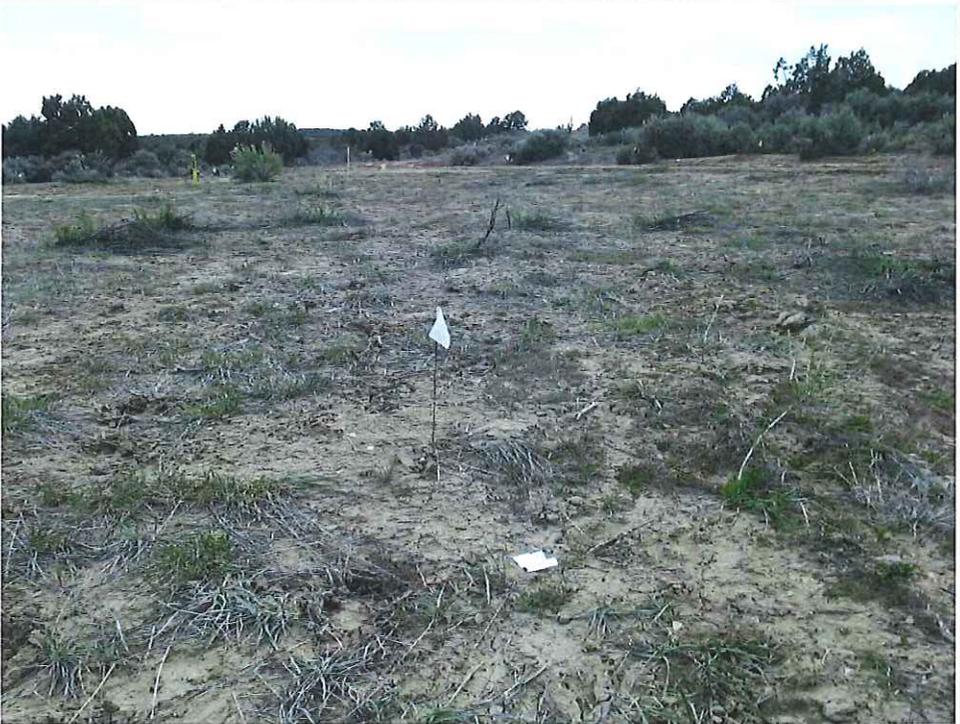
Photo #2

Client: ConocoPhillips	
Project Name: San Juan 32-9 Unit 35 San Juan County, NM	
Date Photo Taken: April 21, 2016	
BGT GPS and Location: 36.91534, -107.76442 SW¼ NE¼, Section 10, T31N, R9W	
Taken by: Sam Glasses, AES
