Pit, Below-Grade Tank, or
Proposed Alternative Method Permit or Closure Plan Application

Burlington Resources Oil & Gas Company, LP
San Juan Basin
Below Grade Tank Closure Report

Lease Name: San Juan 27-4 Unit 5

API No.: 30-039-07136

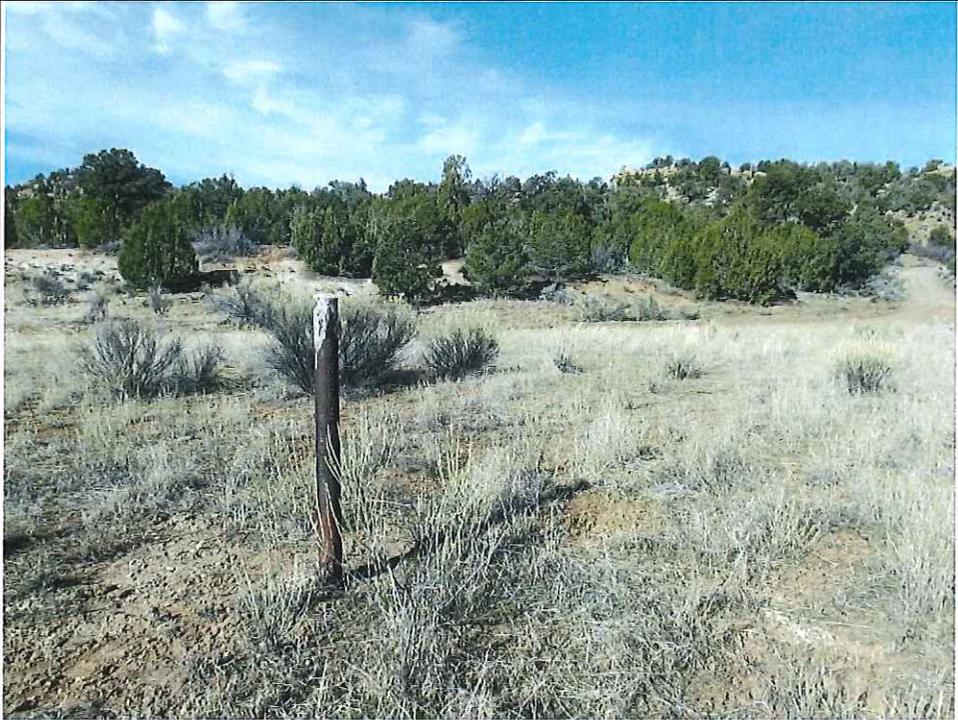
Photo #1

Client: ConocoPhillips	
Project Name: San Juan 27-4 Unit 5 Rio Arriba County, NM	
Date Photo Taken: March 23, 2016	
BGT GPS and Location: 36.59161, -107.28675 NE¼ NE¼, Section 7, T27N, R4W	
Taken by: Sam Glasses, AES

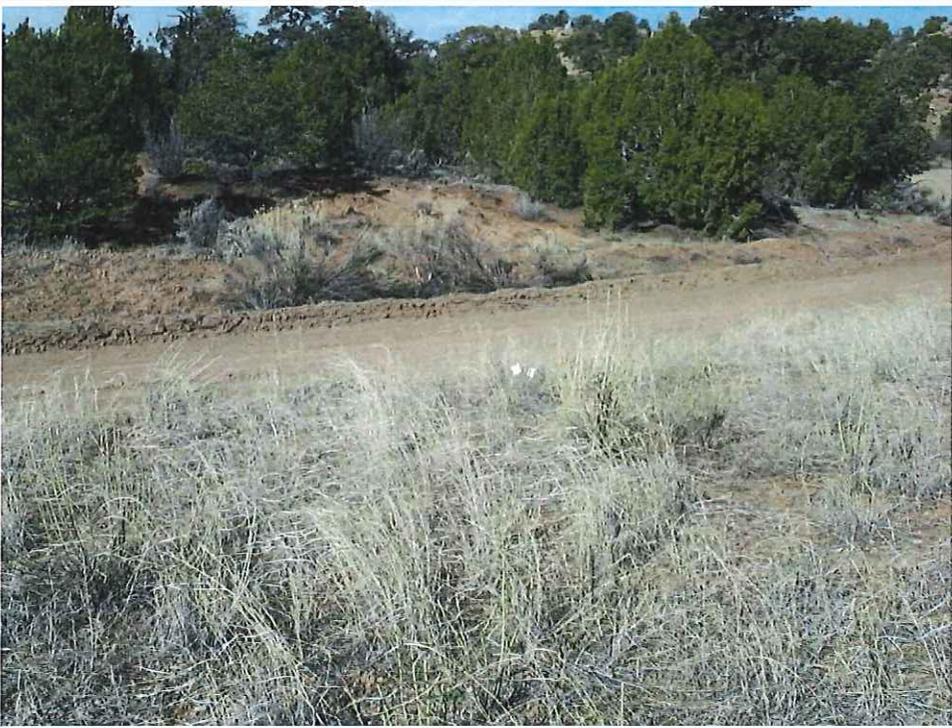
Photo #2

Client: ConocoPhillips	
Project Name: San Juan 27-4 Unit 5 Rio Arriba County, NM	
Date Photo Taken: March 23, 2016	
BGT GPS and Location: 36.59161, -107.28675 NE¼ NE¼, Section 7, T27N, R4W	
Taken by: Sam Glasses, AES
