Pit, Below-Grade Tank, or  
Proposed Alternative Method Permit or Closure Plan Application

Facility or well name: Huerfano 206

BGT CLOSED  
PRIOR TO  
CLOSURE PLAN  
APPROVAL

R:\Animas 2000\Dropbox\2013 Projects\ConocoPhillips\Huerfano #206\Huerfano #206 BGT Closure and Final Excavation Report 072613.docx

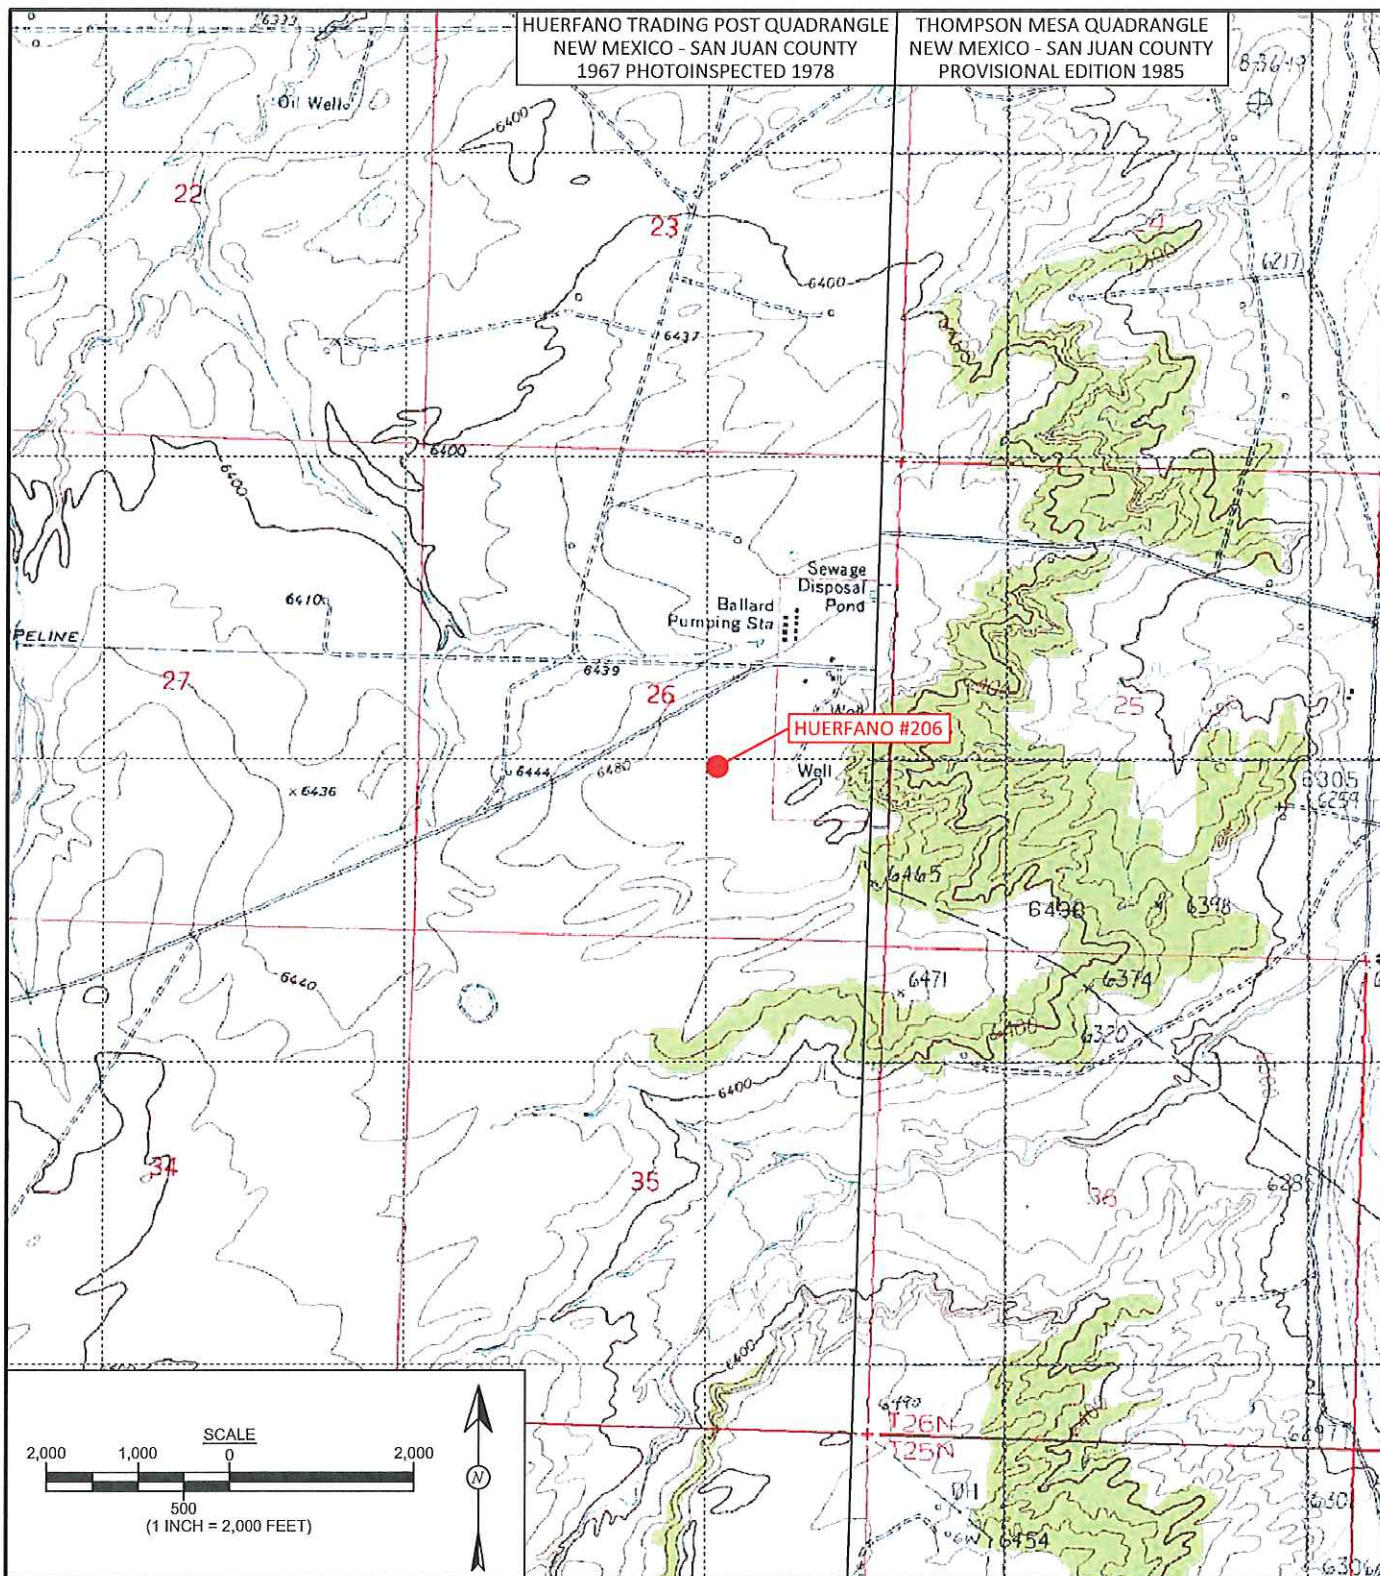
**FIGURE 1**

**TOPOGRAPHIC SITE LOCATION MAP**  
 ConocoPhillips  
 HUERFANO #206  
 NW¼ SE¼, SECTION 26, T26N, R9W  
 SAN JUAN COUNTY, NEW MEXICO  
 N36.45700, W107.75587

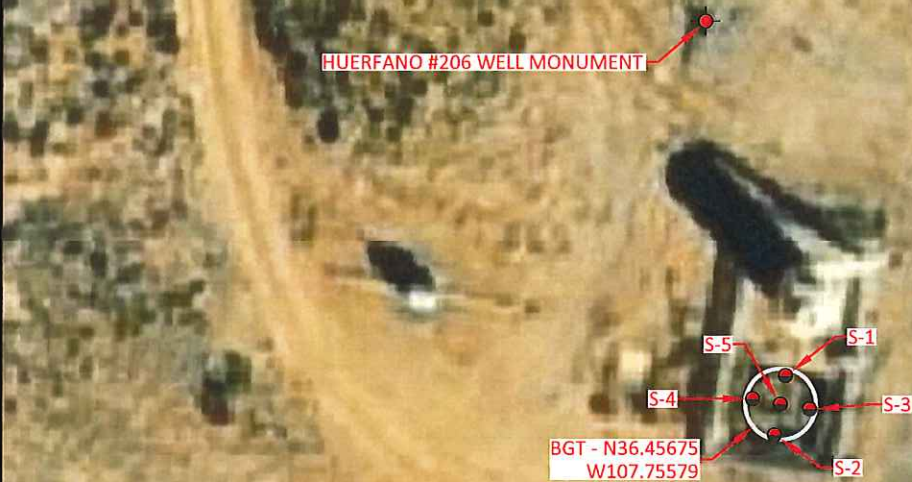
AERIAL SOURCE: © 2012 PICTOMETRY INTERNATIONAL CORP. ONLINE, AERIAL DATE: FEBRUARY 20, 2009

HUERFANO #206 WELL MONUMENT

METER  
HOUSE

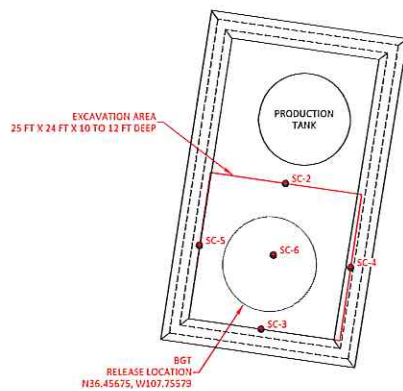
Field Screening Results				
Sample ID	Date	Depth (ft)	OVM- PID (ppm)	TPH (mg/kg)
NMOCD ACTION LEVEL			100	1,000
SC-2	6/14/13	1 to 10	4.4	64.5
SC-3	6/14/13	1 to 12	24.8	700
SC-4	6/14/13	1 to 12	29.1	114
SC-5	6/14/13	1 to 10	4.2	245
SC-6	6/14/13	10 to 12	2.7	1,510

Laboratory Analytical Results				
Sample ID	Date	Depth (ft)	TPH - GRO (mg/kg)	TPH - DRO (mg/kg)
NMOCD ACTION LEVEL			1,000	
SC-6	6/14/13	10 to 12	<50	370

Based on excavation of petroleum hydrocarbon impacted soils, field screening, and laboratory analytical results for VOCs, benzene, total BTEX, TPH, and chlorides, no further work is recommended for the Huerfano #206.
