## Release Notification

Site Name: <b>Chaco 2408 32P 114H</b>	Site Type: <b>Well Site</b>
Date Release Discovered: <b>8/21/2019</b>	API# (if applicable): <b>30-045-35441</b>

## **Chaco 2408 32P 114H Narrative**

Enduring Resources, LLC  
Spill Closure Report  
Chaco 2408 32P 114H Release

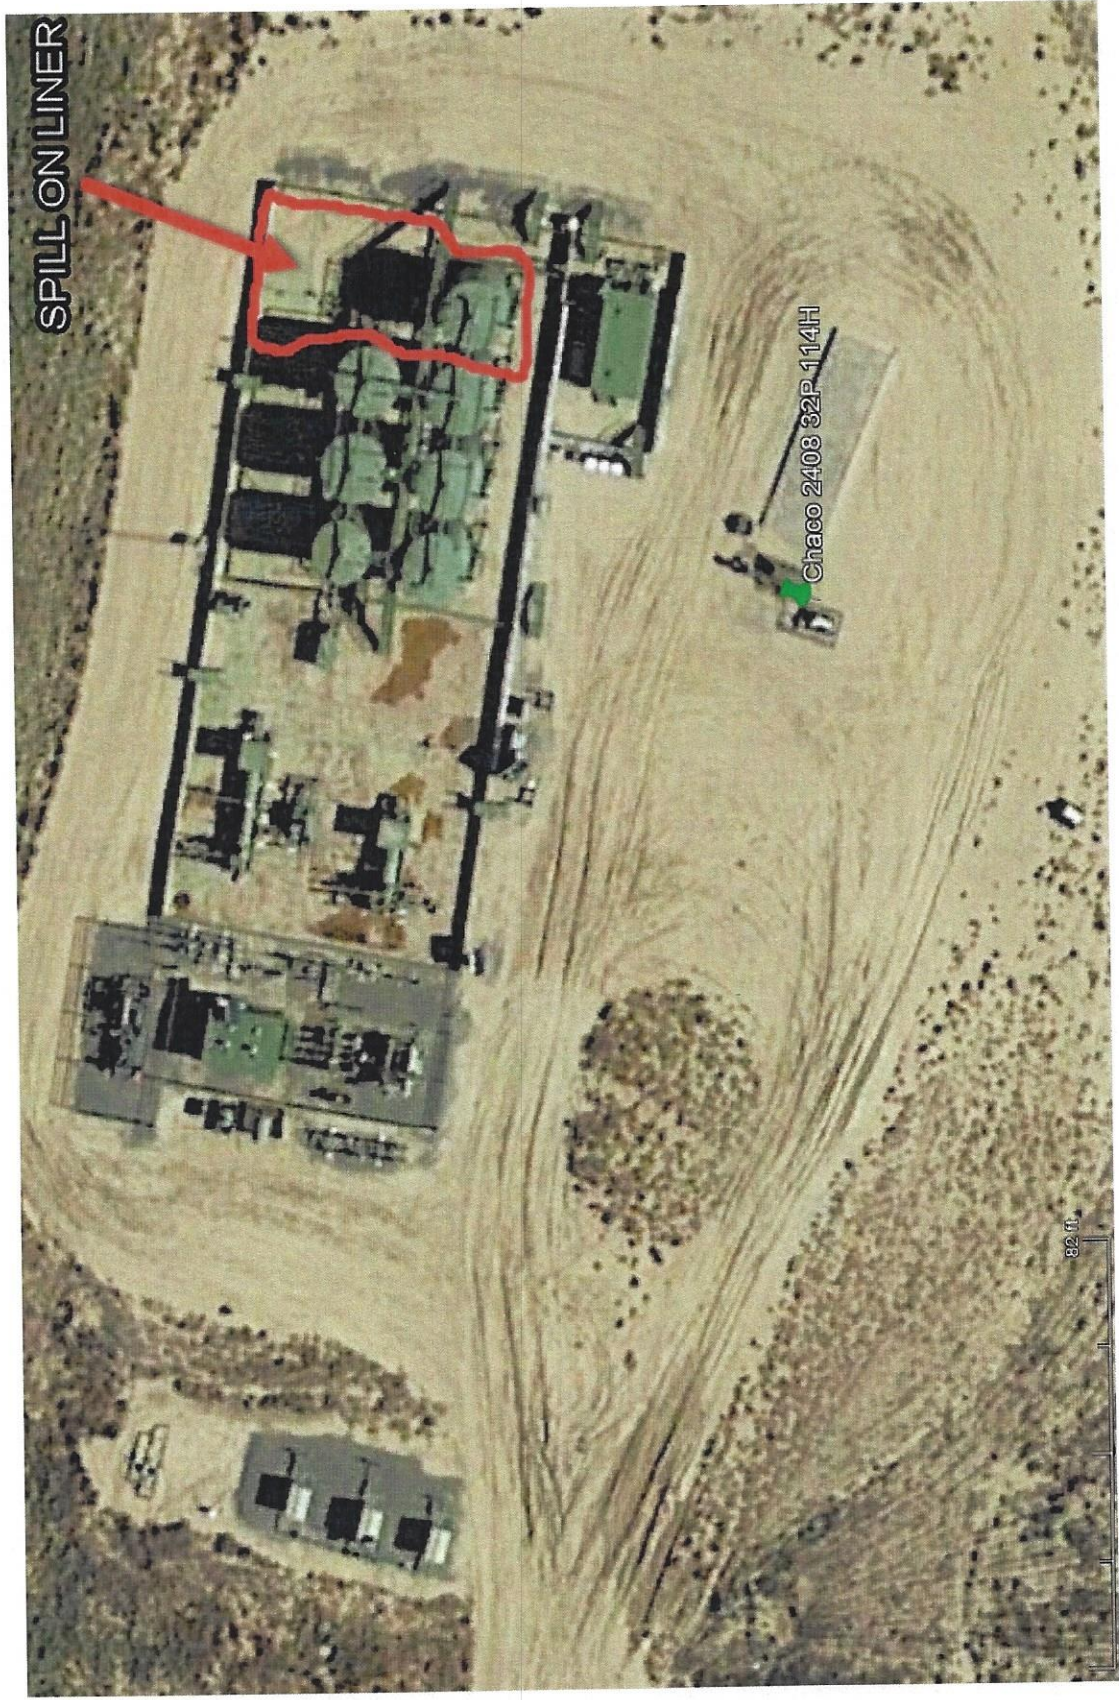
Chaco 2408 32P 114H

SPILL ON LINER

82 ft

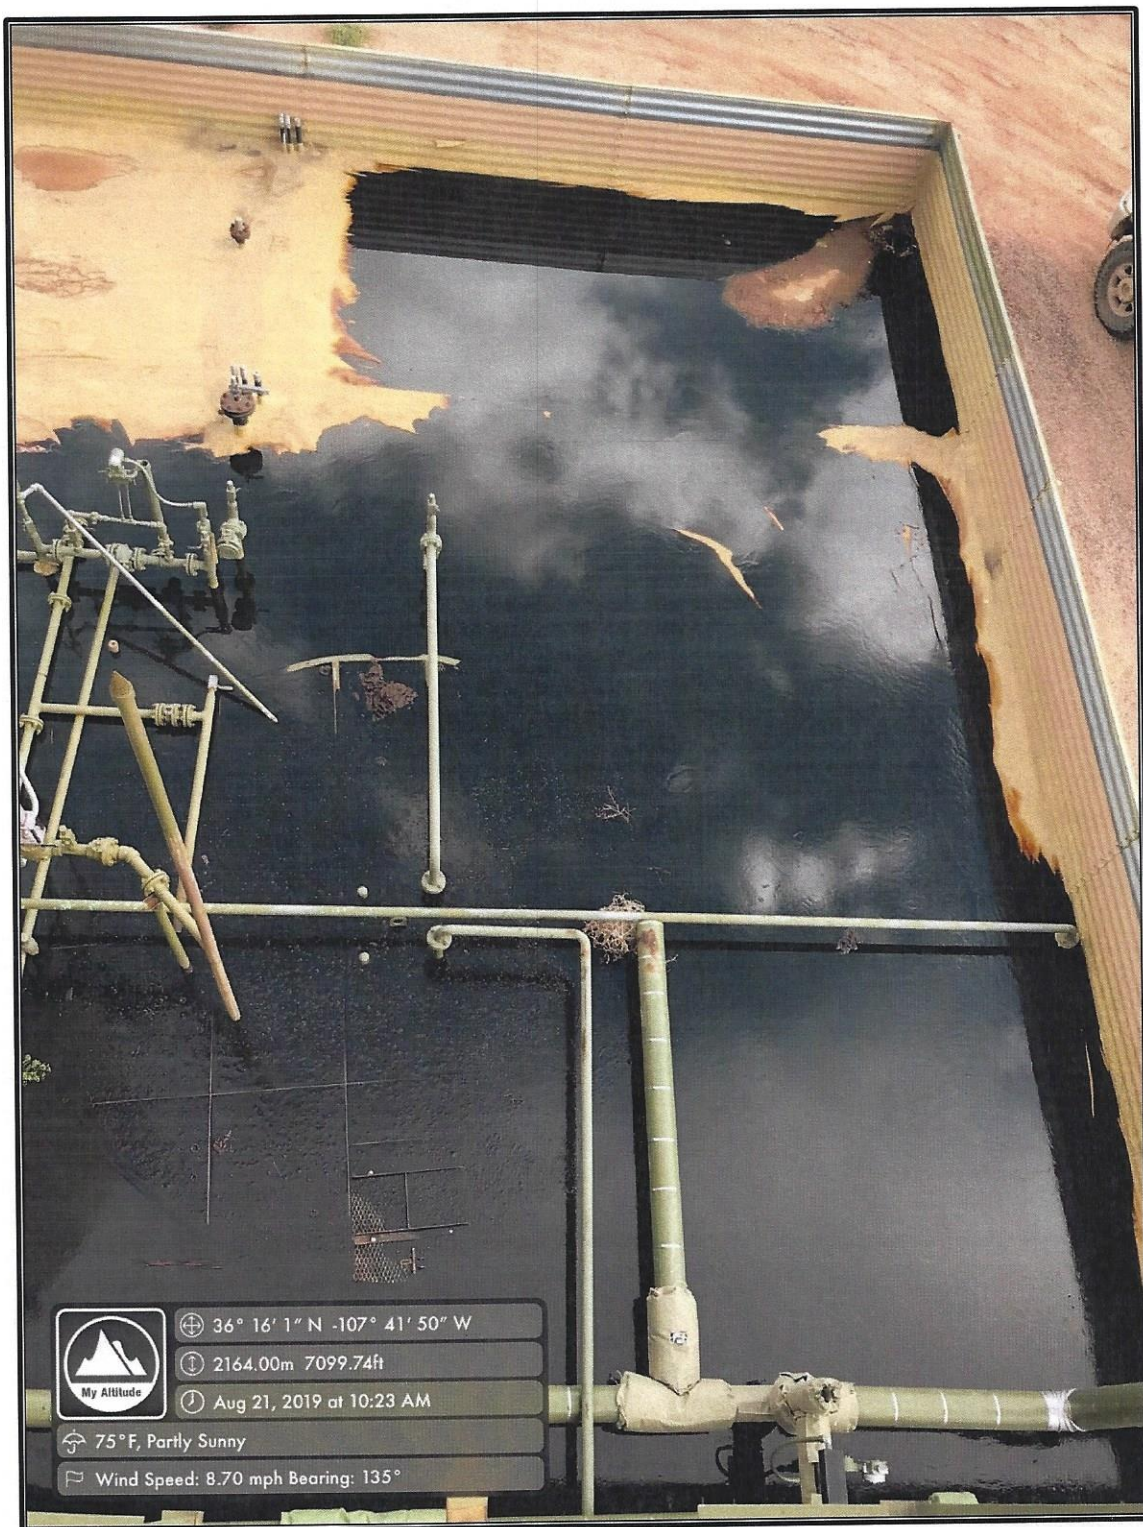
Photo 1: Picture of Spill on Liner (View 1)

A lease operator discovered an overflow of the below grade tank at the location, overflowing 20 bbls of oil and water onto the tank berm liner. The below grade tank was emptied, and the fluids on the liner were cleaned up using a hydrovac. The cause of the overflow was determined to be vandalism, as a manual valve was opened, emptying the contents of the on-site water tank into the below grade tank, overflowing it. The manual valve has since been locked.

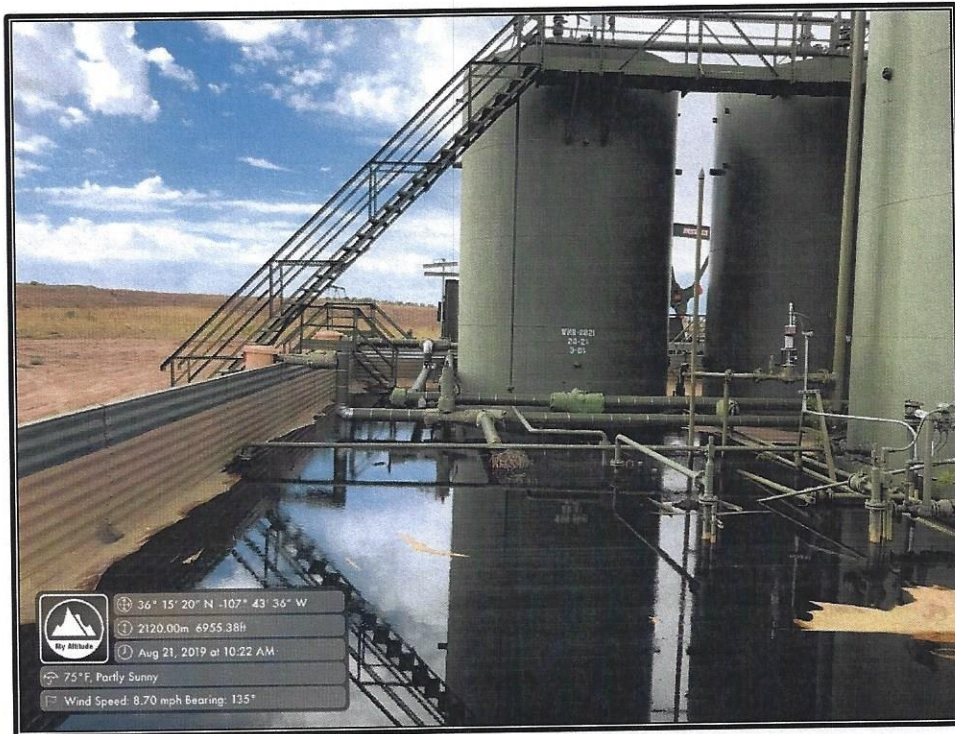
Photo 2: Picture of Spill on Liner (View 2)

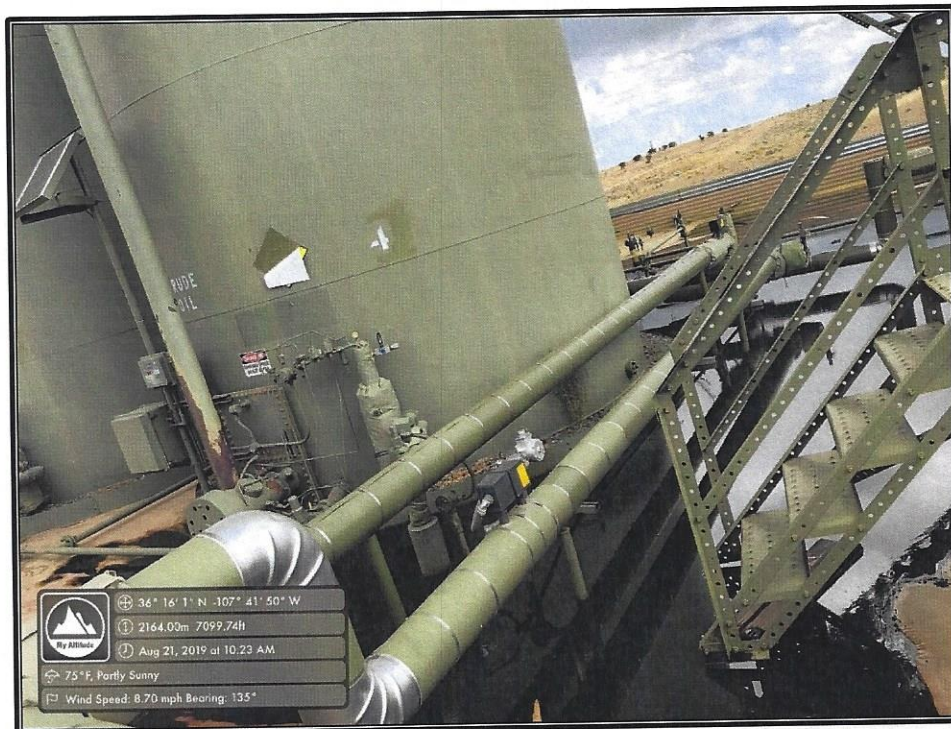
Photo 3: Picture of Spill on Liner (View 3)

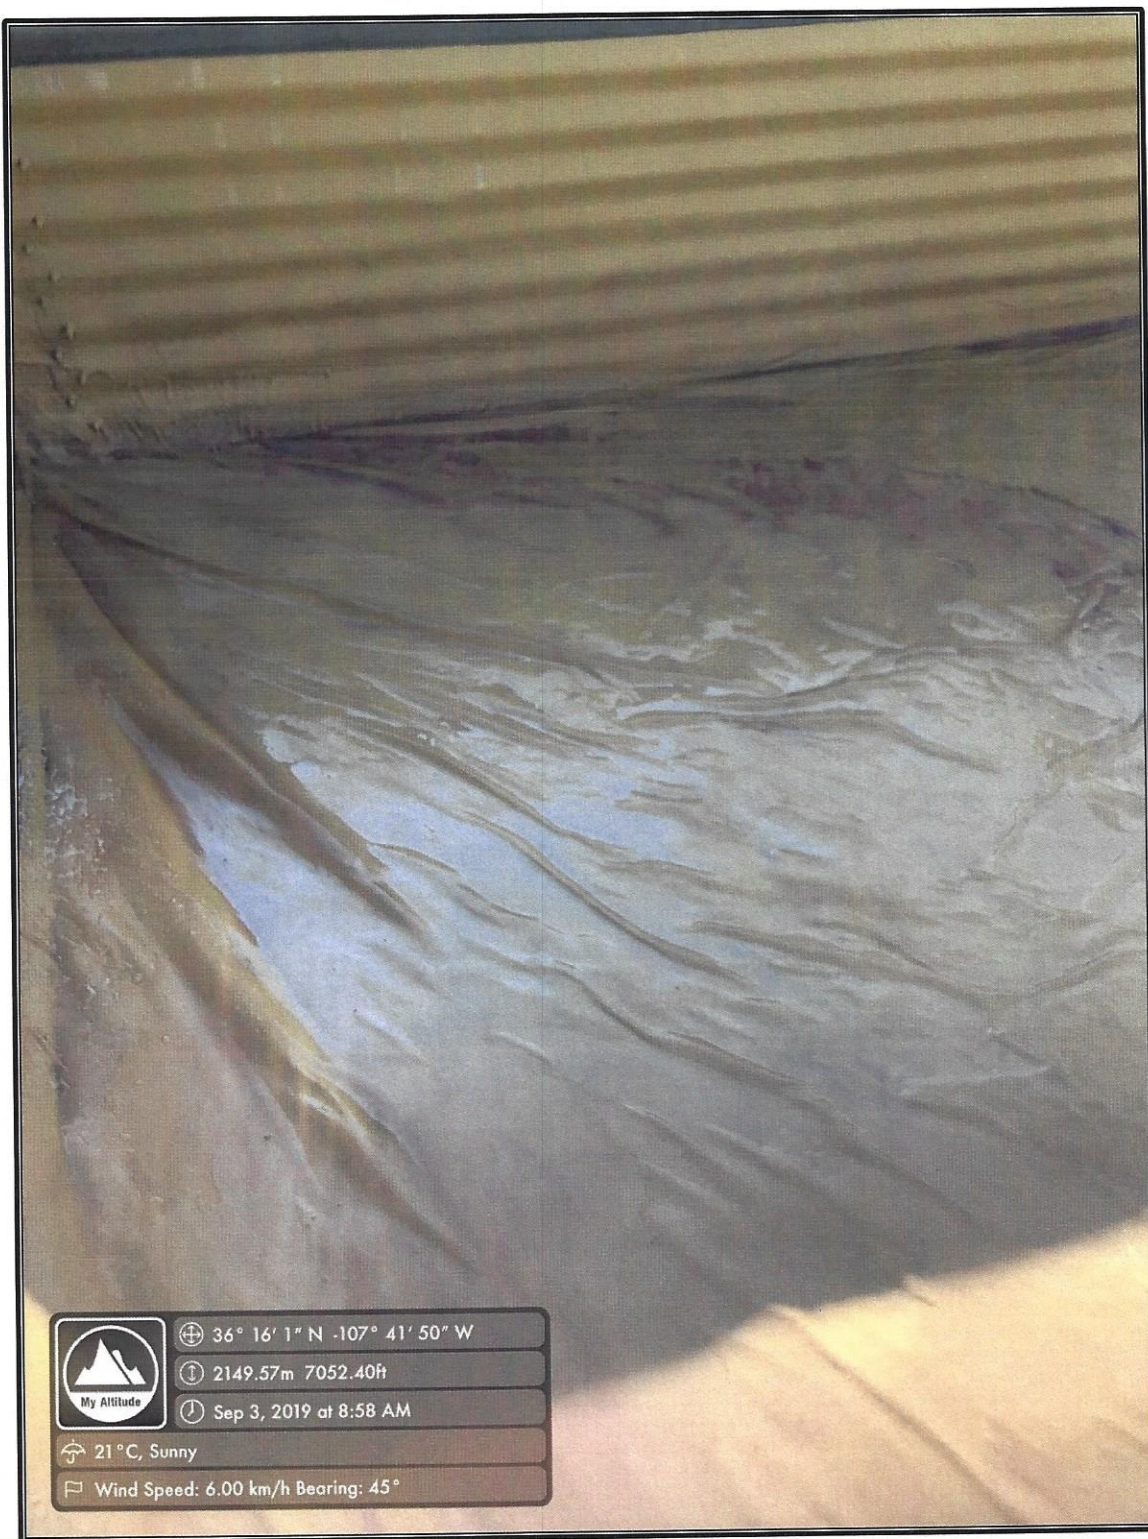
Jonathan Kelly, NMOCD, met on-site to inspect the liner. Jonathan noted some blow sand in the north-east corner of the lined berm, and requested it be removed. He took some photos of the liner, and said he would get with Cory Smith, NMOCD, when he returned from vacation.

Photo 4: Picture of Liner After Cleanup of Blow Sand in North-East Corner (View 1)

An extension was granted on the initial C-141 until 9/10/2019 while the NMOCD reviewed the data from the liner inspection. A hydrovac crew was on-site to remove the blow sand from the North-East corner of the liner tank berm. Pictures of the liner after the material was removed are attached in the *Photo Page*.

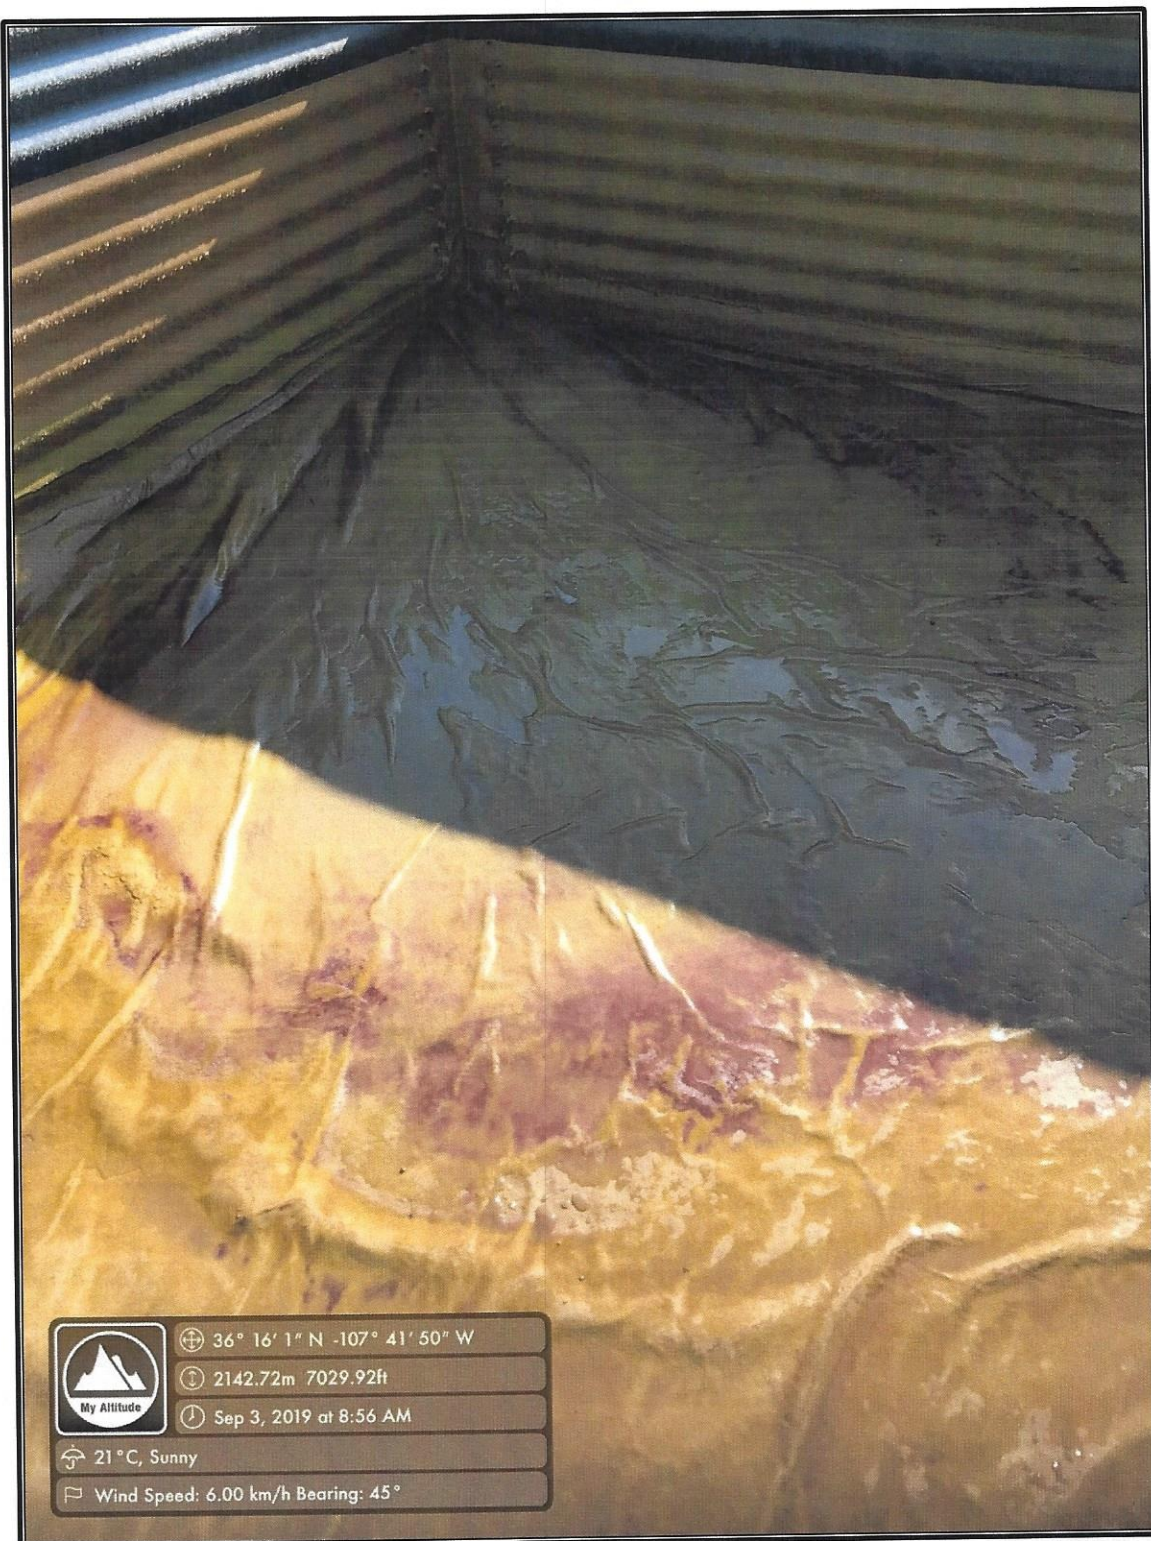
Photo 5: Picture of Liner After Cleanup of Blow Sand in North-East Corner (View 2)

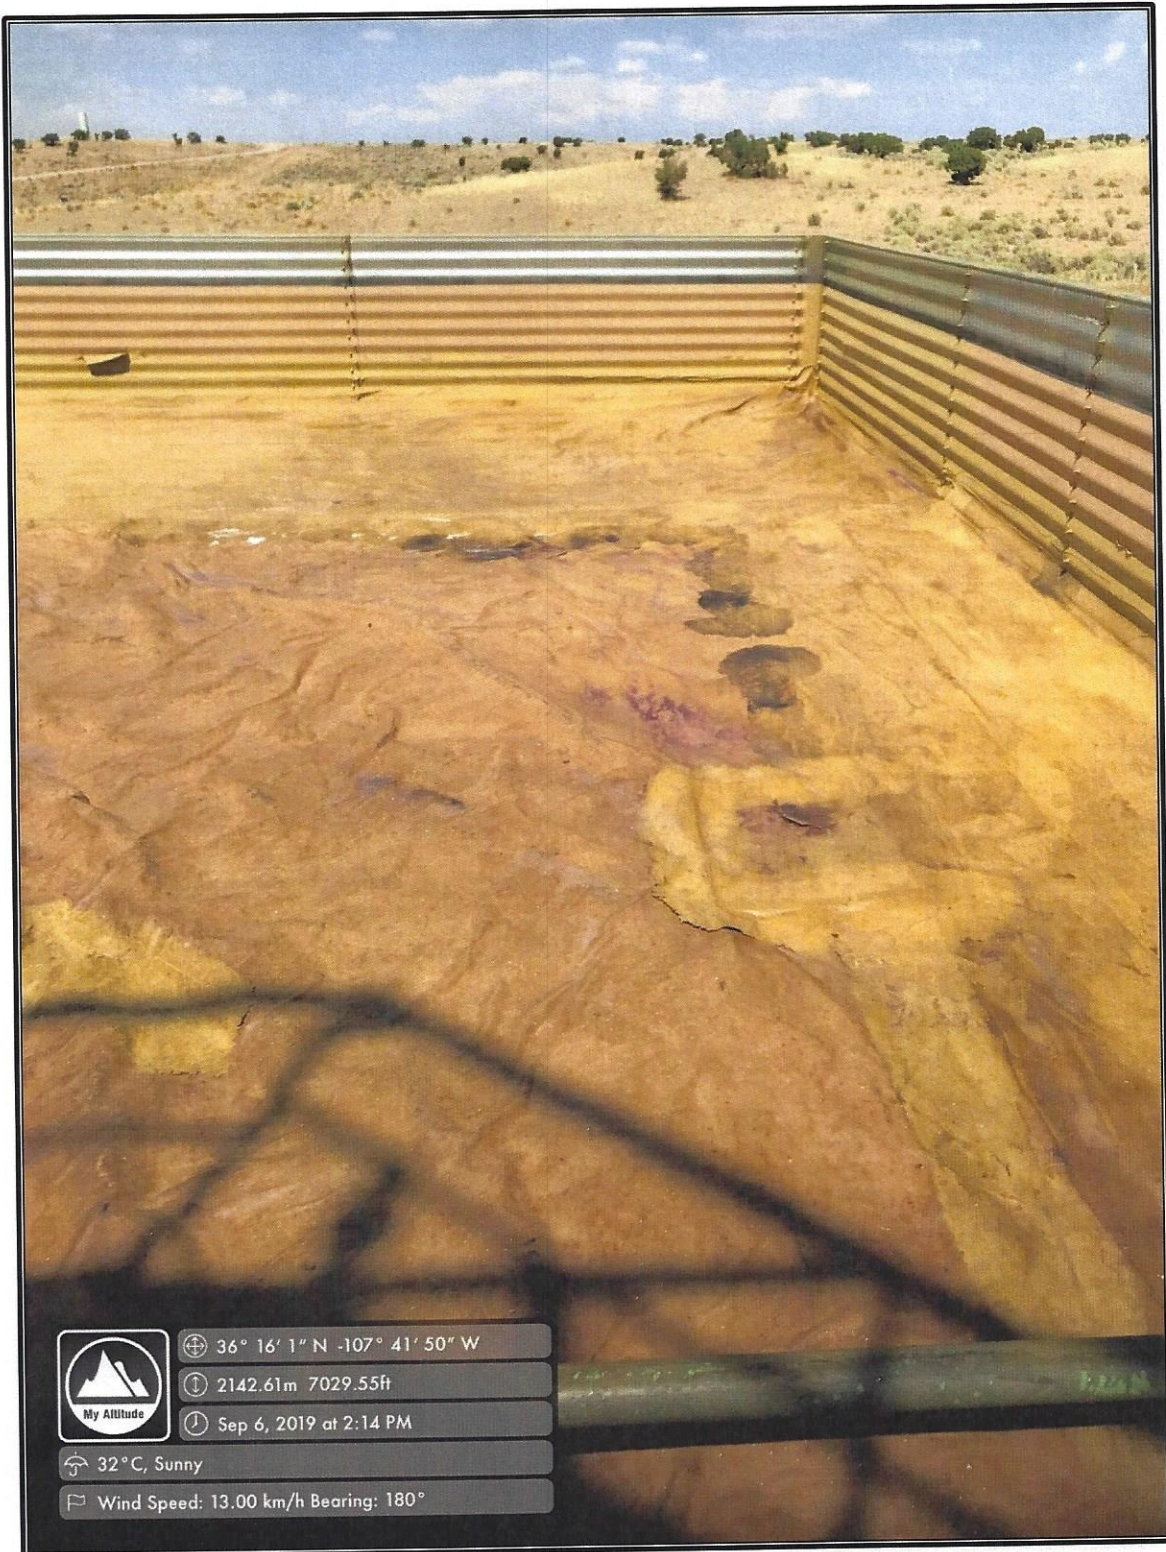
Cory Smith, NMOCD, visits the site and requests some remaining oily spots on the liner be cleaned up, and that the residual oil in the below grade tank is removed.

Photo 6: Picture of Liner After Cleanup (View 1)

A hydrovac crew was on-site to clean the remaining oily spots on the liner, and to remove all residual oil from the below grade tank. Pictures of the liner after cleaning and the below grade tank are attached in the *Photo Page*.

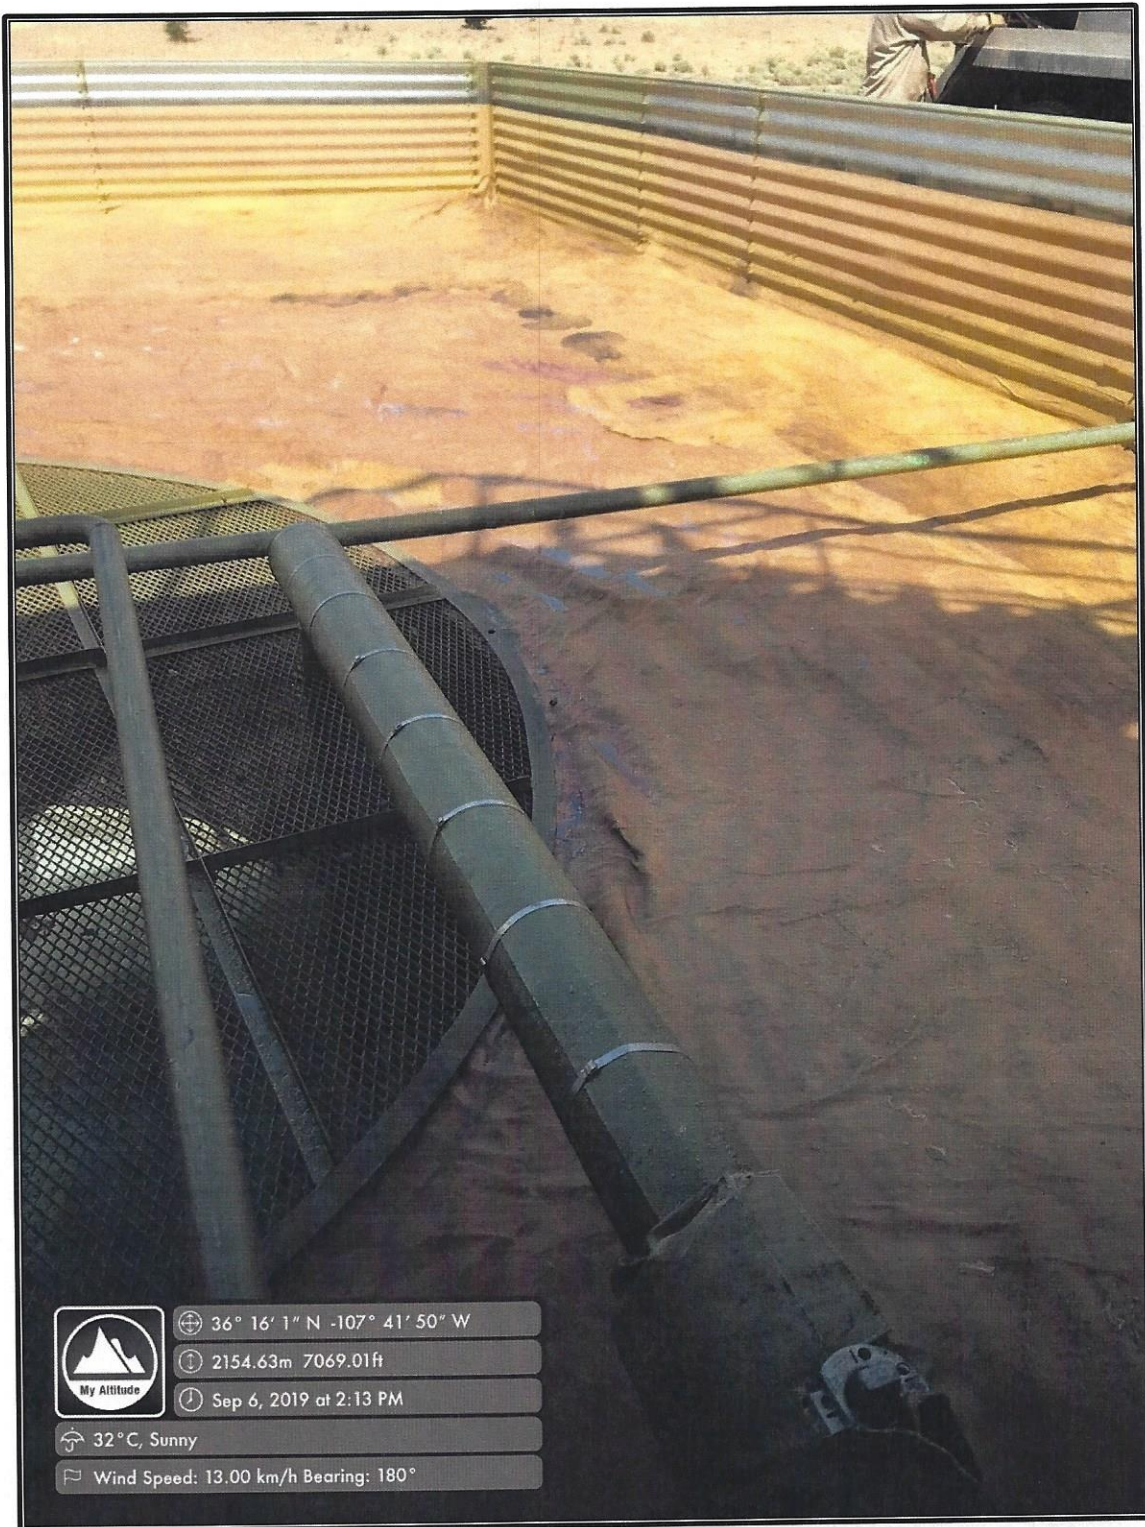
Photo 7: Picture of Liner After Cleanup (View 2)

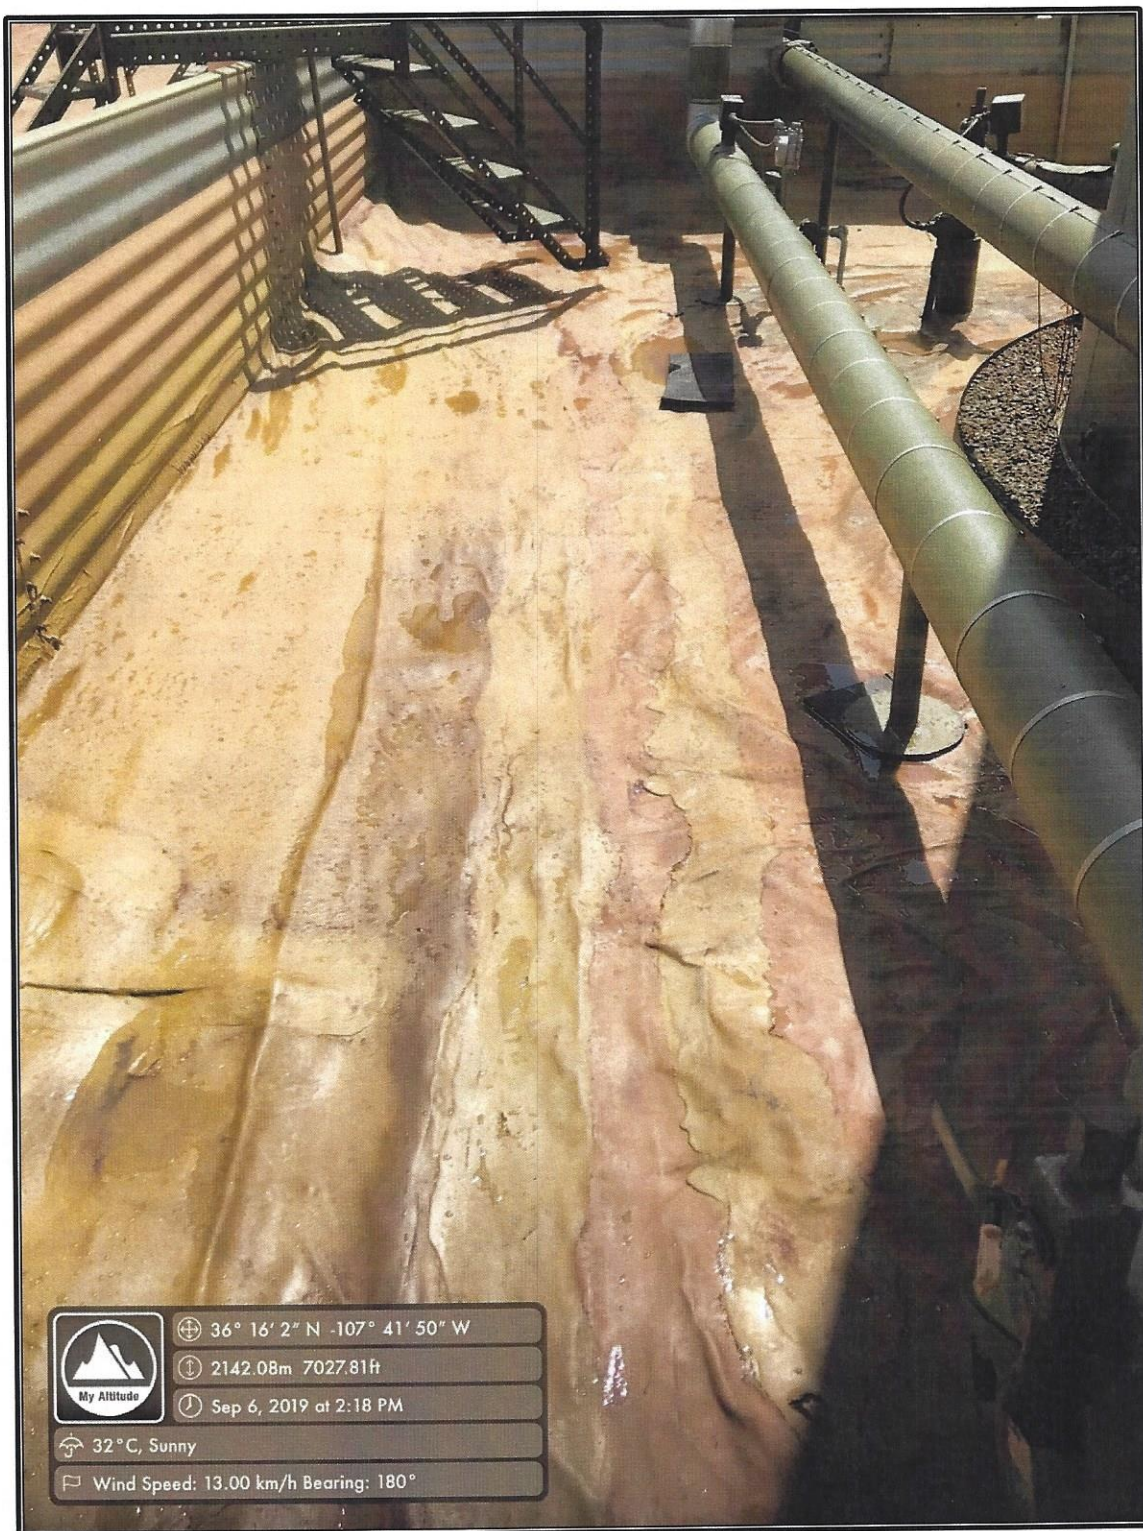
Photo 8: Picture of Liner After Cleanup (View 3)

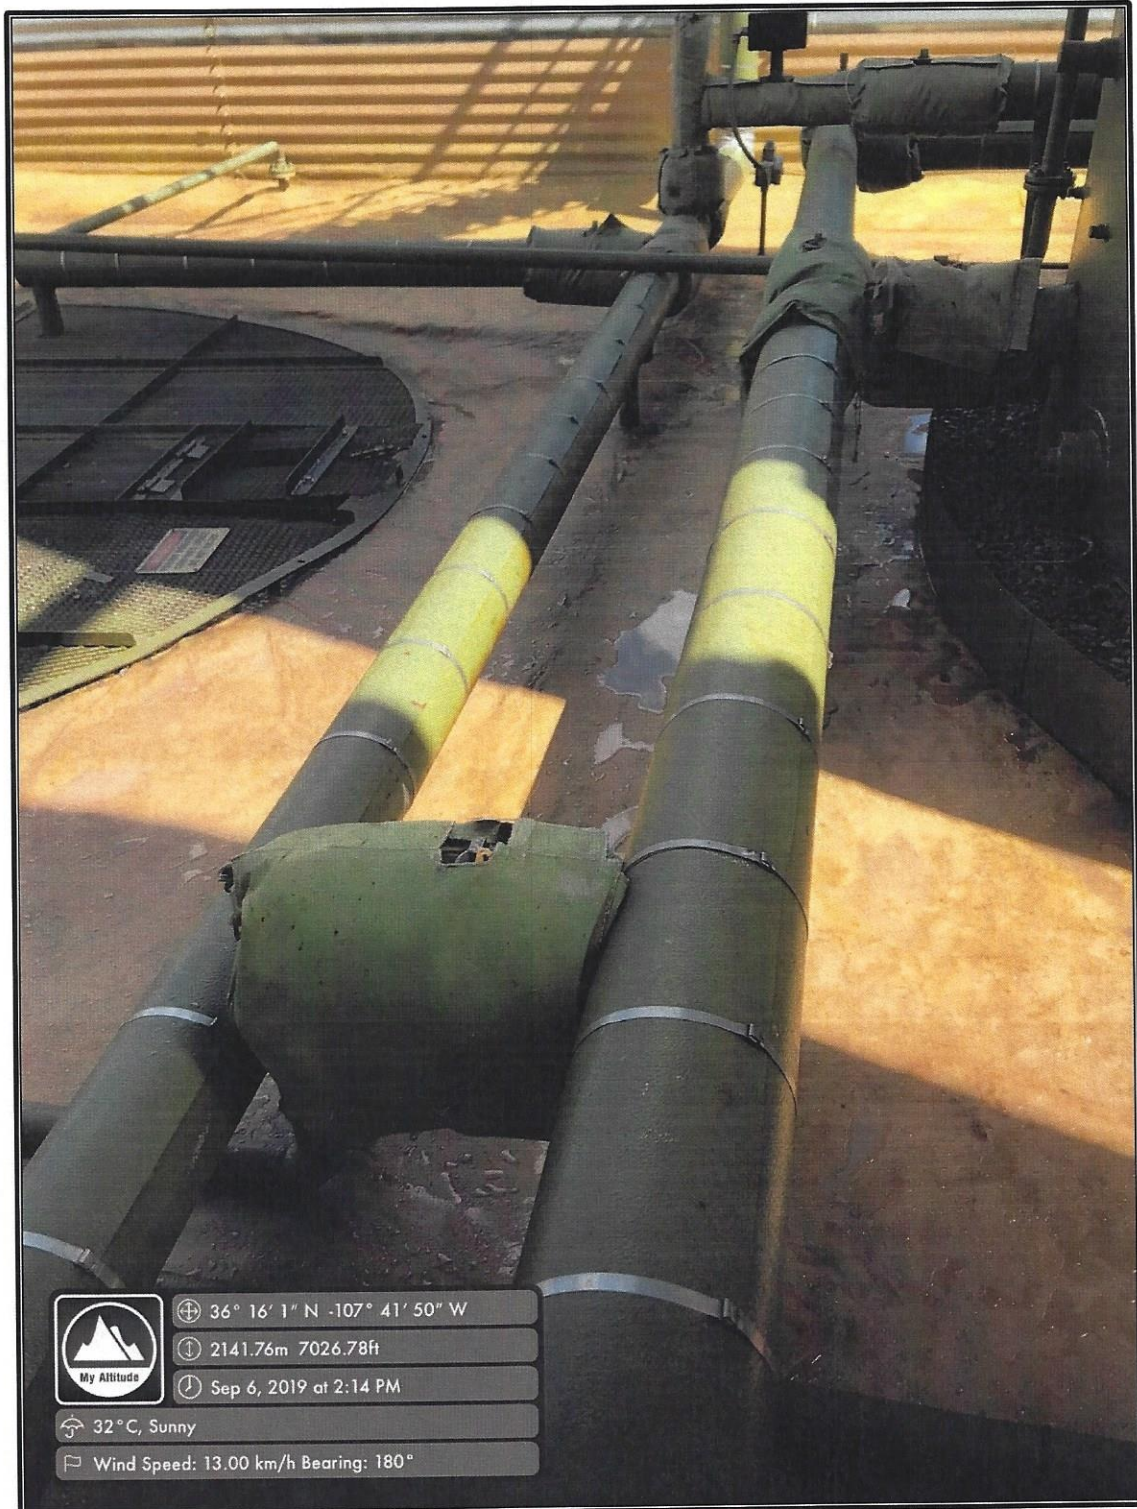
Photo 9: Picture of Liner After Cleanup (View 4)

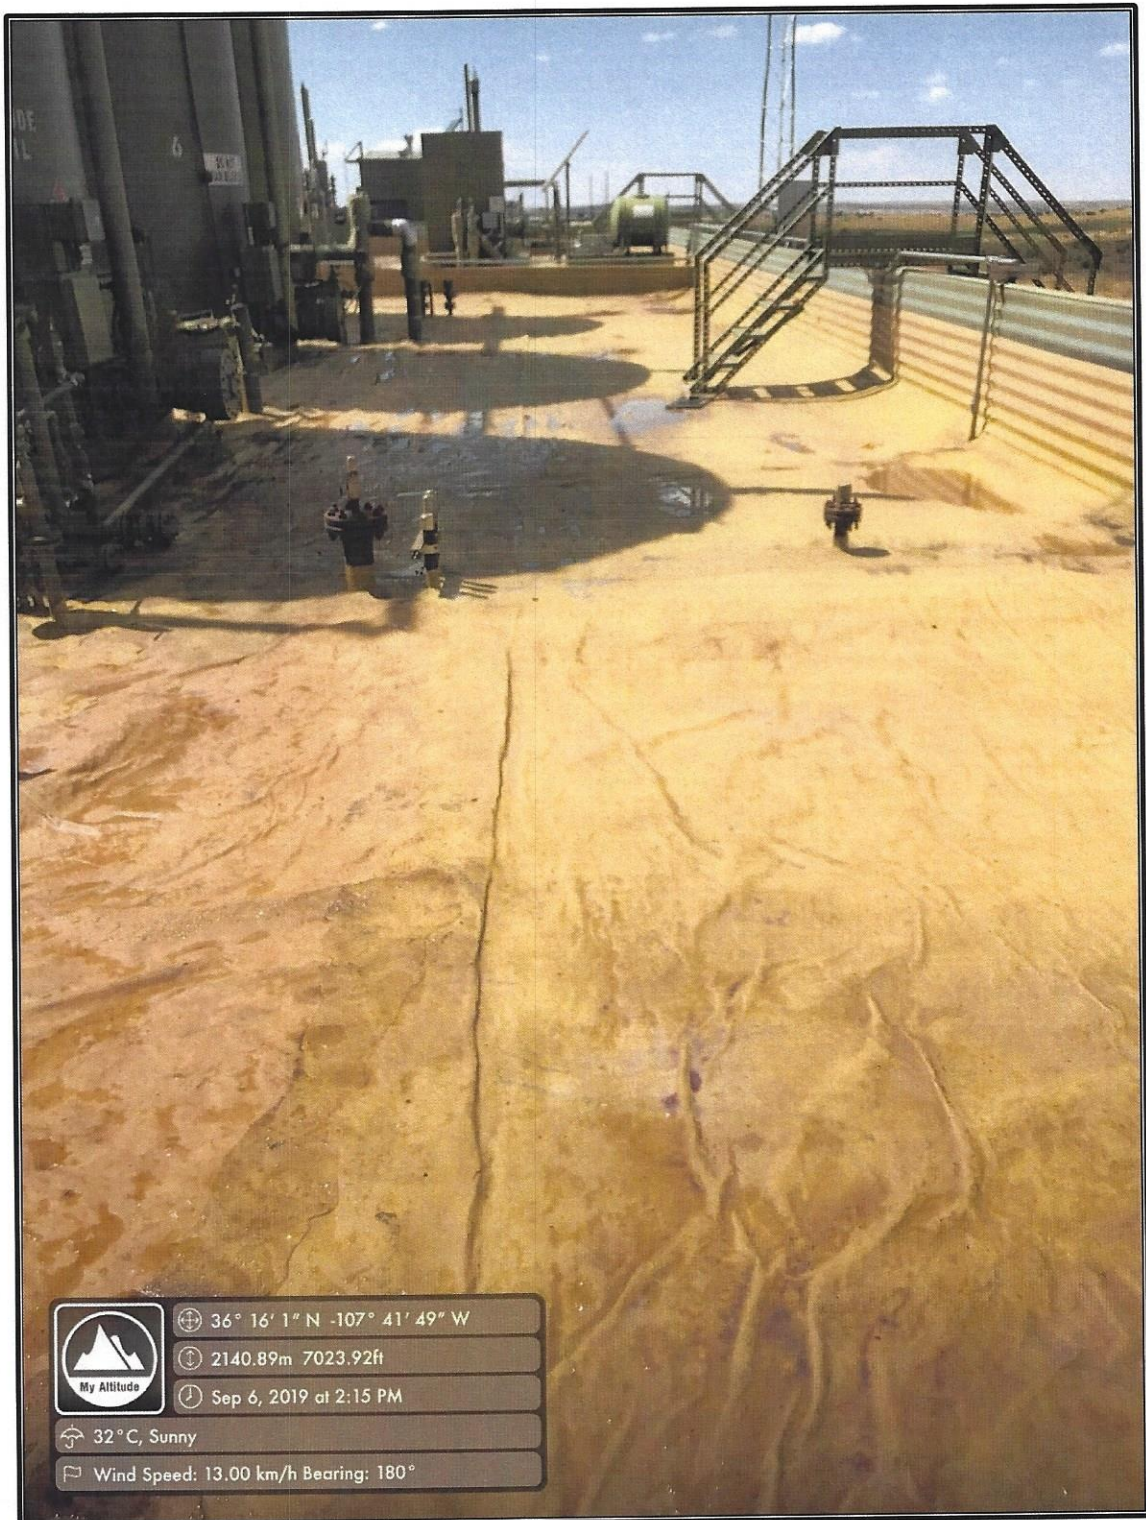
Photo 10: Picture of Liner After Cleanup (View 5)

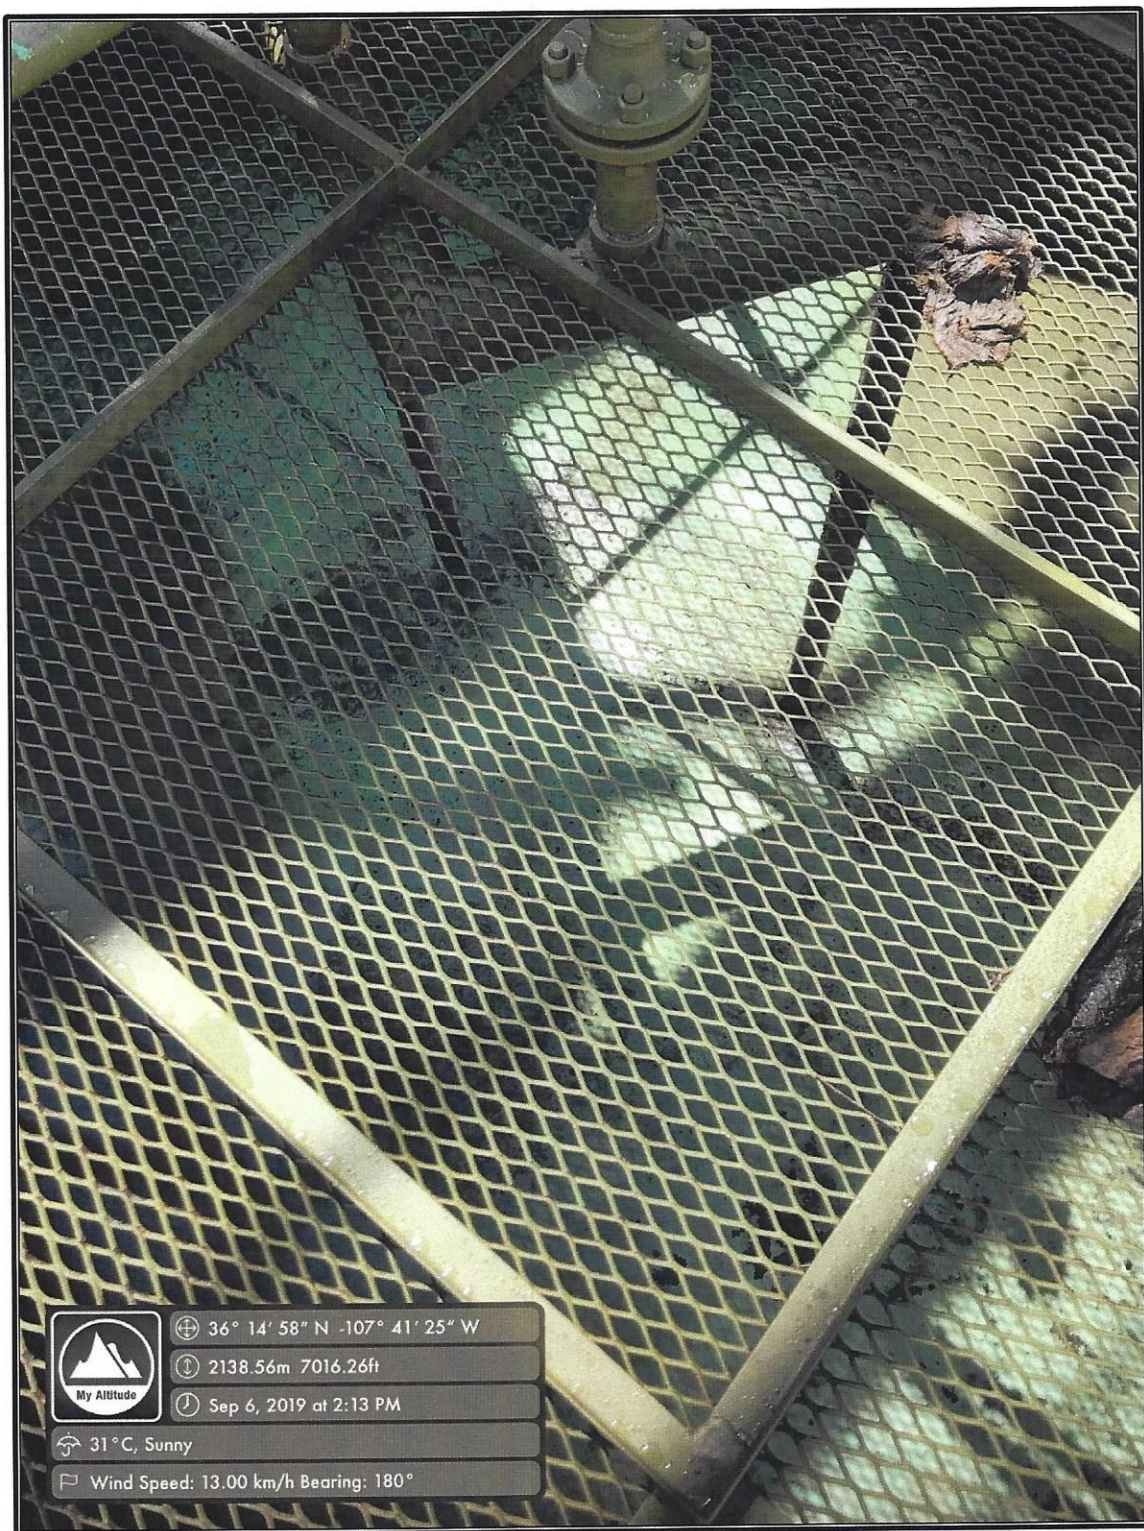
Photo 11: Picture of Pit Tank After Clean-Out (View 1)

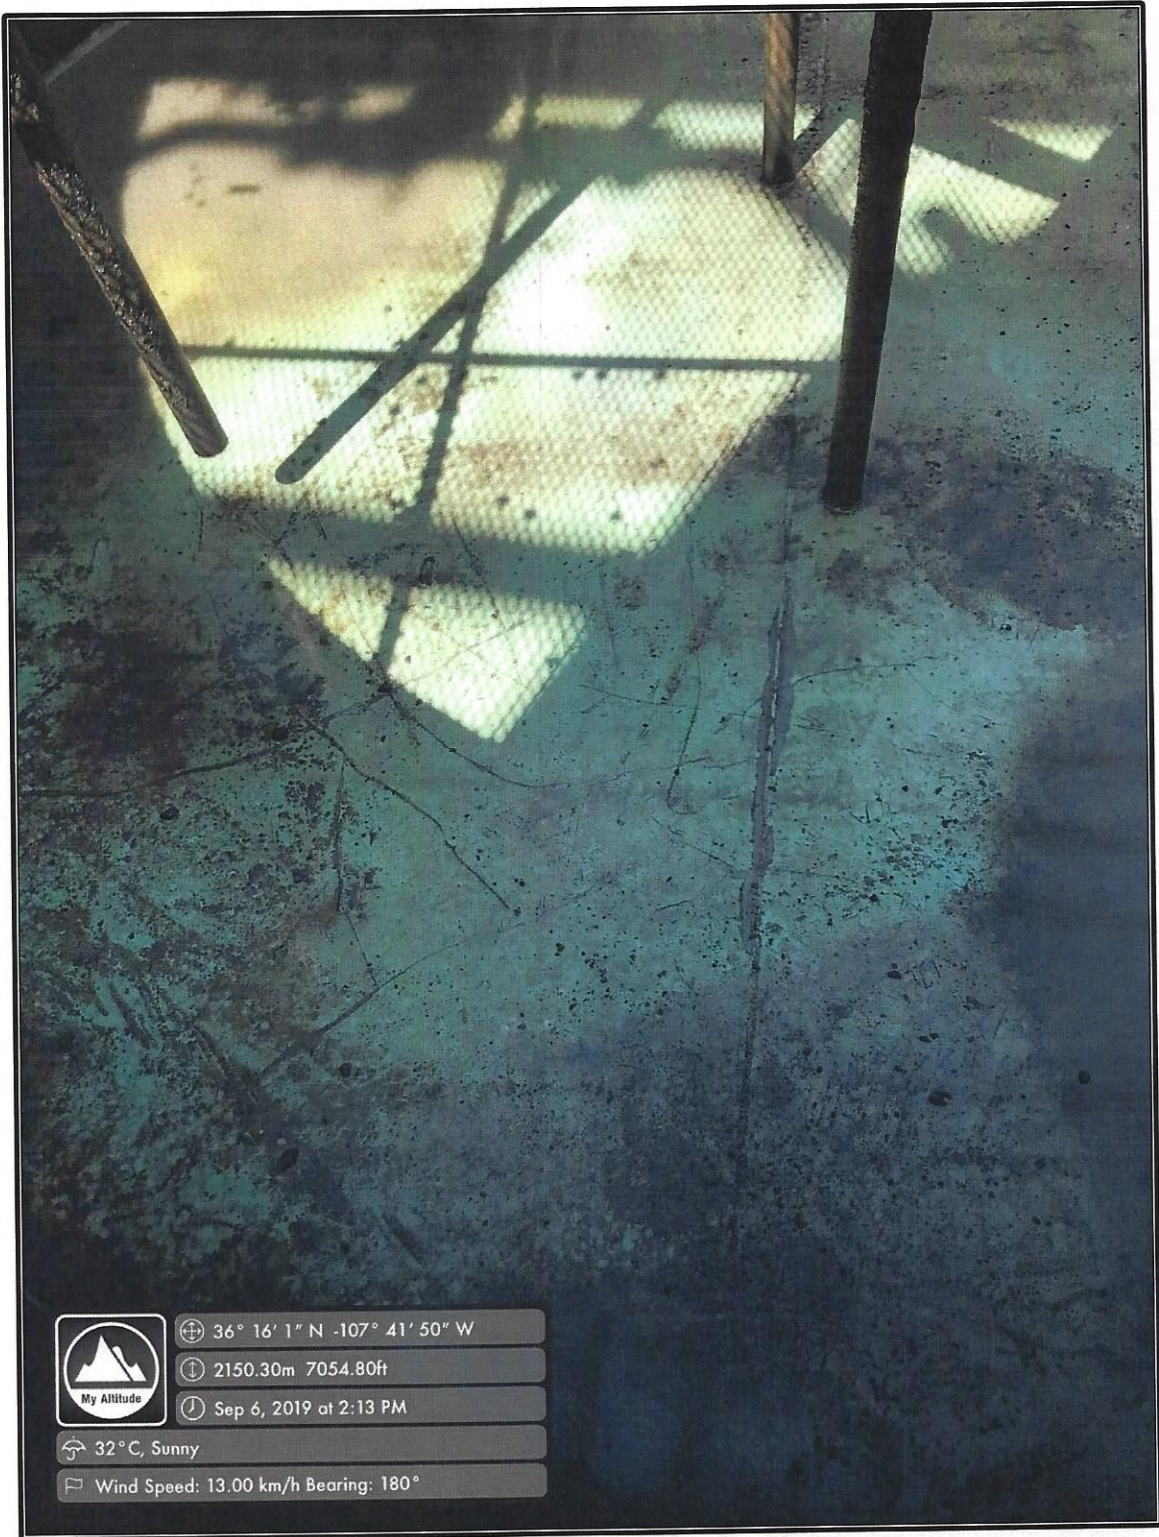
Photo 12: Picture of Pit Tank After Clean-Out (View 2)
