(formally BP America Production Company)
SAN JUAN BASIN, NORTHWEST NEW MEXICO

#### BELOW-GRADE TANK CLOSURE PLAN

Day B # 4 – Tank ID: A <u>API #: 3004508437</u> Unit Letter M, Section 8, T29N, R08W

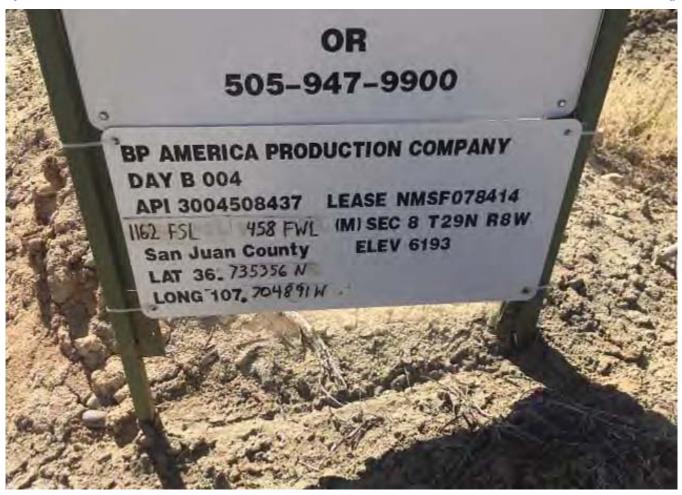
<u>Closure report on C-144 form is included & contains a photo of the current reclamation</u> requirements completed.

BGT area has been backfilled with clean, earthen material. Reclamation will be completed within the allowable timeframe and will meet the specified requirements of 19.15.17.13 NMAC.
