Release Notification and Corrective Action

Name of Company <b>ConocoPhillips Company</b>	Contact <b>Shelly Cook-Cowden</b>
Address <b>3401 E. 30<sup>th</sup> St., Farmington, NM 87402</b>	Telephone No. <b>505-324-5140</b>
Facility Name <b>State Com 31-8 Unit #2</b>	Facility Type <b>Gas well API 3004527765</b>

**RE: Release Assessment Report for the State Com 31-8 #2  
San Juan County, New Mexico**

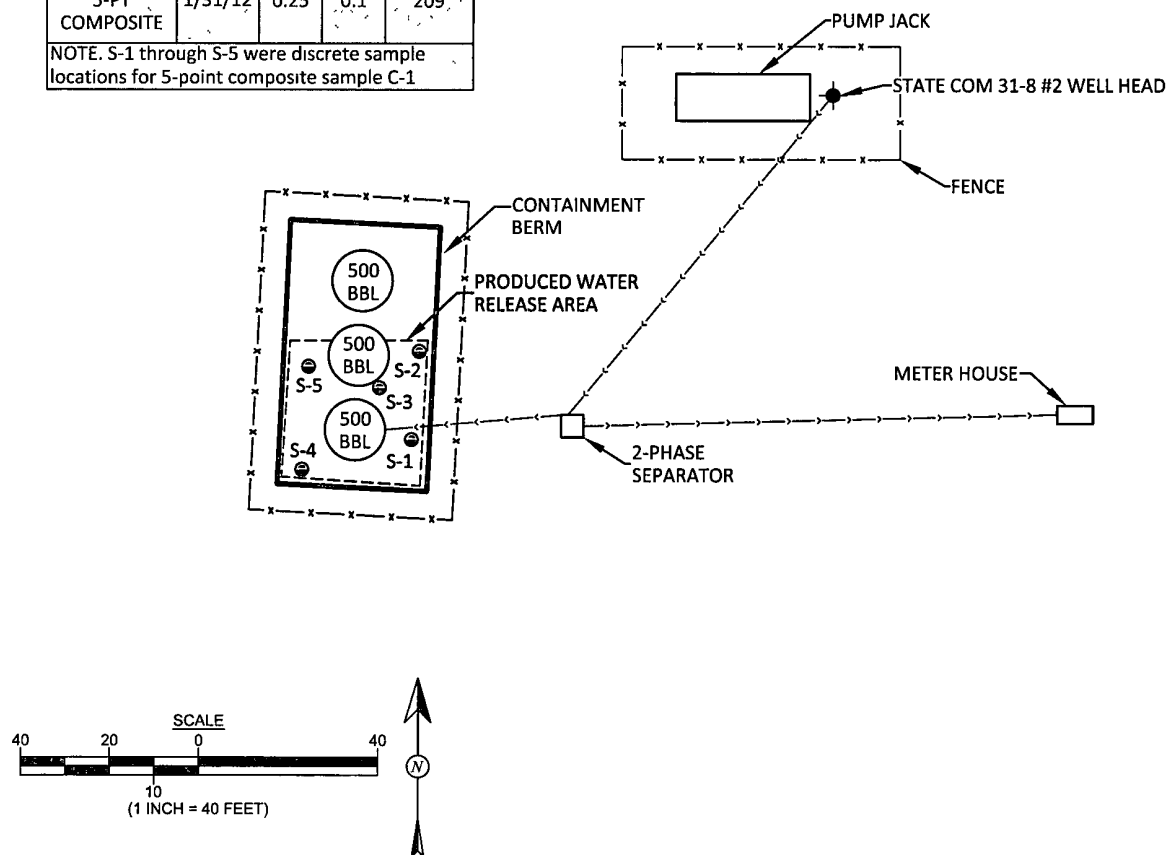
**FIGURE 2**

AES was initially contacted by Shelly Cook-Cowden of CoP on January 30, 2012, and on January 31, 2012, Ross Kennemer of AES completed the confirmation soil sampling. No CoP representatives were on-site during the field work, which included collecting a 5-point composite sample of produced water impacted soil within the storage tank secondary containment area. Discrete sample locations, which were used to make the composite, are shown on Figure 2.

SOIL SAMPLE RESULTS				
Sample ID	Date	Depth (ft)	OVM PID (ppm)	Field TPH 418.1 (mg/kg)
C-1 5-PT COMPOSITE	1/31/12	0.25	0.1	209
NOTE. S-1 through S-5 were discrete sample locations for 5-point composite sample C-1

**SAMPLE LOCATIONS AND RESULTS**  
 JANUARY 2012  
 ConocoPhillips  
 STATE COM 31-8 #2  
 SAN JUAN COUNTY, NEW MEXICO  
 SW¼, SW¼, SECTION 2, T31N, R8W  
 N36.92186°, W107.65080°

A de-contaminated stainless steel sampling trowel was used to collect five discrete soil samples from the surface of the impacted soil, and the soil samples were then thoroughly mixed within a sampling bag. One composite sample was collected from the combined sample volume and field-screened for volatile organic compounds (VOCs) and total petroleum hydrocarbon (TPH). Field-screening for VOC vapors was conducted with a photo-ionization detector (PID) organic vapor meter (OVM). The TPH sample was analyzed per USEPA Method 418.1 using a Buck Scientific Model HC-404 Total Hydrocarbon Analyzer Infrared Spectrometer (Buck). Soil sample results are presented below in Table 1, and sample locations are included on Figure 2.

VOC and TPH field-screening results were below applicable NMOCD action levels and indicate that there were no petroleum hydrocarbon impacts resulting from the produced water release. No additional soil sampling or mitigation activities are recommended.
