Burlington Resources Oil Gas Company, LP San Juan Basin Closure Report

Lease Name: SAN JUAN 28-5 UNIT 69N

API No.: 30-039-31074

In accordance with Rule 19.15.17.13 NMAC the following information describes the closure of the temporary pit referenced above. All proper documentation regarding closure activities is being included with the C-144. The temporary pit for this location was constructed and location drilled before June 16, 2008 (effective date for Rule 19.15.17). While closure of the temporary pit did fall within the rule some dates for submittals are after the rig release date.

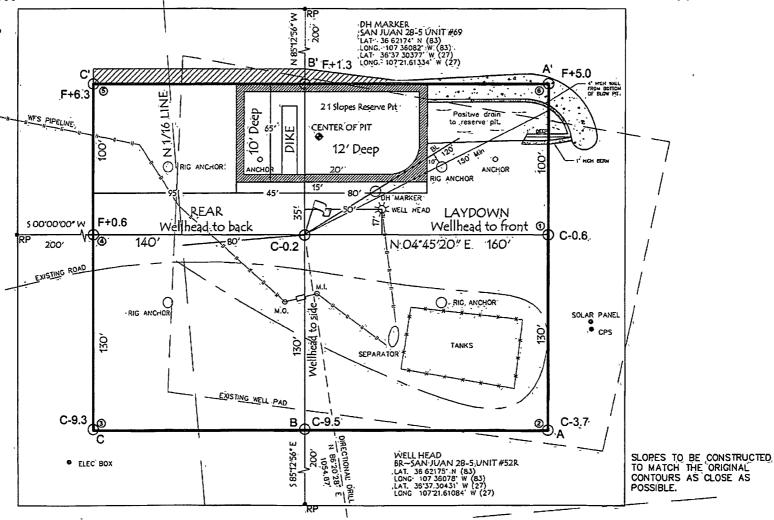
TOTAL PERMITTED AREA 330', x.400' = 3.03 ACRES SCALE: 1" = 60"

RESERVE PIT DIKE: TO BE 8' ABOVE DEEP SIDE (OVERFLOW = 3' WIDE AND 1' ABOVE SHALLOW SIDE). RUSSELL SURVEYING, INC. IS NOT LIABLE FOR UNDERGROUND UTILITIES OR PIPELINES.
CONTRACTOR SHOULD CALL ONE-CALL FOR LOCATION OF ANY MARKED OR UNMARKED, BURIED PIPELINES OR CABLES ON WELL PAD, IN CONSTRUCTION ZONE AND/OR ACCESS ROAD AT LEAST TWO (2) WORKING DAYS PRIOR TO CONSTRUCTION.

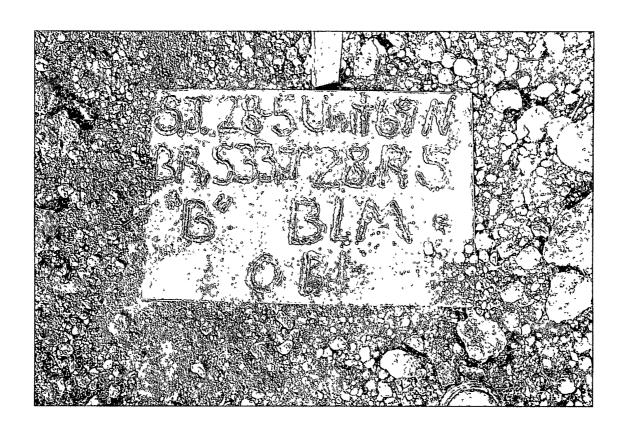
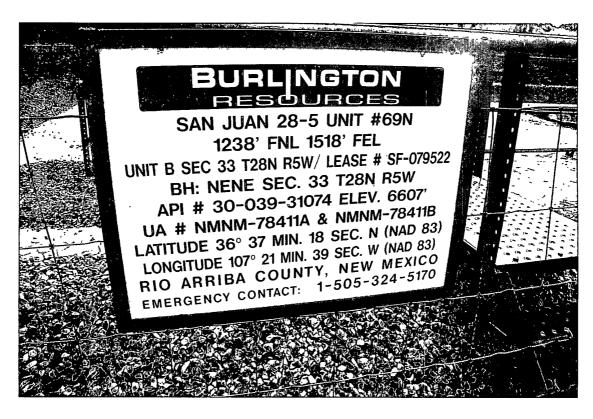
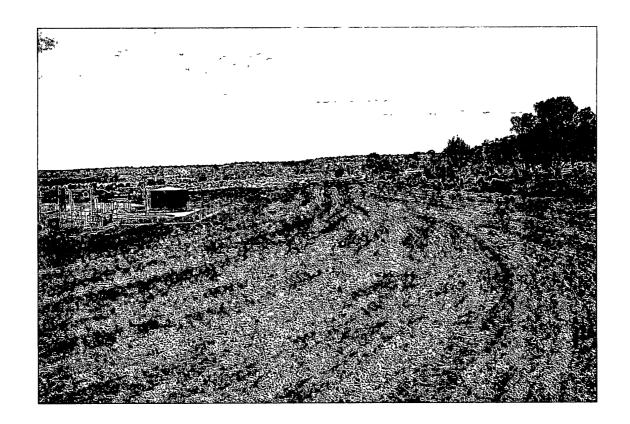
Reclamation Form:
Date: 9-6-2012
Well Name: <u>\$5</u> 28-5 &9 N
Footages: 1238 FNL, 1518 FFL Unit Letter: 13
Section: 33 , T- 28 -N, R- 5 -W, County: RA State: NM
Reclamation Contractor:
Reclamation Start Date: 8-14-12
Reclamation Complete Date: <u> </u>
Road Completion Date: 8-22-12
Seeding Date: 9-4-12
**PIT MARKER STATUS (When Required): Picture of Marker set needed
MARKER PLACED: 8-31-12 (DATE)
LATATUDE: 36 37. 296
LONGITUDE: 107 21.662
Pit Manifold removed 8-14-12 (DATE)
Construction Inspector: Norman Faver Date: 9-6-12
Inspector Signature:
Office Use Only: SubtaskDSMFolderPictures
