Release Notification and Corrective Action

Name of Company Burlington Resources Oil & Gas Company	Contact Crystal Tafoya
Address 3401 East 30th St, Farmington, NM	Telephone No. (505) 326-9837
Facility Name: Newberry 9A	Facility Type: Gas Well

**RE: Below Grade Tank Closure Report
Newberry #9A
San Juan County, New Mexico**

Animas Environmental Services, LLC (AES) is pleased to provide the final report associated with the below grade tank (BGT) closure at ConocoPhillips (CoP) Newberry #9A, located in San Juan County, New Mexico. Tank removal had been completed by CoP contractors prior to AES' arrival at the location.

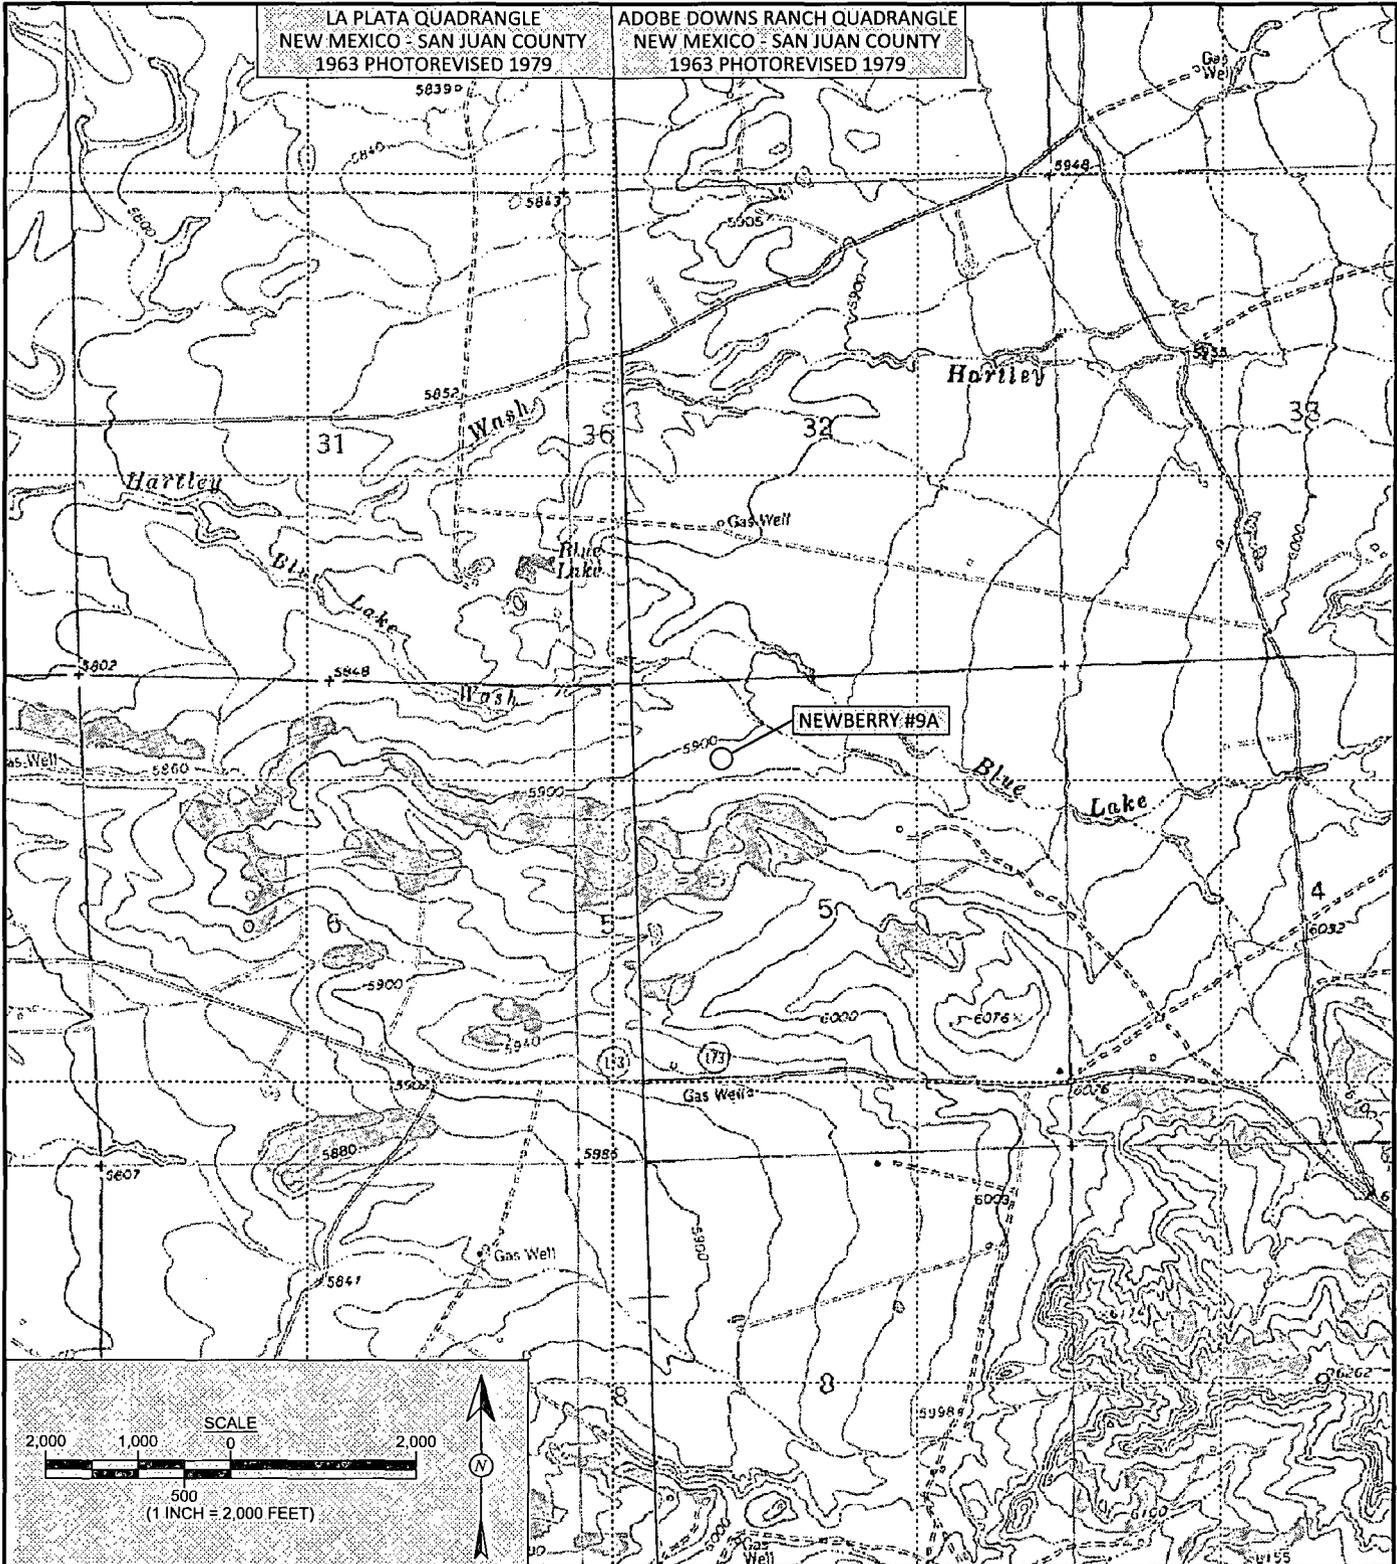
FIGURE 1
TOPOGRAPHIC SITE LOCATION MAP
ConocoPhillips
NEWBERRY #9A
SAN JUAN COUNTY, NEW MEXICO
NE¼ NW¼, SECTION 5, T31N, R12W
N36.93272, W108.12163

Figure 1. Topographic Site Location Map
