Pit, Closed-Loop System, Below-Grade Tank, or
Proposed Alternative Method Permit or Closure Plan Application

Burlington Resources Oil Gas Company, LP
San Juan Basin
Below Grade Tank Closure Report

Lease Name: CULPEPPER MARTIN 11C

API No.: 30-045-30553

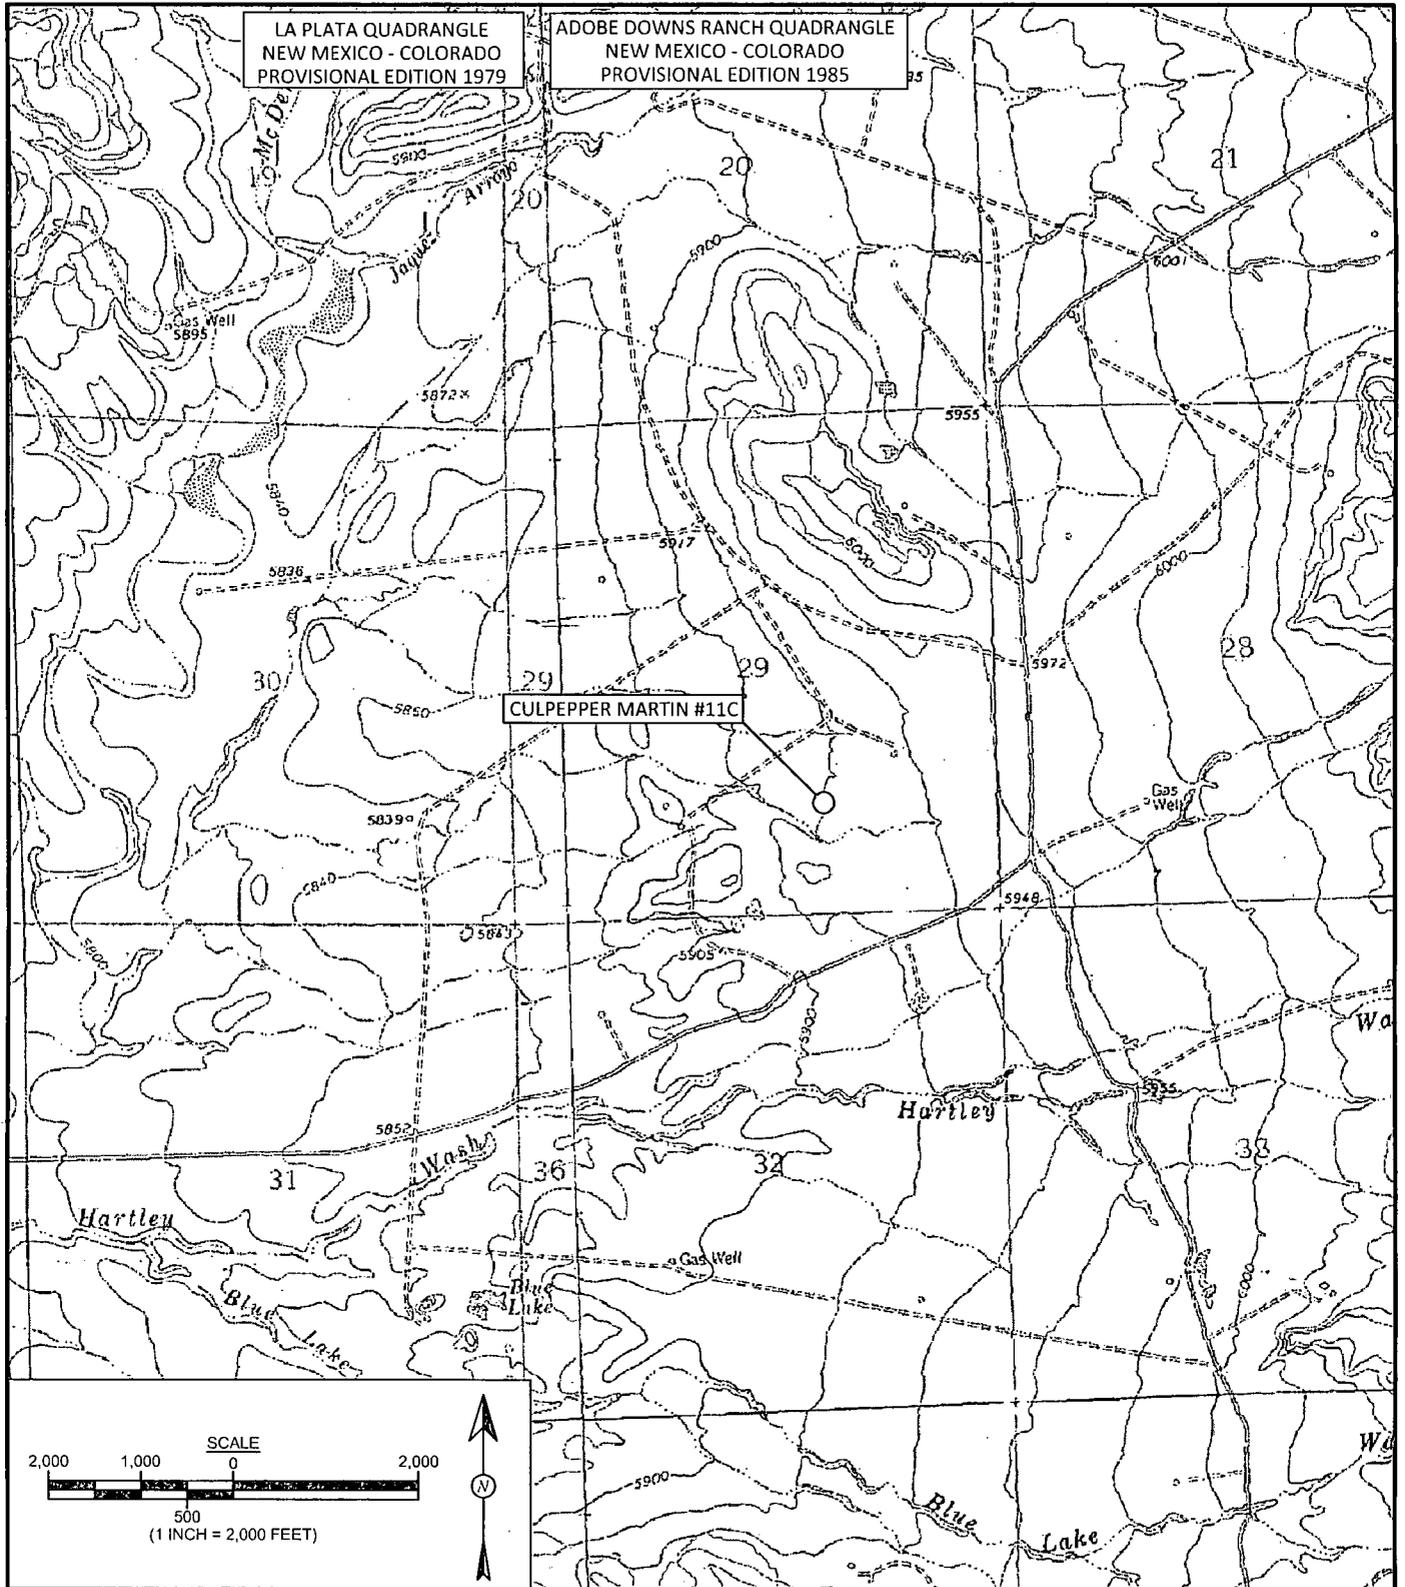
CULPEPPER MARTIN #11C

LA PLATA QUADRANGLE
NEW MEXICO - COLORADO
PROVISIONAL EDITION 1979

ADOBE DOWNS RANCH QUADRANGLE
NEW MEXICO - COLORADO
PROVISIONAL EDITION 1985
