Release Notification and Corrective Action

Name of Company Burlington Resources Oil & Gas Company	Contact Lindsay Dumas
Address 3401 East 30th St, Farmington, NM	Telephone No. (505) 599-4089
Facility Name: San Juan 28-6 167M	Facility Type: Gas

**RE: Initial Release Assessment and Final Excavation Report
San Juan 28-6 Unit #167M
Rio Arriba County, New Mexico**

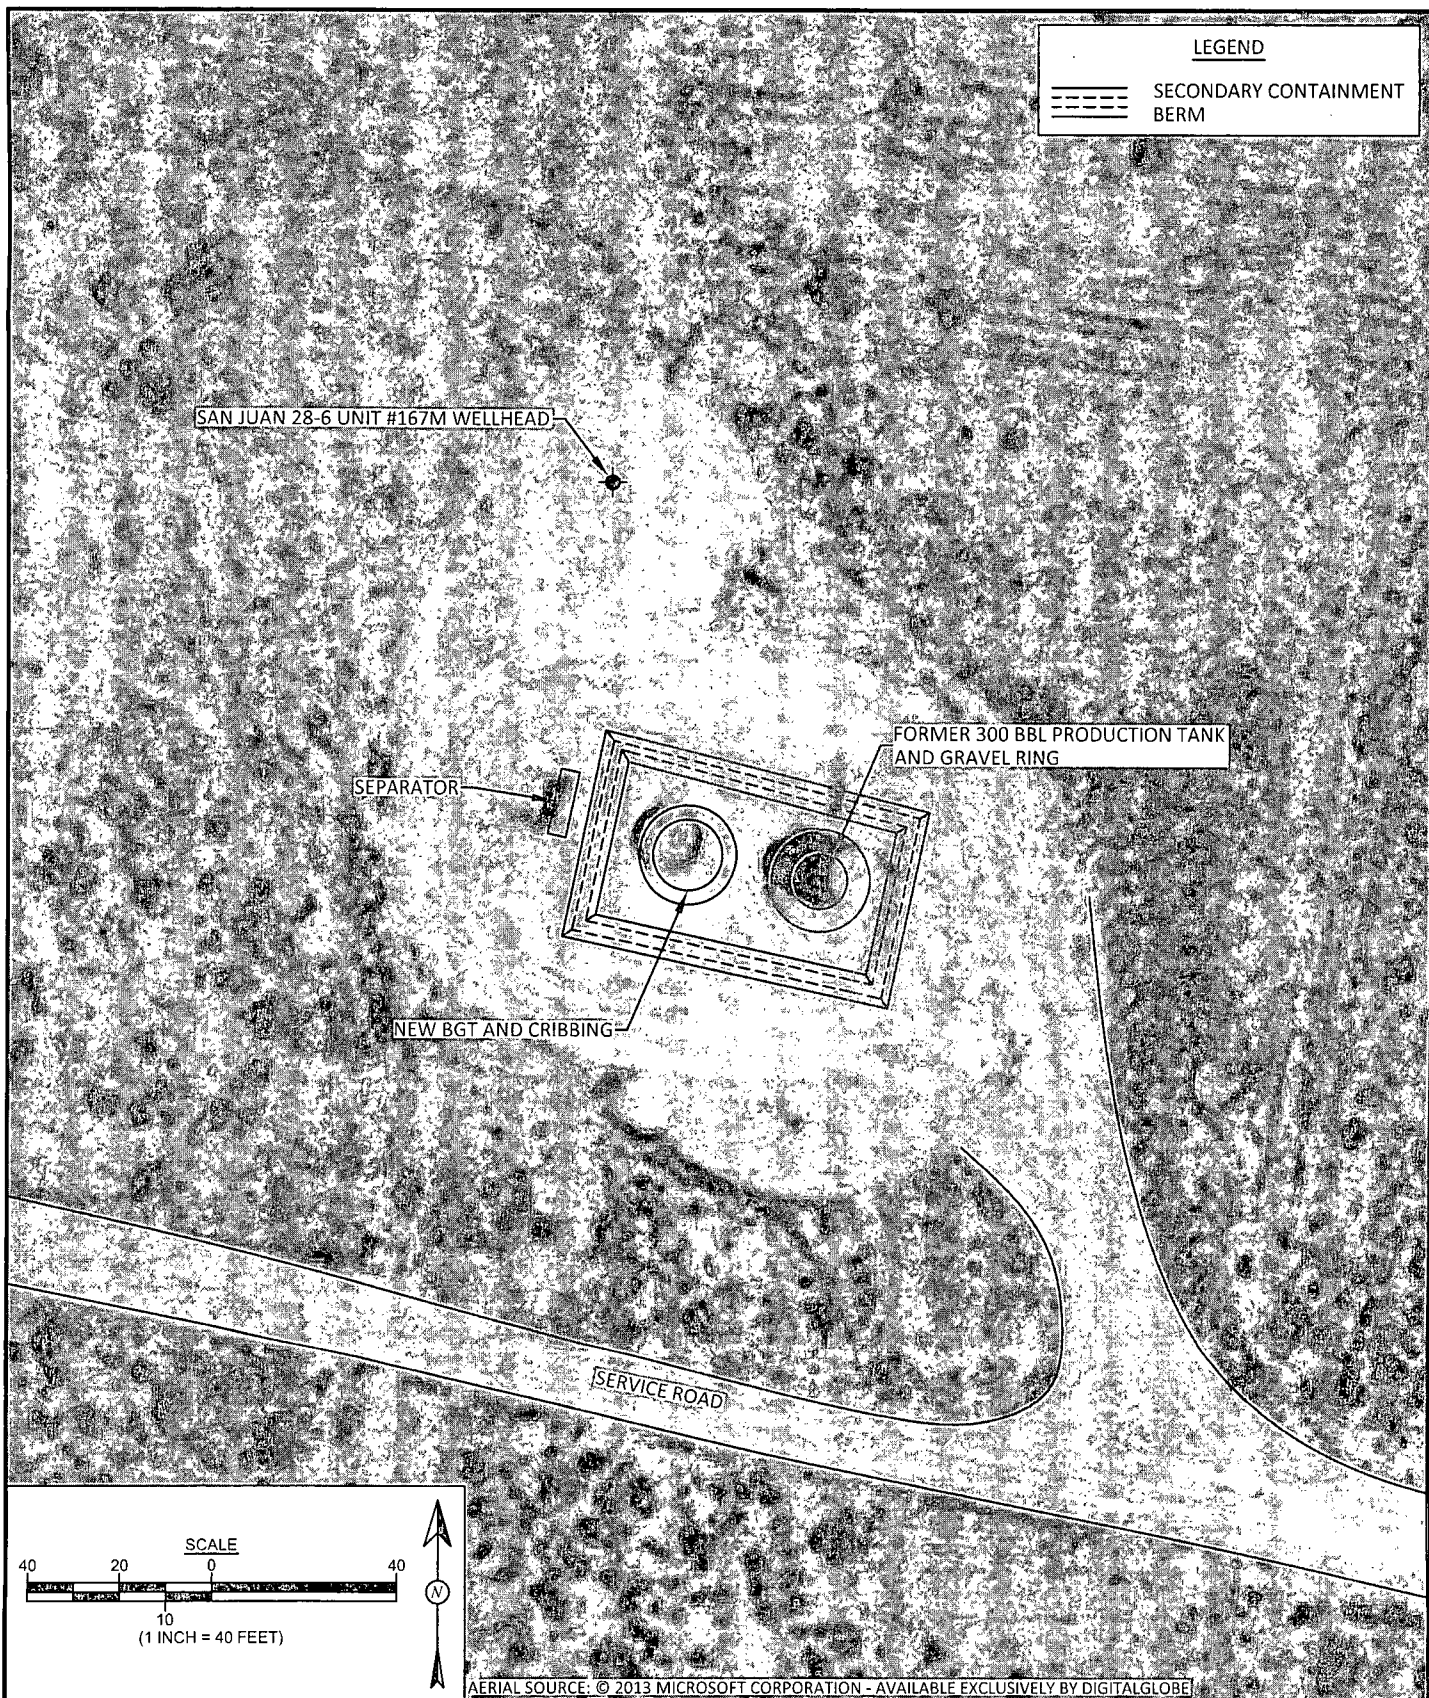
FIGURE 2

**AERIAL SITE MAP
SEPTEMBER 2013**

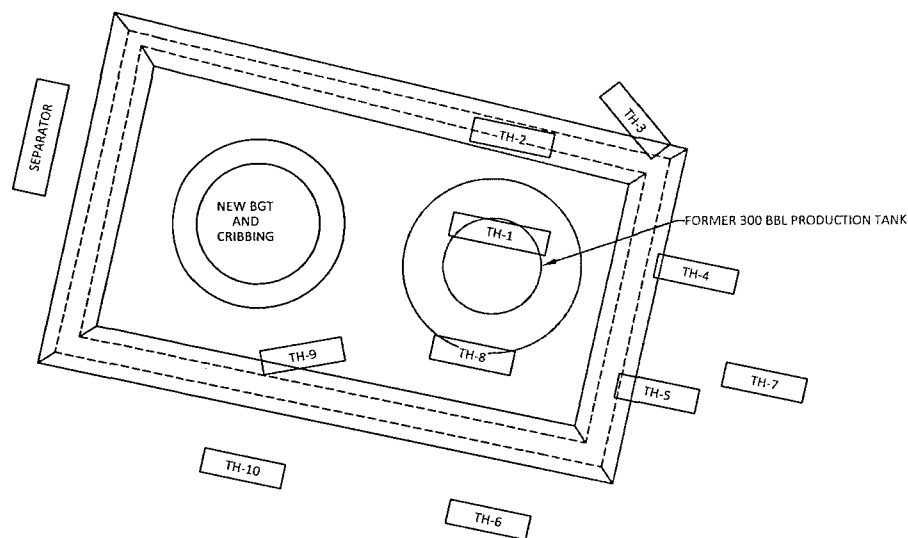
FIGURE 3

AES was initially contacted by Crystal Tafoya of CoP on September 9, 2013, and on September 12, 2013, Heather Woods and Stephanie Lynn of AES completed the release assessment field work. The assessment included collection and field screening of 33 soil samples from 10 assessment trenches (TH-1 through TH-10) in and around the release area. Based on the field screening results, AES recommended further excavation of the release area. Sample locations are shown on Figure 3.

On September 12, 2013, initial assessment field screening results for VOCs via OVM showed concentrations ranging from 0.7 ppm in TH-10 up to 7,301 ppm in TH-2. Field TPH concentrations ranged from 100 mg/kg in TH-10 to greater than 2,500 mg/kg in TH-1.

INITIAL ASSESSMENT SAMPLE
LOCATIONS AND RESULTS
SEPTEMBER 2013
ConocoPhillips
SAN JUAN 28-6 UNIT #167M
SW¼, SE¼, SECTION 4, T27N, R6W
RIO ARriba COUNTY, NEW MEXICO
N36.59837, W107.46928

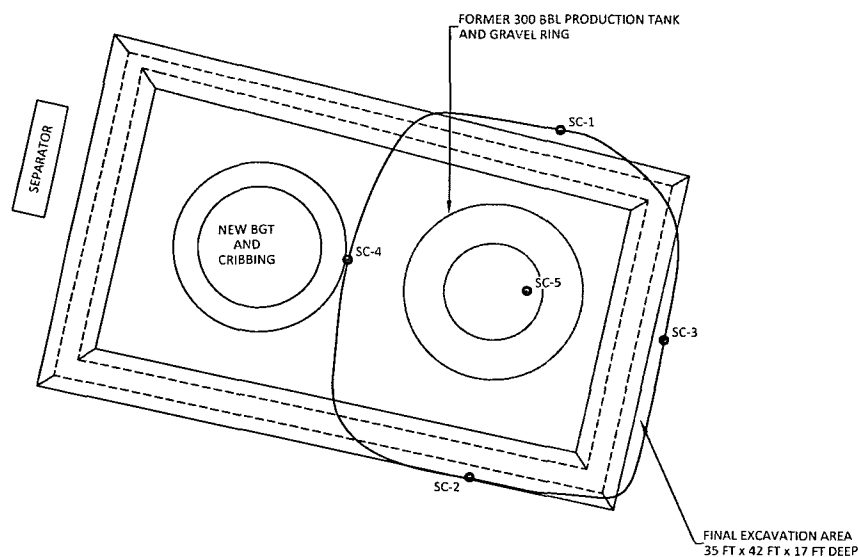
FIGURE 4

On September 26, 2013, AES returned to the location to collect confirmation soil samples of the excavation. The field screening activities included collection of five confirmation soil samples (SC-1 through SC-5) of the walls and base of the excavation. The area of the final excavation was approximately 35 feet by 42 feet by 17 feet in depth. Sample locations and final excavation extents are presented on Figure 4.

On September 26, 2013, final excavation field screening results for VOCs via OVM were each measured at 0.0 ppm. Field TPH ranged from 40.7 mg/kg in SC-2 up to 76.3 mg/kg in SC-3. Results are included below in Table 1 and on Figures 3 and 4. The AES Field Screening Reports are attached.

FINAL EXCAVATION SAMPLE
LOCATIONS AND RESULTS
SEPTEMBER 2013
ConocoPhillips
SAN JUAN 28-6 UNIT #167M
SW¼ SE¼, SECTION 4, T27N, R6W
RIO ARriba COUNTY, NEW MEXICO
N36.59837, W107.46928

On September 26, 2013, final clearance of the excavation area was completed. Field screening results of the excavation extents showed that VOC and TPH concentrations were below applicable NMOCD action levels for all four sidewalls and base of the excavation. Based on the final field screening results, no further work is recommended at the San Juan 28-6 Unit #167M.
