Release Notification and Corrective Action

**RE: Wilson #2 Below Grade Tank Closure Report
San Juan County, New Mexico**

FIGURE 2
GENERAL SITE MAP
BELOW GRADE TANK CLOSURE
MAY 2012
 ConocoPhillips
 WILSON #2
 SAN JUAN COUNTY, NEW MEXICO
 SW¼, NE¼, SECTION 31, T29N, R10W
 N36.68541, W107.92200

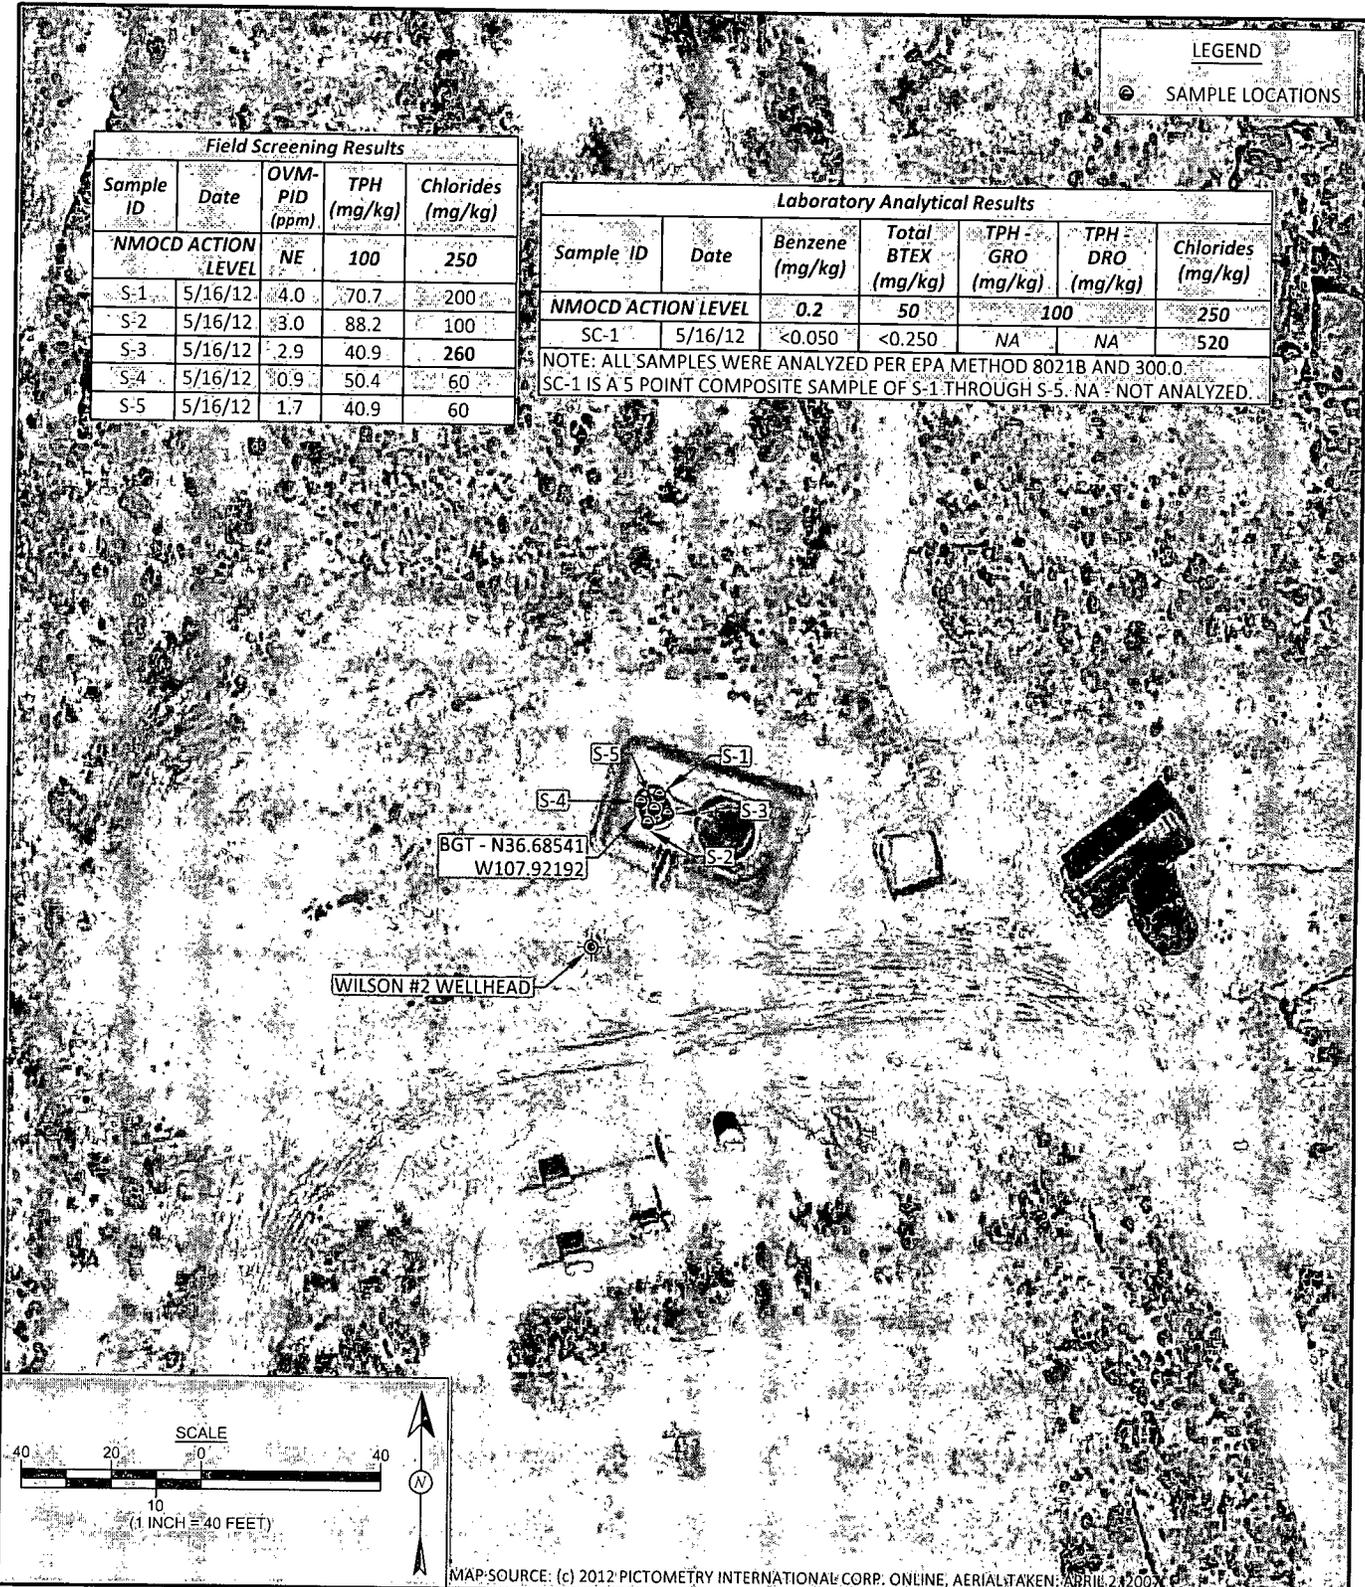
On May 16, 2012, AES personnel conducted field screening and collected five soil samples (S-1 through S-5) and one 5-point composite (SC-1) from below the BGT. Soil samples S-1 through S-5 were collected from approximately 0.5 feet below the former BGT for field screening of volatile organic compounds (VOCs), total petroleum hydrocarbon (TPH), and chlorides. Soil sample SC-1 was submitted for confirmation laboratory analysis. Soil sample locations are included on Figure 2.

Field screening for VOCs via OVM showed readings ranging from 0.9 ppm in S-4 up to 4.0 ppm in S-1. Field TPH concentrations ranged from 40.9 mg/kg in S-3 and S-5 up to 88.2 mg/kg in S-2. Field chloride concentrations were between 60 mg/kg in S-4 and S-5 up to 260 mg/kg in S-3. Field screening results are summarized in Table 1 and presented on Figure 2. The AES Field Screening Report is attached.

Laboratory analytical results showed that the benzene and total BTEX concentrations in SC-1 were less than 0.050 mg/kg and less than 0.25 mg/kg, respectively. The laboratory chloride concentration was reported at 520 mg/kg. Laboratory analytical results are summarized in Table 2 and included on Figure 2. Laboratory analytical reports are attached.

**SAMPLE LOCATIONS**

NMOCD action levels for BGT closures are specified in New Mexico Administrative Code (NMAC) 19.15.17.13E. Benzene concentrations in SC-1 were below the laboratory detection limit of 0.050 mg/kg, and total BTEX concentrations were below the NMOCD action level of 50 mg/kg. Field TPH concentrations were below the NMOCD action level of 100 mg/kg in all samples. Chloride concentrations in SC-1 were reported above the NMOCD action level of 250 mg/kg with 520 mg/kg. Based on field screening and laboratory analytical results for chlorides, CoP consulted with NMOCD regarding elevated chloride concentrations, and NMOCD concurred that the excavation could be backfilled. No further work is recommended.
