Pit, Below-Grade Tank, or  
Proposed Alternative Method Permit or Closure Plan Application

BP AMERICA PRODUCTION COMPANY  
SAN JUAN BASIN, NORTHWEST NEW MEXICO

BELOW-GRADE TANK CLOSURE PLAN

Gallegos Canyon Unit 124E  
API No. 3004526289  
Unit Letter N, Section 35, T28N, R12W

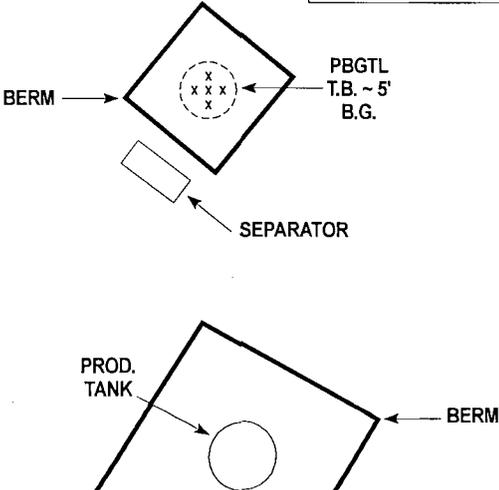
DISCOLORATION/STAINING OBSERVED: YES  NO  EXPLANATION - \_\_\_\_\_

APPARENT EVIDENCE OF A RELEASE OBSERVED AND/OR OCCURRED: YES  NO  EXPLANATION: \_\_\_\_\_
