Pit, Closed-Loop System, Below-Grade Tank, or
Proposed Alternative Method Permit or Closure Plan Application

**Logos Operating, LLC
San Juan Basin
Closure Report**

**Lease Name: LOGOS 6
API NO: 30-045-35422**

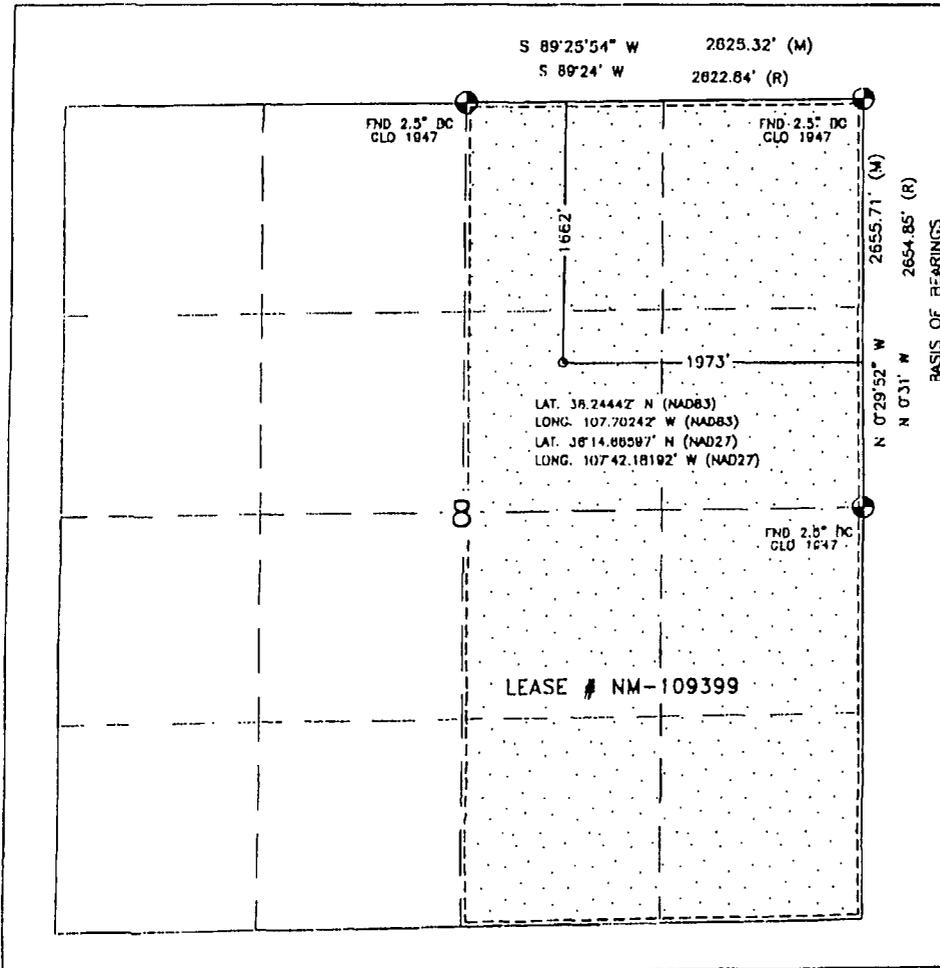
Form C-102
Revised August 1, 2011

¹² Dedicated Acres E/2 SEC. 8 - 320.0 Acres	¹³ Joint or Infill	¹⁴ Consolidation Code	¹⁵ Order No.
---	-------------------------------	----------------------------------	-------------------------

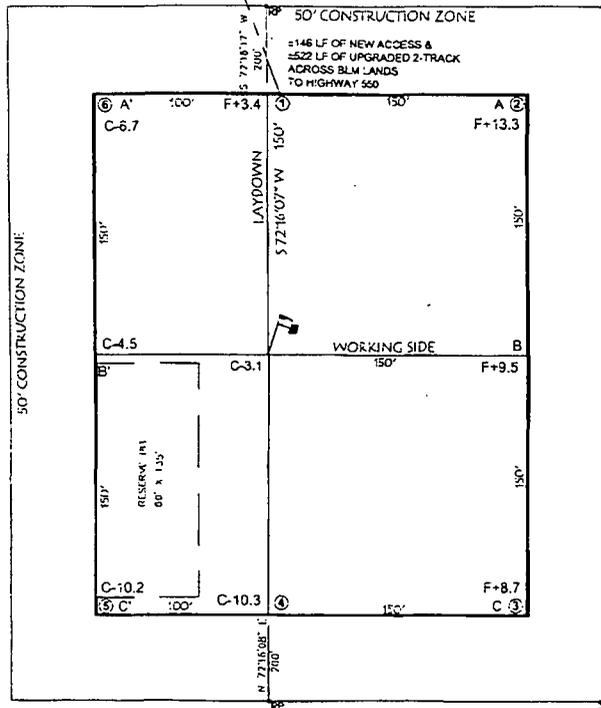
SCOPES TO BE CONSTRUCTED TO MATCH THE ORIGINAL CONTOURS AS CLOSE AS POSSIBLE.

TOTAL PERMITTED AREA
 350' x 400' = 3.21 ACRES
 SCALE: 1" = 80'
 JOB No.: LGS009
 DATE: 10/19/12
 DRAWN BY: GRR
