Release Notification and Corrective Action

**RE: Final Excavation Report
Grambling C #7
San Juan County, New Mexico**

TOPOGRAPHIC SITE LOCATION MAP
 ConocoPhillips
 GRAMBLING C #7
 NE¼ NE¼, SECTION 12, T30N, R10W
 SAN JUAN COUNTY, NEW MEXICO
 N36.83139, W107.83070

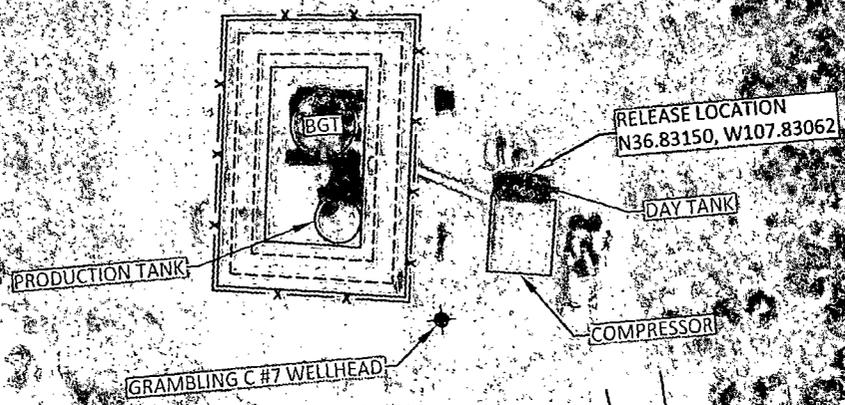
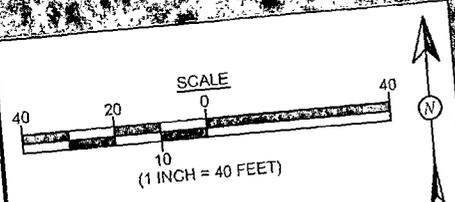
FIGURE 2

**AERIAL SITE MAP
JULY 2014**

ConocoPhillips
GRAMBLING C #7
NE¼, NE¼, SECTION 12, T30N, R10W
SAN JUAN COUNTY, NEW MEXICO
N36.83139, W107.83070

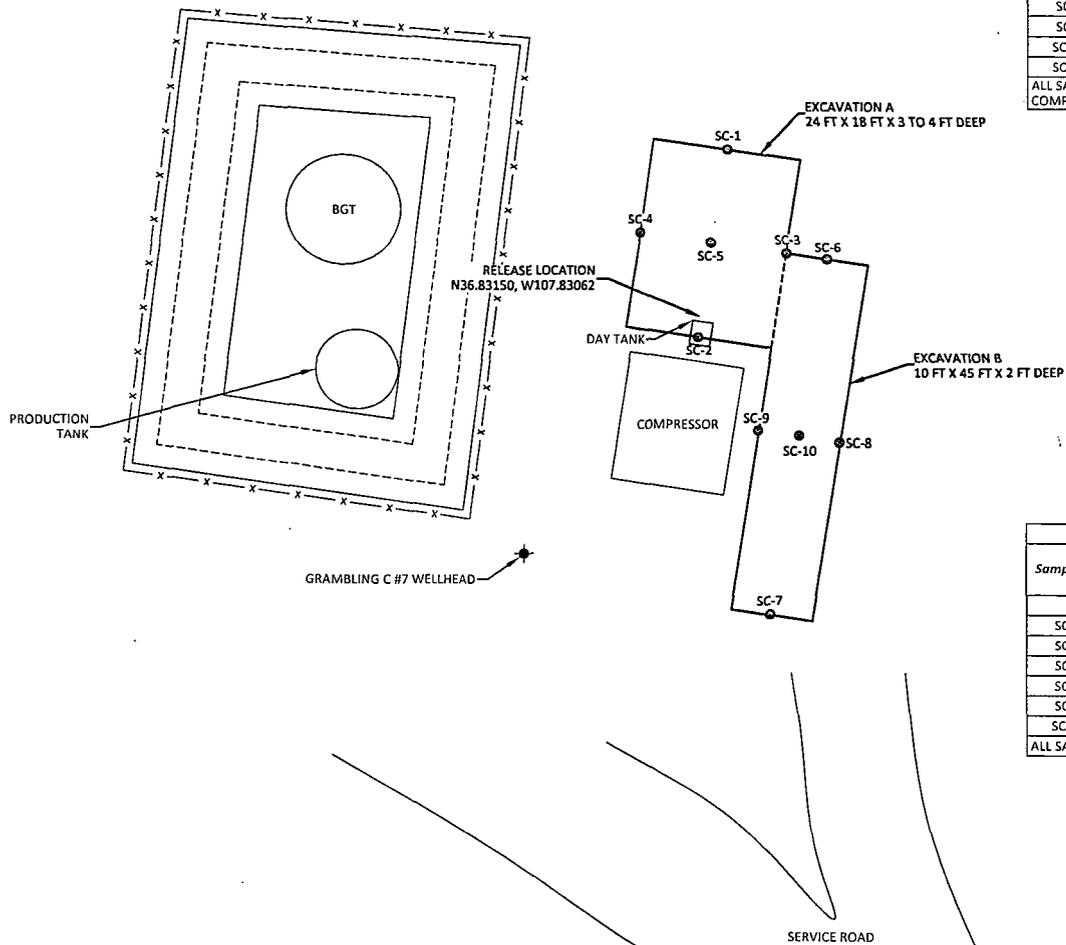
FIGURE 3

EXCAVATION SAMPLE LOCATIONS AND RESULTS JULY 2014
 ConocoPhillips
 GRAMBLING C #7
 NE¼ NE¼, SECTION 12, T30N, R10W
 SAN JUAN COUNTY, NEW MEXICO
 N36.83139, W107.83070

Field Sampling Results				
Sample ID	Date	Depth (ft)	OVM-PID (ppm)	TPH (mg/kg)
NMOC ACTION LEVEL				
SC-1	7/18/14	1 to 3	0.3	63.5
SC-2	7/18/14	1 to 4	0.5	63.5
SC-3	7/18/14	1 to 4	0.2	45.8
SC-4	7/18/14	1 to 4	0.4	53.3
SC-5	7/18/14	3 to 4	0.4	93.3
SC-6	7/18/14	1 to 2	0.6	82.4
SC-7	7/18/14	1 to 2	0.2	40.4
SC-8	7/18/14	1 to 2	0.1	62.1
SC-9	7/18/14	1 to 2	0.1	62.1
SC-10	7/18/14	2	0.2	49.9
SC-11	7/18/14	1 to 2	0.2	NA

ALL SAMPLES ARE COMPOSITE SAMPLES. SC-11 WAS A COMPOSITE OF EXCAVATION B. NA - NOT ANALYZED.

Laboratory Analytical Results					
Sample ID	Date	Depth (ft)	TPH - GRO (mg/kg)	TPH - DRO (mg/kg)	TPH - MRO (mg/kg)
NMOC ACTION LEVEL					
SC-1	7/8/14	1 to 3	<5.0	<10	<50
SC-2	7/8/14	1 to 4	<4.7	<9.9	<50
SC-3	7/8/14	1 to 4	<4.8	<10	<50
SC-4	7/8/14	1 to 4	<4.9	<10	<50
SC-5	7/8/14	3 to 4	<4.8	<10	<50
SC-11	7/8/14	1 to 2	<4.7	<10	<50

ALL SAMPLES WERE ANALYZED PER EPA METHOD 8015D.

AES was initially contacted by Lisa Hunter of CoP on July 15, 2014, and on July 18, 2014, Emilee Skyles and David Reese of AES completed excavation field work. Field sampling activities included collection of 11 confirmation composite soil samples from the walls and base of two excavations. The final area of Excavation A measured approximately 24 feet by 18 feet by 3 to 4 feet in depth, and the final area of Excavation B measured approximately 10 feet by 45 feet by 2 feet in depth. Sample locations and final excavation extents are presented on Figure 3.

On July 18, 2014, final excavation field screening results for VOCs via OVM ranged from 0.1 ppm in SC-8 and SC-9 up to 0.6 ppm in SC-6. Field TPH concentrations ranged from 40.4 mg/kg in SC-7 up to 93.3 mg/kg in SC-5. Results are included below in Table 1 and on Figure 3. The AES Field Sampling Report is attached.

Laboratory analyses for SC-1 through SC-5 and SC-11 were used to confirm field sampling results from the final excavations. TPH concentrations as GRO/DRO/MRO were reported below the NMOCD action level of 100 mg/kg in all samples. Results are presented in Table 2 and on Figure 3. The laboratory analytical reports are attached.
