Release Notification and Corrective Action

Name of Company <b>ConocoPhillips Company</b>	Contact <b>Lindsay Dumas</b>
Address <b>3401 East 30<sup>th</sup> St, Farmington, NM</b>	Telephone No. <b>(505) 599-4089</b>
Facility Name: <b>Huerfano 156</b>	Facility Type: <b>Gas Well</b>

**RE: Final Excavation Report  
Huerfano #156  
San Juan County, New Mexico**

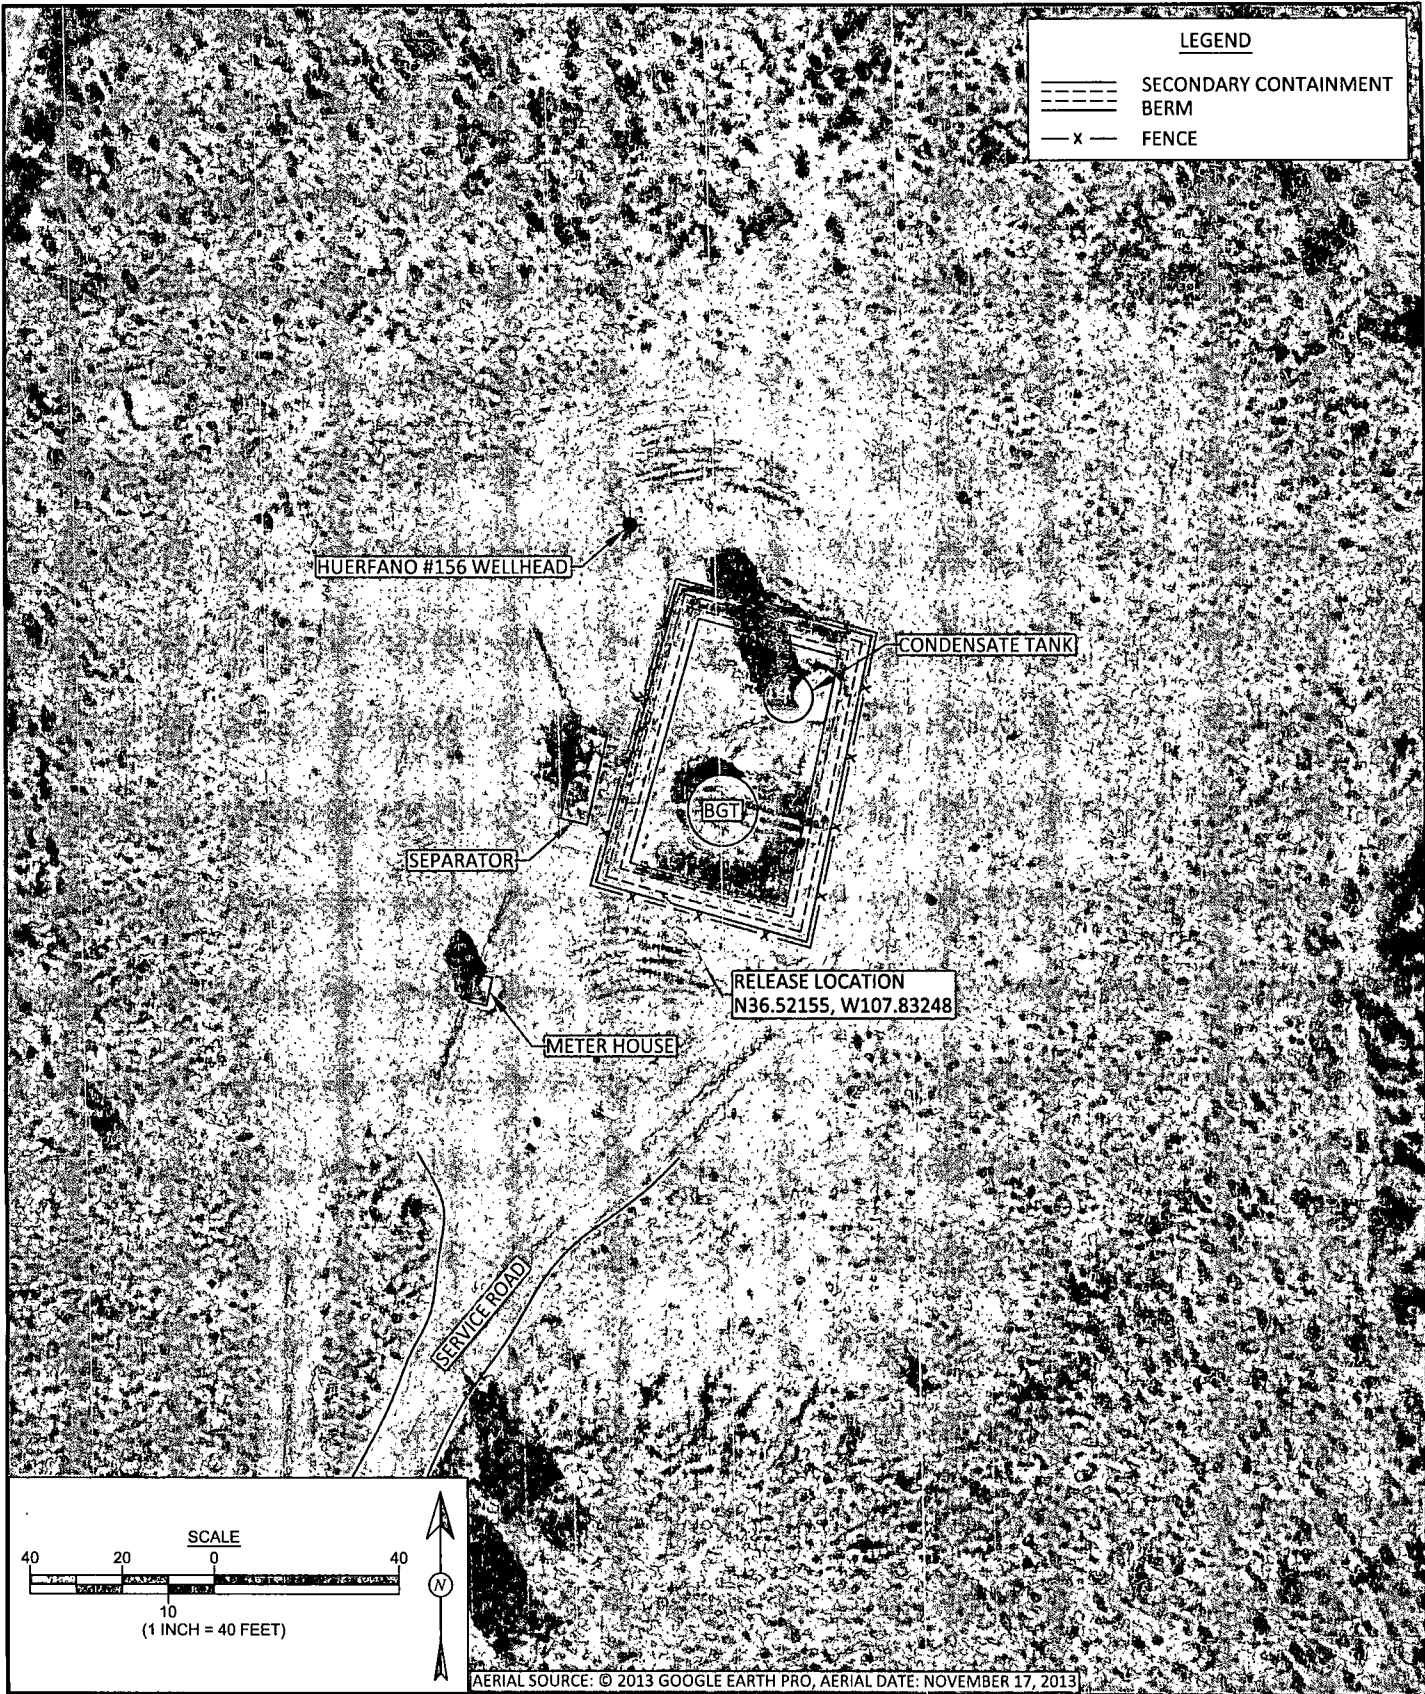
## FIGURE 2

### AERIAL SITE MAP OCTOBER 2014

ConocoPhillips  
HUERFANO #156  
NE¼ NW¼, SECTION 6, T26N, R9W  
SAN JUAN COUNTY, NEW MEXICO  
N36.52175, W107.83254
