Pit, Closed-Loop System, Below-Grade Tank, or Proposed Alternative Method Permit or Closure Plan Application

BELOW-GRADE TANK CLOSURE PLAN

Lobato Gas Com C 001
API No. 3004508760
Unit Letter H, Section 3, T29N, R9W

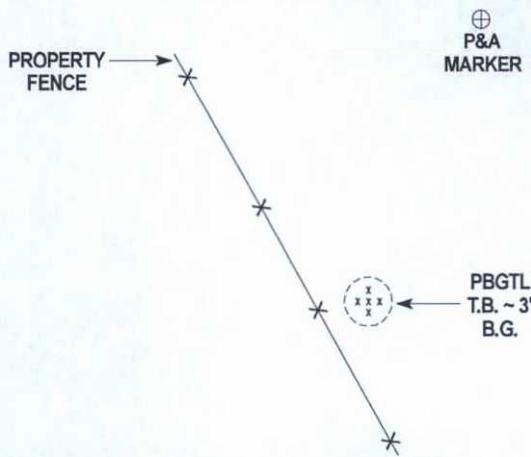
SITE SKETCH BGT Located: off / on site PLOT PLAN circle: **attached**

X - S.P.D.

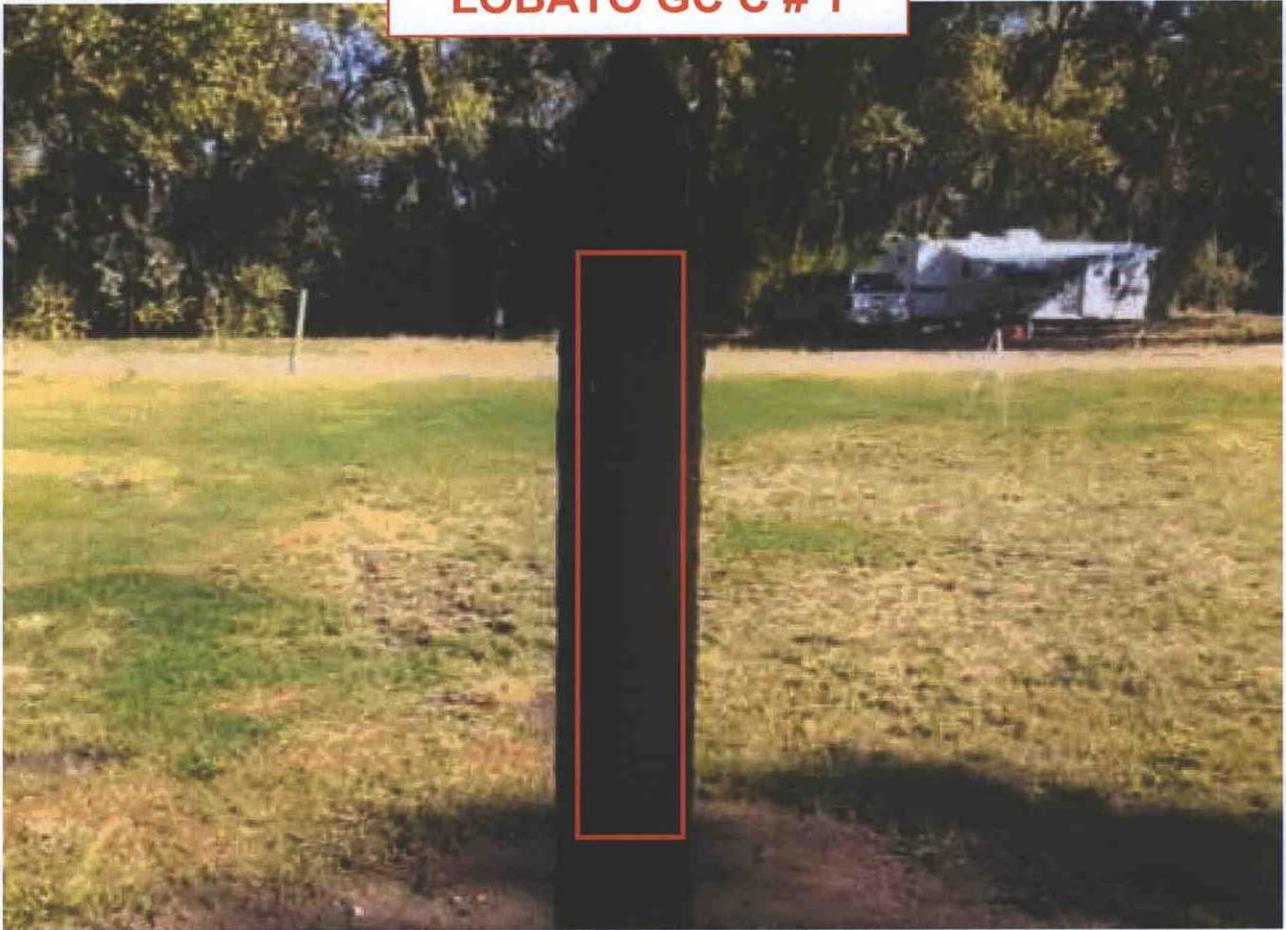
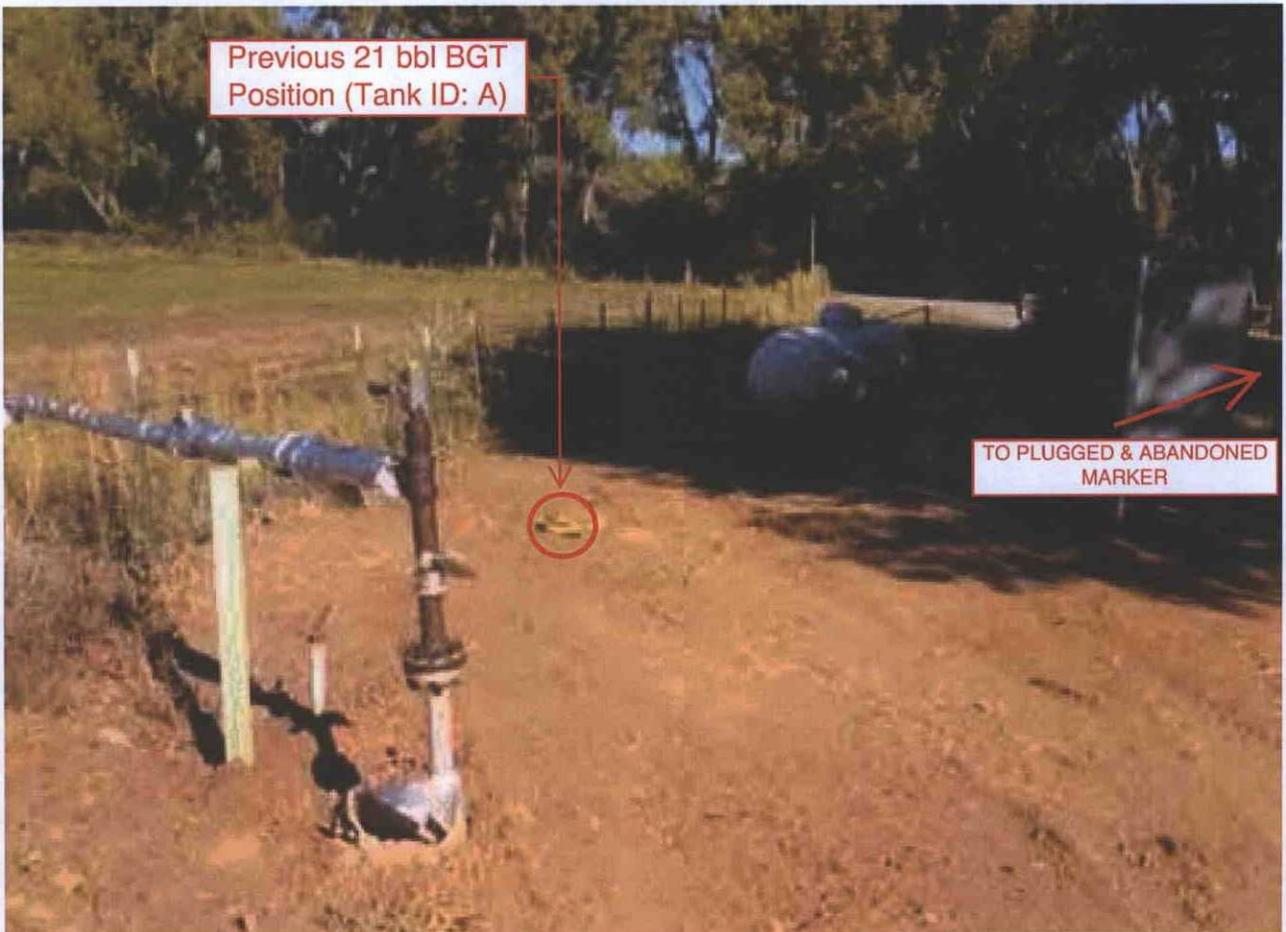
LOBATO GC C # 1

Previous 21 bbl BGT
Position (Tank ID: A)

TO PLUGGED & ABANDONED
MARKER

Describe Cause of Problem and Remedial Action Taken.* The BGT was removed during stripping of the site during the plugging and abandonment. Sampling of the soil beneath the former BGT location was done subsequently and witnessed by the NMOCD. Soil analysis resulted for TPH, BTEX and chloride below BGT closure standards. Analysis results are attached.
