14308 Proposed Alternative Method Permit or Closure Plan Application

1.
Operator: ConocoPhillips Company OGRID #: 217817
Address: PO BOX 4289, Farmington, NM 87499
Facility or well name: AXI APACHE J 21
API Number: 30-039-20437 OCD Permit Number: _____
U/L or Qtr/Qtr I (NESE) Section 5 Township 25N Range 5W County: Rio Arriba
Center of Proposed Design: Latitude 36.42626 °N Longitude -107.37725 °W NAD: 1927 1983
Surface Owner: Federal State Private Tribal Trust or Indian Allotment

BGT Closure Photograph Log
ConocoPhillips
AXI Apache J 21
Unit Letter I, Section 5, Township 25N, Range 5W
N36.89674, W107.77069
Rio Arriba County, NM
February 15, 2016

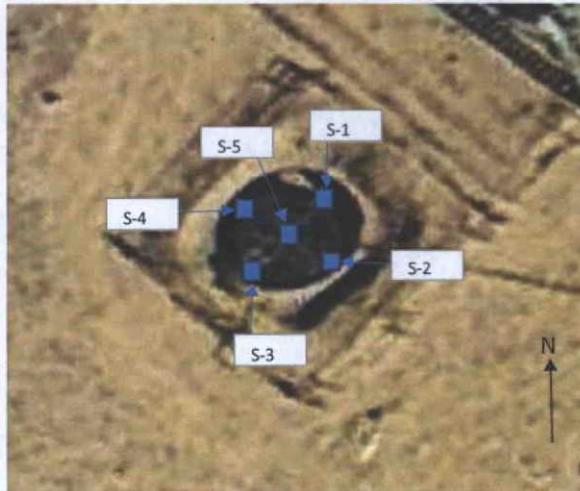
SC-1 is a 5-point composite of S-1 through S-5, collected 0.5 ft below BGT.

Sample SC-1 was laboratory analyzed for TPH (8015), BTEX (8021) and chlorides (300.0).

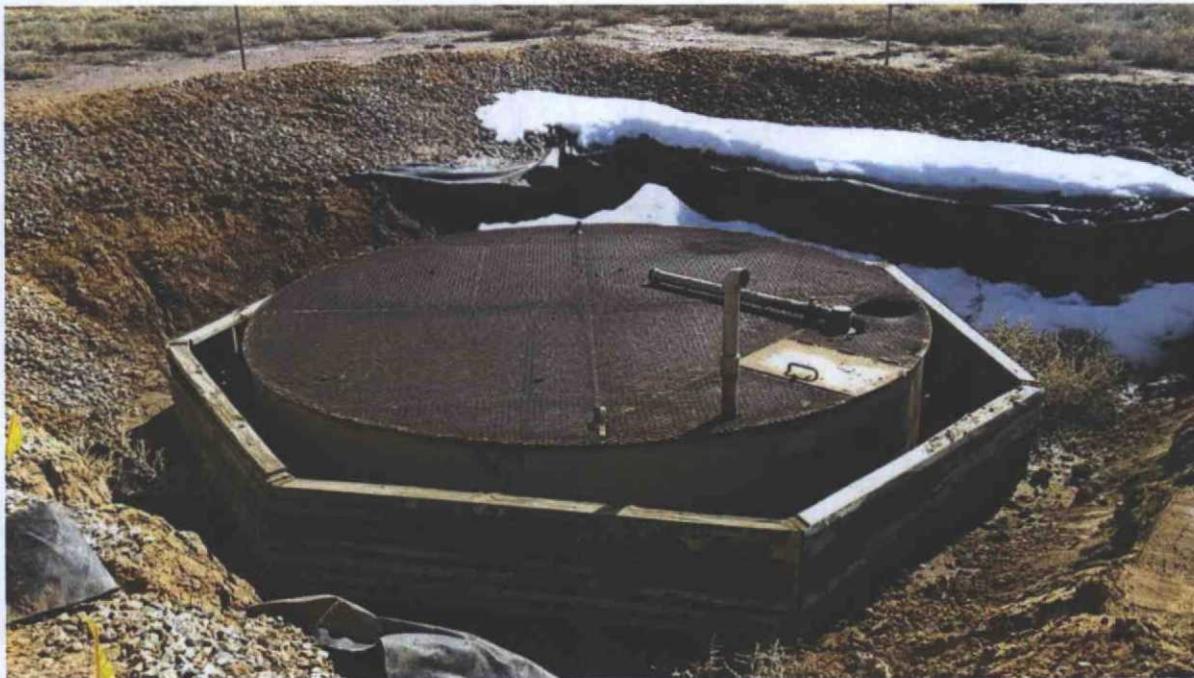
Photograph 1. General view of below grade tank in place before closure activities.

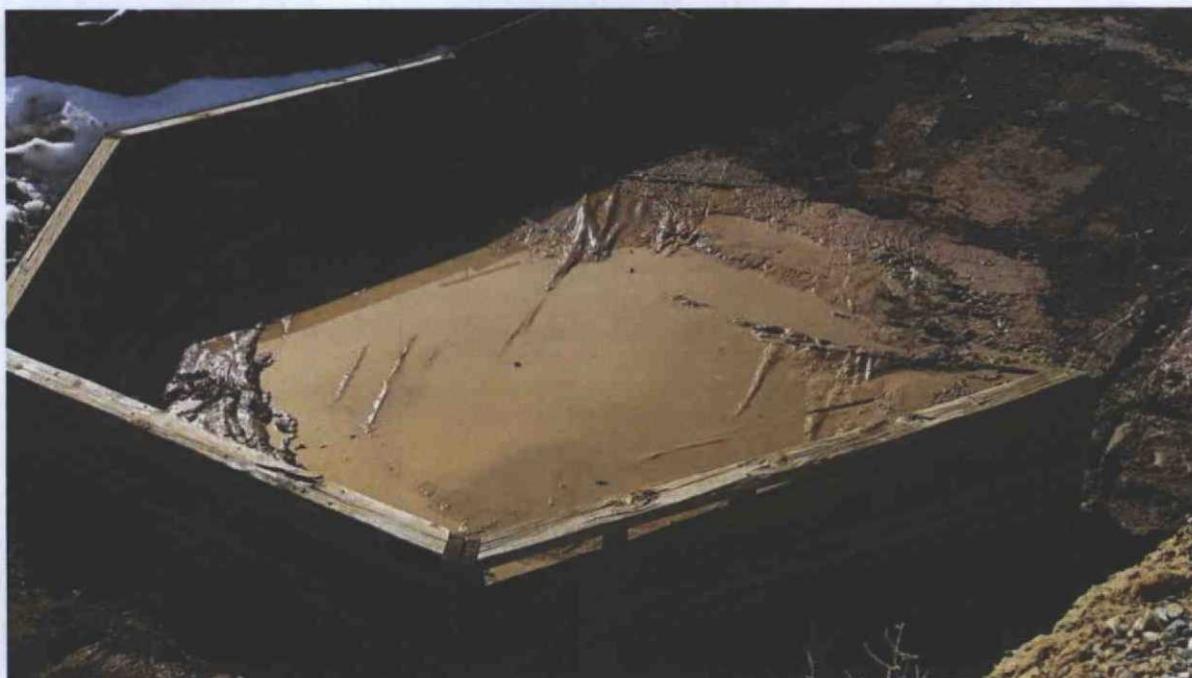
Photograph 2. View of below grade tank location following the removal of the tank.

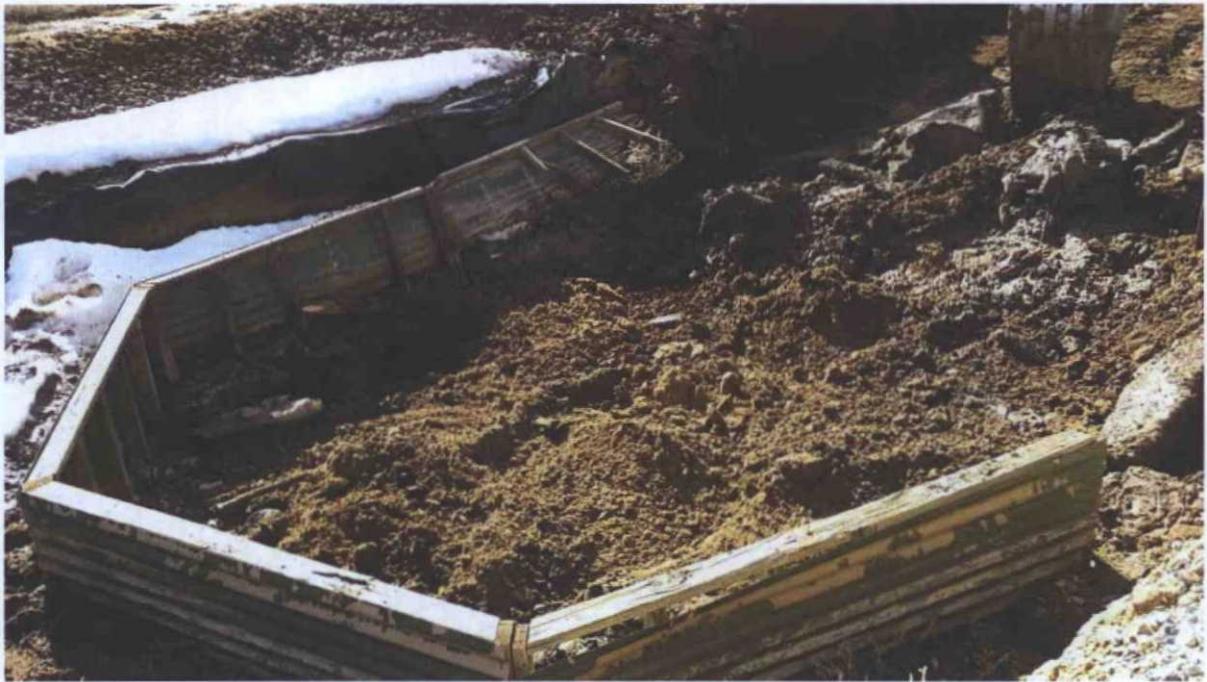
Observations: No staining or excess moisture observed below liner.

Photograph 3. View of the below grade tank location following the removal of the liner.

On February 15, 2016, following removal of the BGT tank and liner, Rule personnel conducted a visual inspection for surface/subsurface indications of a release. No evidence of a release was observed. Rule personnel then collected five soil samples (S-1 through S-5) from 0.5 feet beneath the floor of the BGT excavation.
