Burlington Resources Oil & Gas Company, LP
San Juan Basin
Below Grade Tank Closure Report

Lease Name: GREER 2
API No.: 30-045-05846

**AERIAL SITE MAP
 BELOW GRADE TANK CLOSURE
 MARCH 2016**
 ConocoPhillips
 GREER #2
 NE¼ SW¼, SECTION 16, T26N, R9W
 SAN JUAN COUNTY, NEW MEXICO
 N36.48579, W107.79692

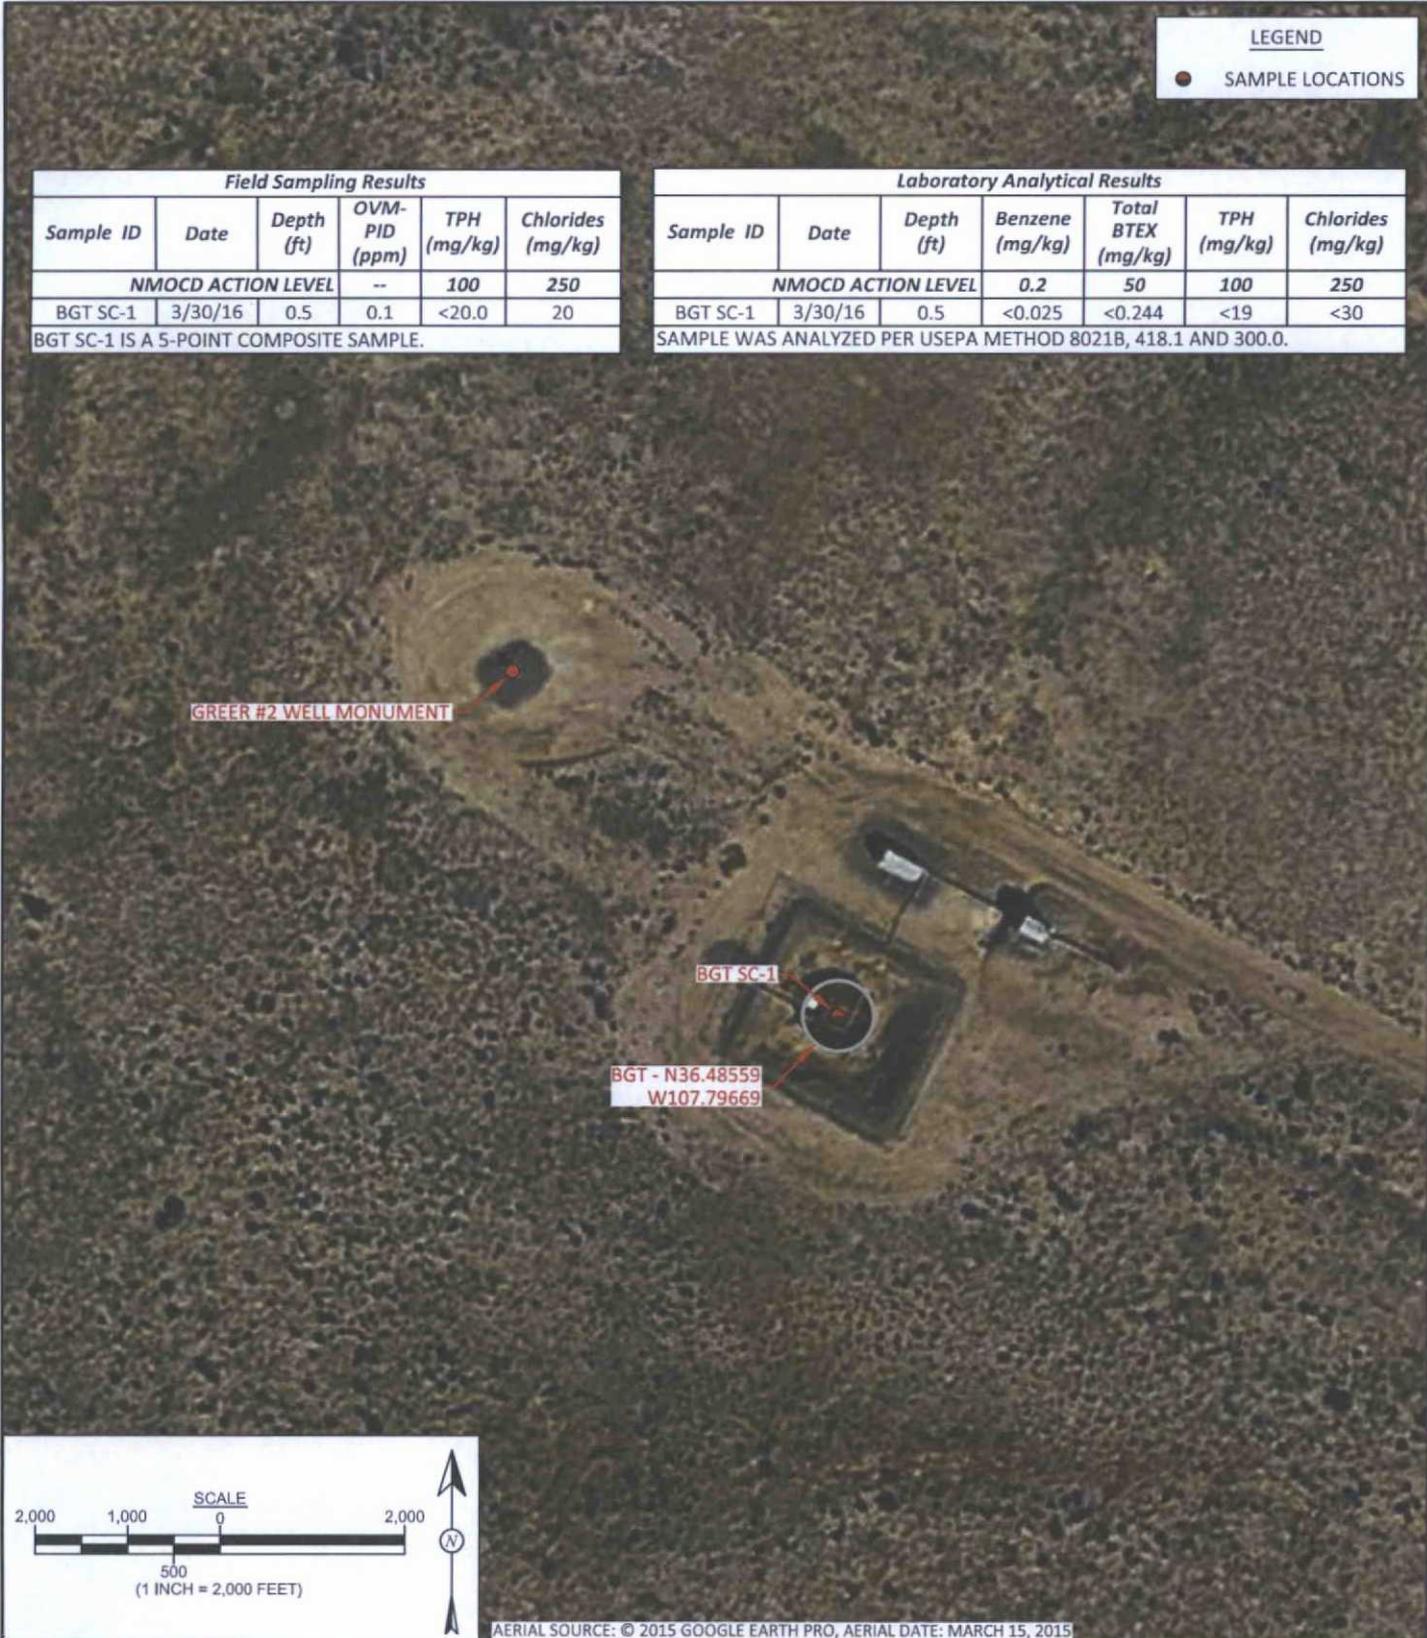
FIGURE 2

Laboratory Analytical Results						
Sample ID	Date	Depth (ft)	Benzene (mg/kg)	Total BTEX (mg/kg)	TPH (mg/kg)	Chlorides (mg/kg)
NMOCD ACTION LEVEL			0.2	50	100	250
BGT SC-1	3/30/16	0.5	<0.025	<0.244	<19	<30

NMOCD action levels for BGT closures are specified in New Mexico Administrative Code (NMAC) 19.15.17.13E. Field TPH concentrations in BGT SC-1 were below the NMOCD action level of 100 mg/kg, with a concentration reported at less than 20 mg/kg. Benzene and total BTEX concentrations were below the NMOCD action levels of 0.2 mg/kg and 50 mg/kg, respectively. Chloride concentrations in BGT SC-1 were below the NMOCD action level of 250 mg/kg. Based on field sampling and laboratory analytical results for benzene, total BTEX, TPH, and chlorides, no further work is recommended at Greer #2.
