**Release Notification and Corrective Action**

## **San Juan 32-9 #17A Release Report**

# ConocoPhillips San Juan 32-9 #17A Release Report

Confirmation Sampling Photograph Log  
ConocoPhillips  
San Juan 32-9 #17A  
Unit Letter F, Section 08, Township 31N, Range 09W  
N36.91557, W107.80631  
San Juan County, NM  
May 26, 2016

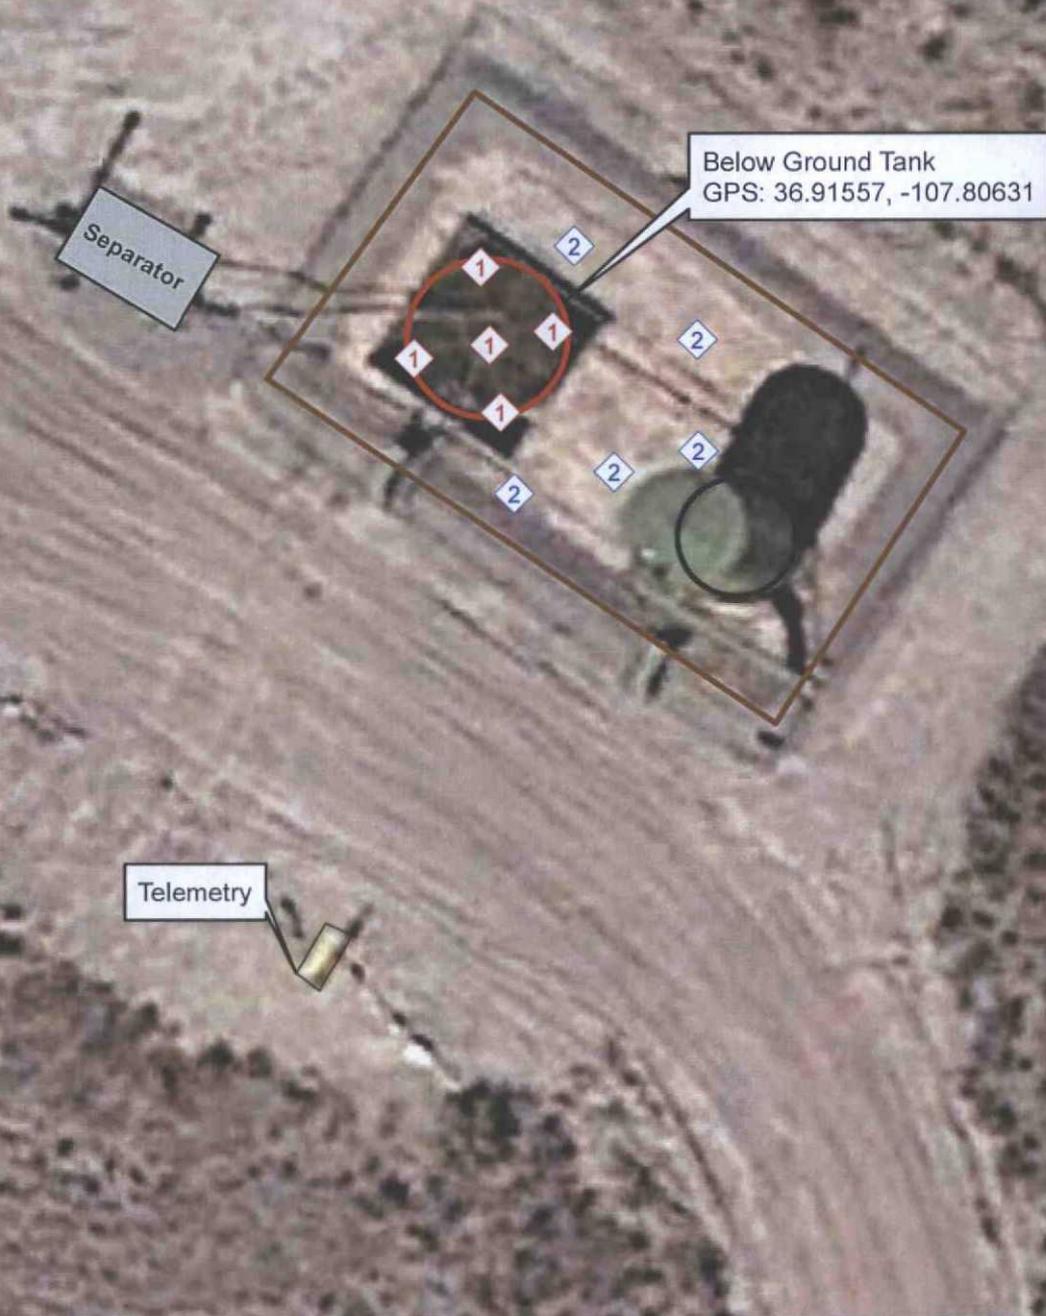
**Figure 2**  
**Aerial Site Map**  
 San Juan 32-9 17A

Approximately 14 cubic yards of soil was excavated from inside the BGT cribbing and transported to the landfarm for disposal/remediation. The maximum extent of the excavation measured approximately 16 feet by 16 feet by 6.5 feet (1.5 feet below the original depth inside the BGT cribbing) in depth. The excavation was backfilled with clean, imported material. A depiction of the final excavation with sample locations is included as Figure 2.

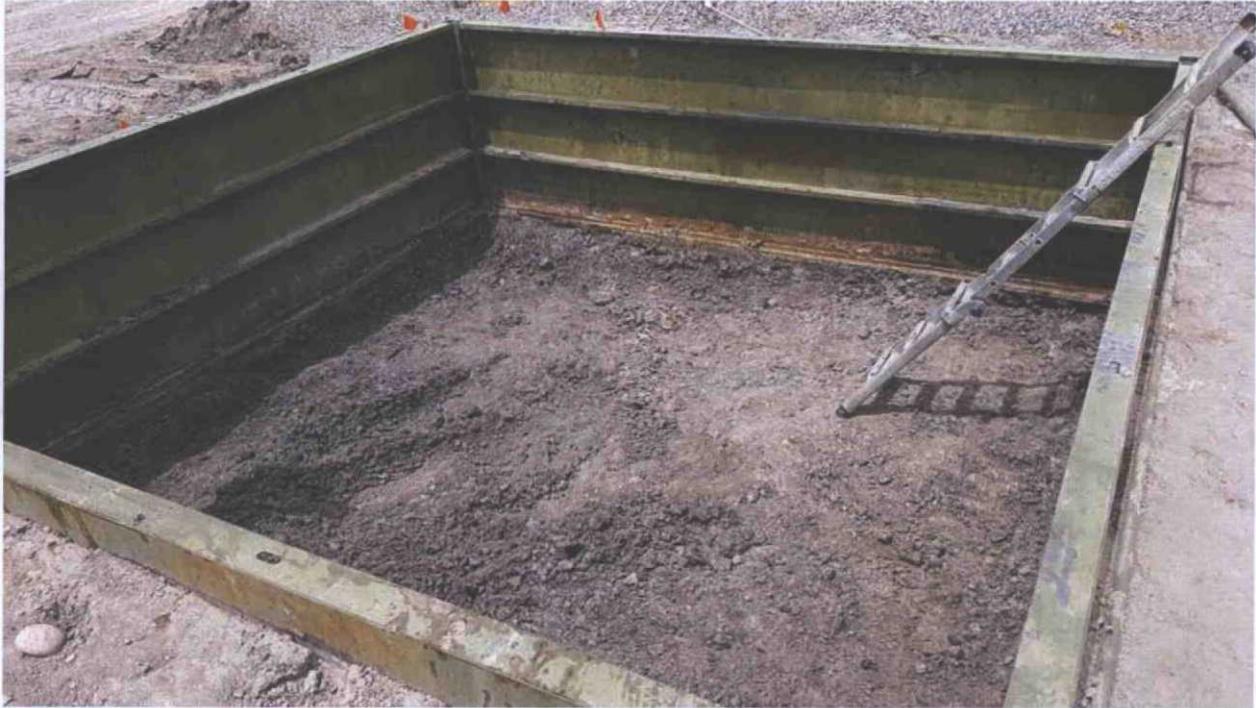
Photograph 1. View facing southwest: final excavation following removal of hydrocarbon impacted soils.

The ConocoPhillips San Juan 32-9 #17A release site is located in Unit Letter F, Section 08, Township 31 North, Range 09 West, in San Juan County, New Mexico. The release of an estimated 70 barrels (bbls) of condensate/produced water, discovered on February 26, 2016, was the result of the failure of the separator back pressure regulator causing overflow of the BGT. Following the excavation of hydrocarbon impacted soils from within the BGT cribbing, confirmation sample SC-1 was collected from the resultant excavation which measured at the maximum extent approximately 16 feet by 16 feet by 6.5 feet (1.5 feet below the original depth inside the BGT cribbing) in depth. Sample SC-2 was collected from within the berm area surrounding the BGT and above grade tank. Laboratory analytical results for confirmation samples SC-1 and SC-2 reported benzene, total BTEX, and total TPH (GRO/DRO) concentrations below the applicable NMOCD action levels for a site rank of 10. Approximately 14 cubic yards of soil was transported to the landfarm for disposal/remediation. The excavation was backfilled with clean, imported material.
