Release Notification and Corrective Action

Name of Company ConocoPhillips Company	Contact Lisa Hunter
Address 3401 East 30th St, Farmington, NM	Telephone No. (505) 258-1607
Facility Name: Holloway Federal #4	Facility Type: Gas Well
Surface Owner Federal	Mineral Owner Federal (SF-078895)
API No. 3004506704

**Re: Holloway Federal #4
Below Grade Tank Closure Sampling Report**

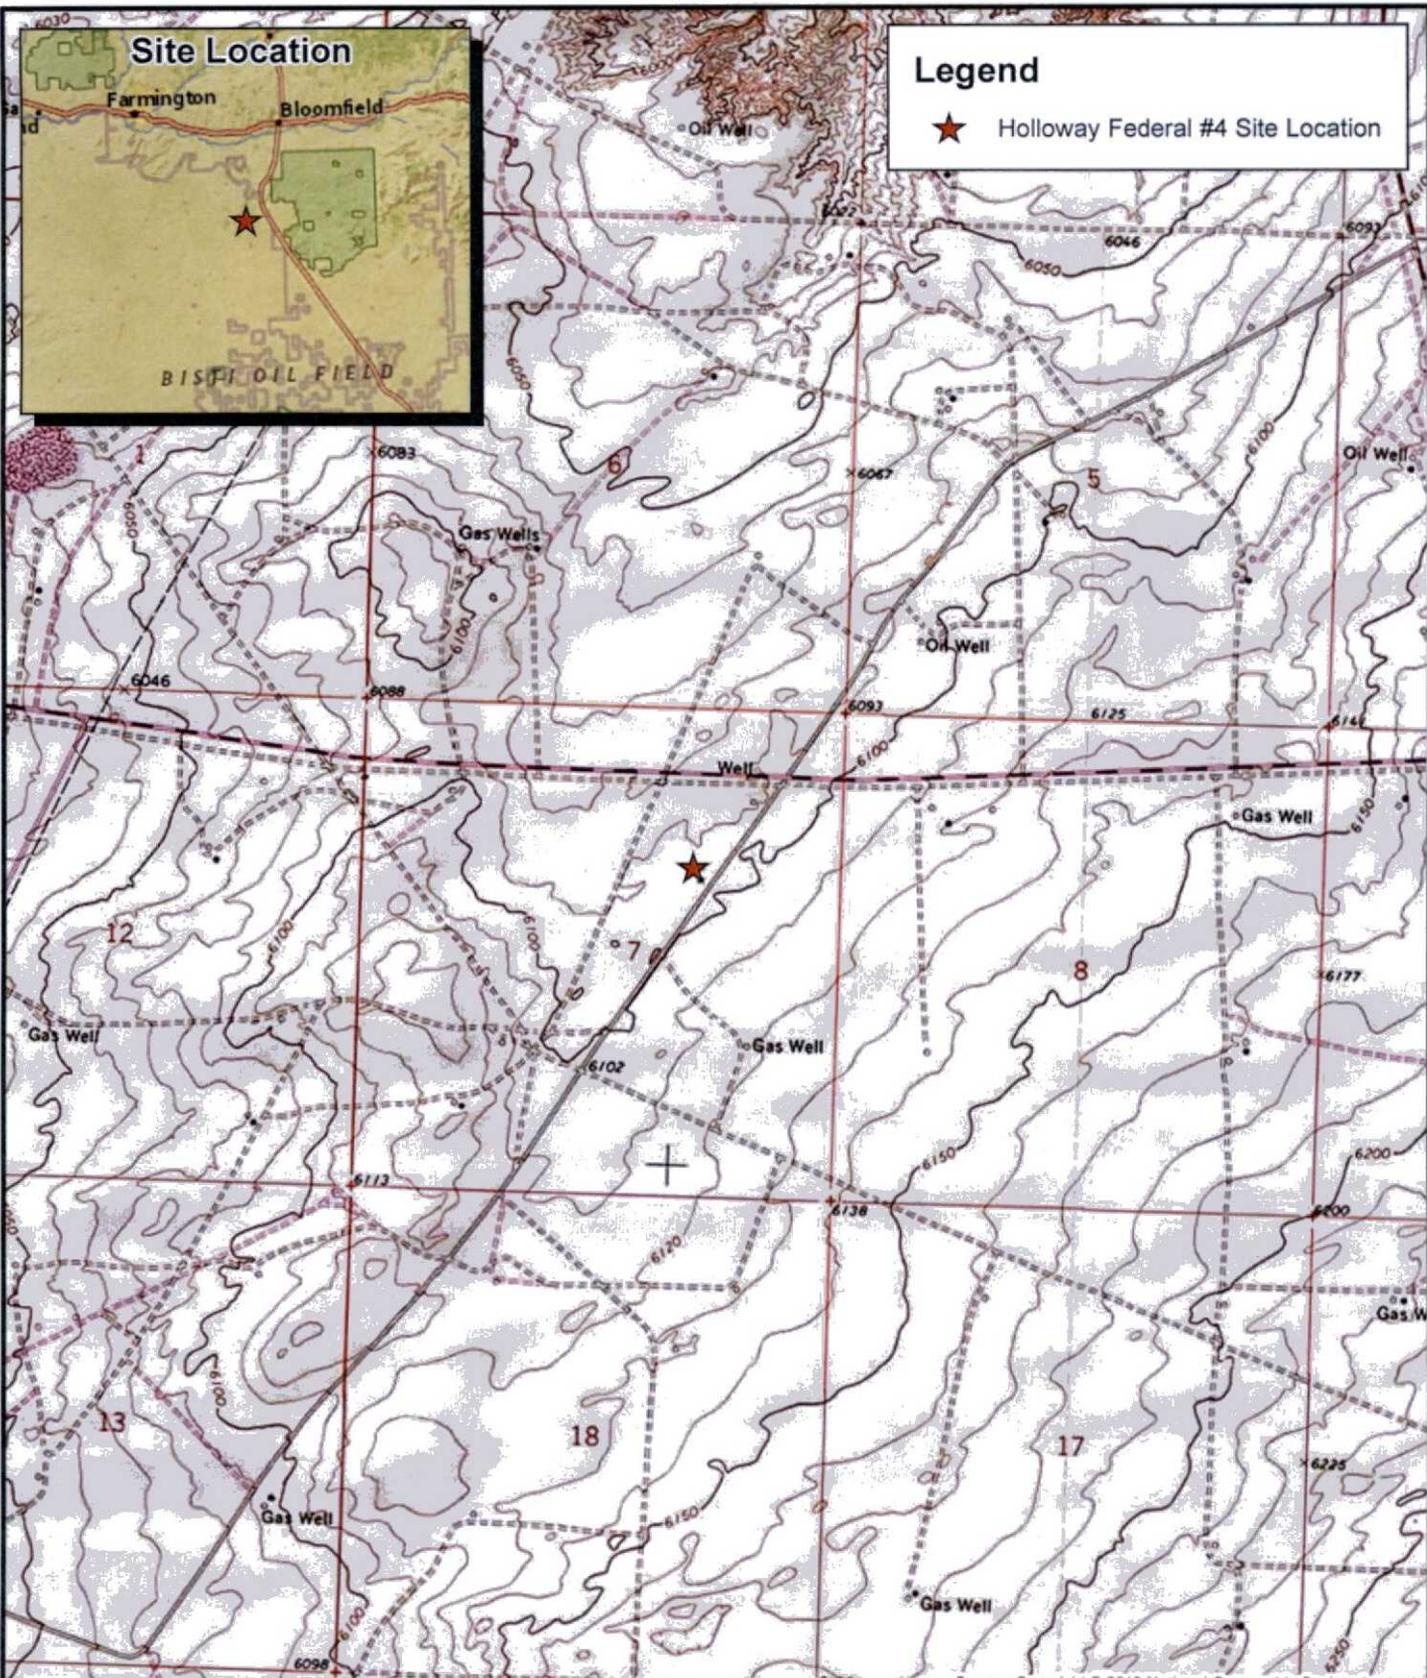
Figure 1
Topographic Site Map
Holloway Federal #4

This report summarizes the below grade tank (BGT) closure sampling activities conducted by Rule Engineering, LLC (Rule) at the ConocoPhillips Holloway Federal #4 located in Unit Letter G, Section 7, Township 27N, Range 11W in San Juan County, New Mexico. Activities included collection and analysis of a 5-point composite soil confirmation sample from beneath the BGT on August 17, 2016. A topographic map of the location is included as Figure 1 and an aerial site map is included as Figure 2.

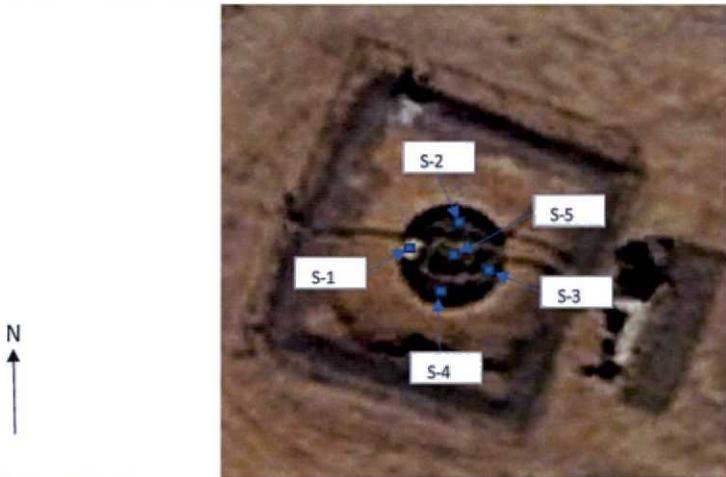
SC-1 is a 5-point composite of S-1 through S-5, collected 0.5 ft below BGT.
 Sample SC-1 was laboratory analyzed for TPH (8015), BTEX (8021) and chlorides (300.0).
