Pit, Below-Grade Tank, or
Proposed Alternative Method Permit or Closure Plan Application

Facility or well name: SAN JUAN 29-4 UNIT 21 - TANK 1 (EAST)

Burlington Resources Oil & Gas Company, LP
San Juan Basin
Below Grade Tank Closure Report

Lease Name: San Juan 29-4 Unit 21 – Tank #1 EAST
API No.: 30-039-21453

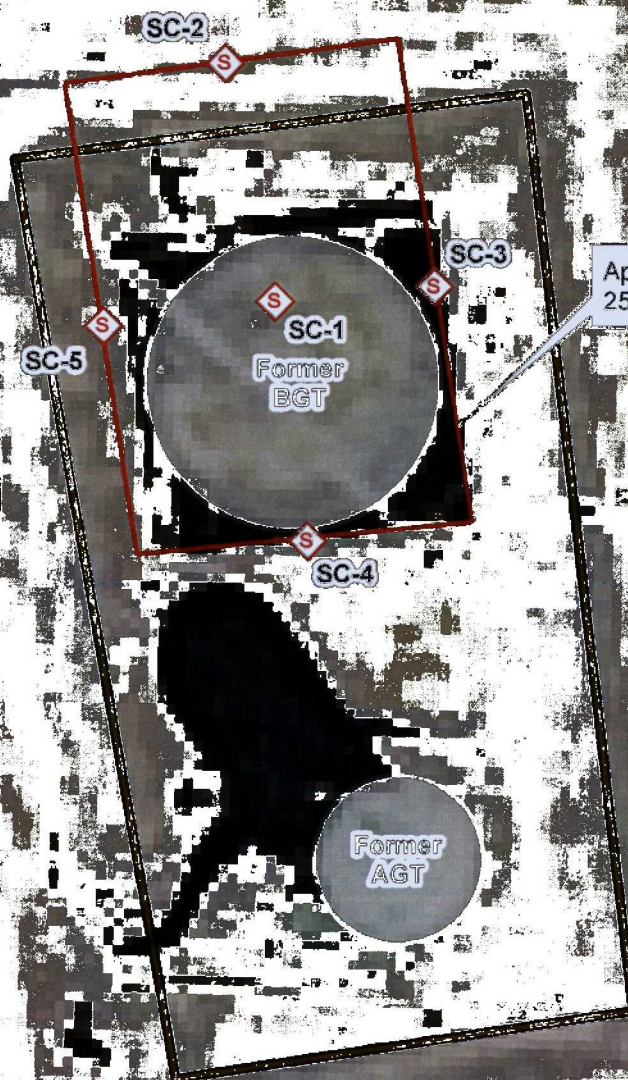
-   Soil Sample
-   Wellhead Monument
-   Above Ground Storage Tank (AGT)
-   Below Grade Tank (BGT)
-   Berm
-   Excavation Extents

Approximate Final Excavation Extents
25 feet x 18 feet x 7 feet in depth

On 07/21/16 a 5 point composite confirmation sampling was collected throughout the excavation of 25' x 18x7' app 116 yds. of material was hauled to Envirotech and the same amount was imported for backfill
Analytical results for the BTEX and TPH were below the regulatory standards (ND) set forth in the NMOCD Guidelines for Remediation of Leaks, Spills and Releases. Chlorides testing was conducted for information purposes and do not exceed the NMOCD action level. No further action is needed. The final lab report is attached for your review.
