Pit, Below-Grade Tank, or
Proposed Alternative Method Permit or Closure Plan Application

ConocoPhillips Company
San Juan Basin
Below Grade Tank Closure Report

Lease Name: JICARILLA E 15

API No.: 30-039-21773

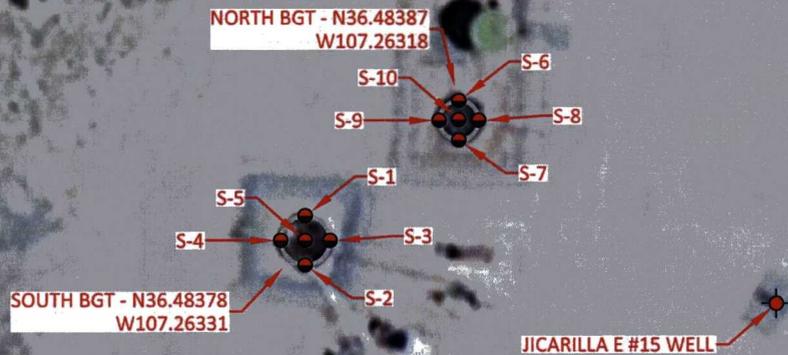
FIGURE 2
AERIAL SITE MAP
BELOW GRADE TANK CLOSURE
OCTOBER 2013
 ConocoPhillips
 JICARILLA E #15
 NW¼, SW¼, SECTION 16, T26N, R4W
 RIO ARriba COUNTY, NEW MEXICO
 N36.48374, W107.26290

SC-1 IS A 5-POINT COMPOSITE SAMPLE OF S-1 THROUGH S-5.
 SC-2 IS A 5-POINT COMPOSITE SAMPLE OF S-6 THROUGH S-10. NA - NOT ANALYZED

AERIAL SOURCE: © 2013 MICROSOFT CORPORATION - AVAILABLE EXCLUSIVELY BY DIGITALGLOBE

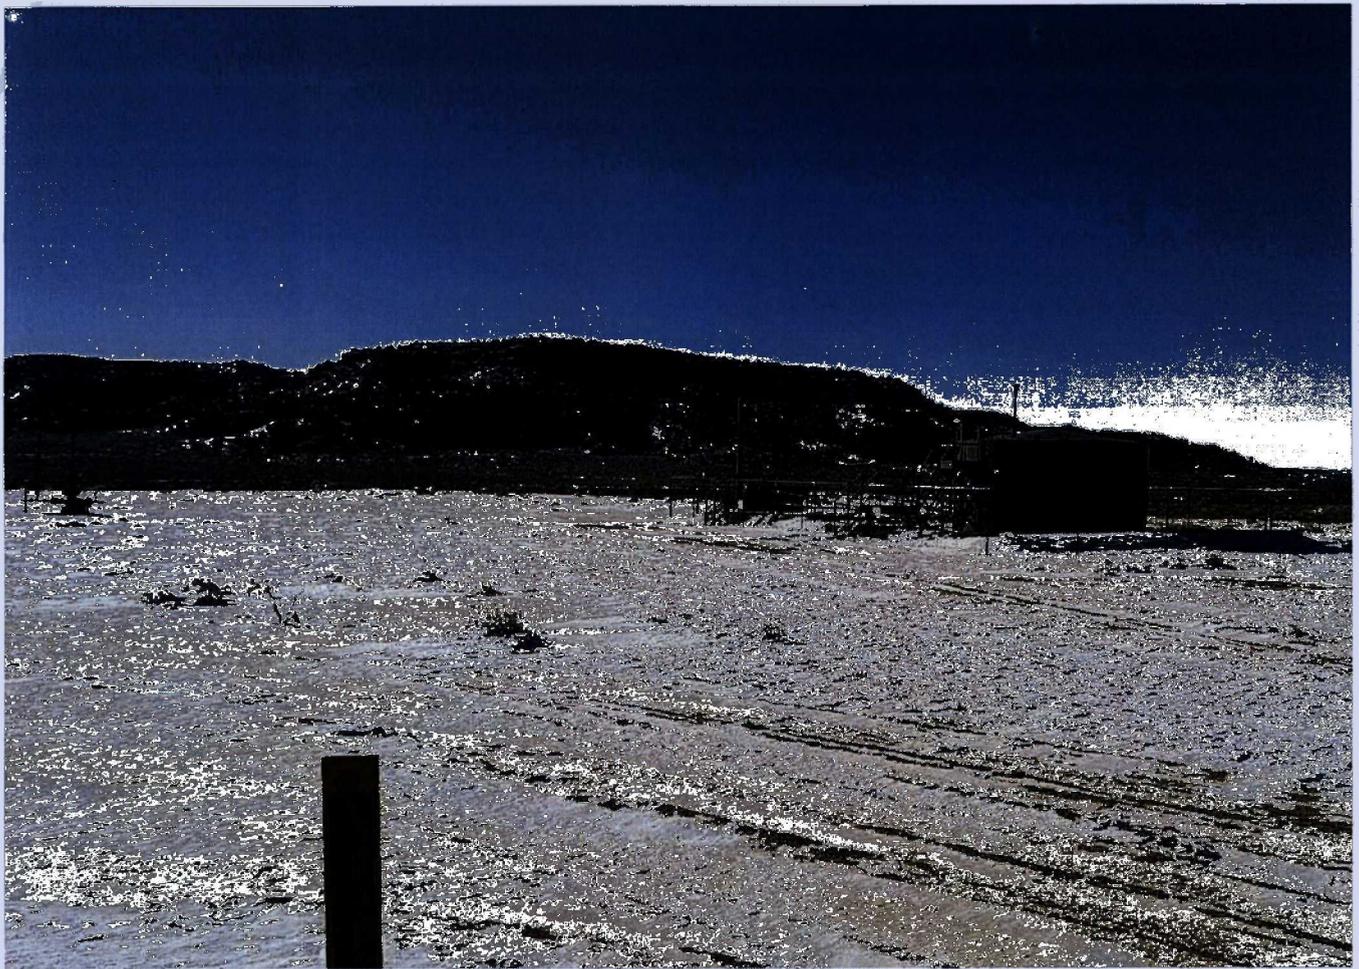
Phillips Company
JICARILLA E 15
JIC CONTRACT 104
NO. 30-039-21773
SW, 1645' FSL & 830' FWL
SEC.16 T026N R004W NMPM
ARRIBA COUNTY, NM ELEV 6730
36° 29' 02" LONG 107° 15' 47"
EMERGENCY NUMBER (505) 324-5170
NO SMOKING NO TRESPASSING
