Pit, Below-Grade Tank, or
Proposed Alternative Method Permit or Closure Plan Application

ConocoPhillips Company
San Juan Basin
Below Grade Tank Closure Report

Lease Name: San Juan 29-5 Unit 4A

API No.: 30-039-21339

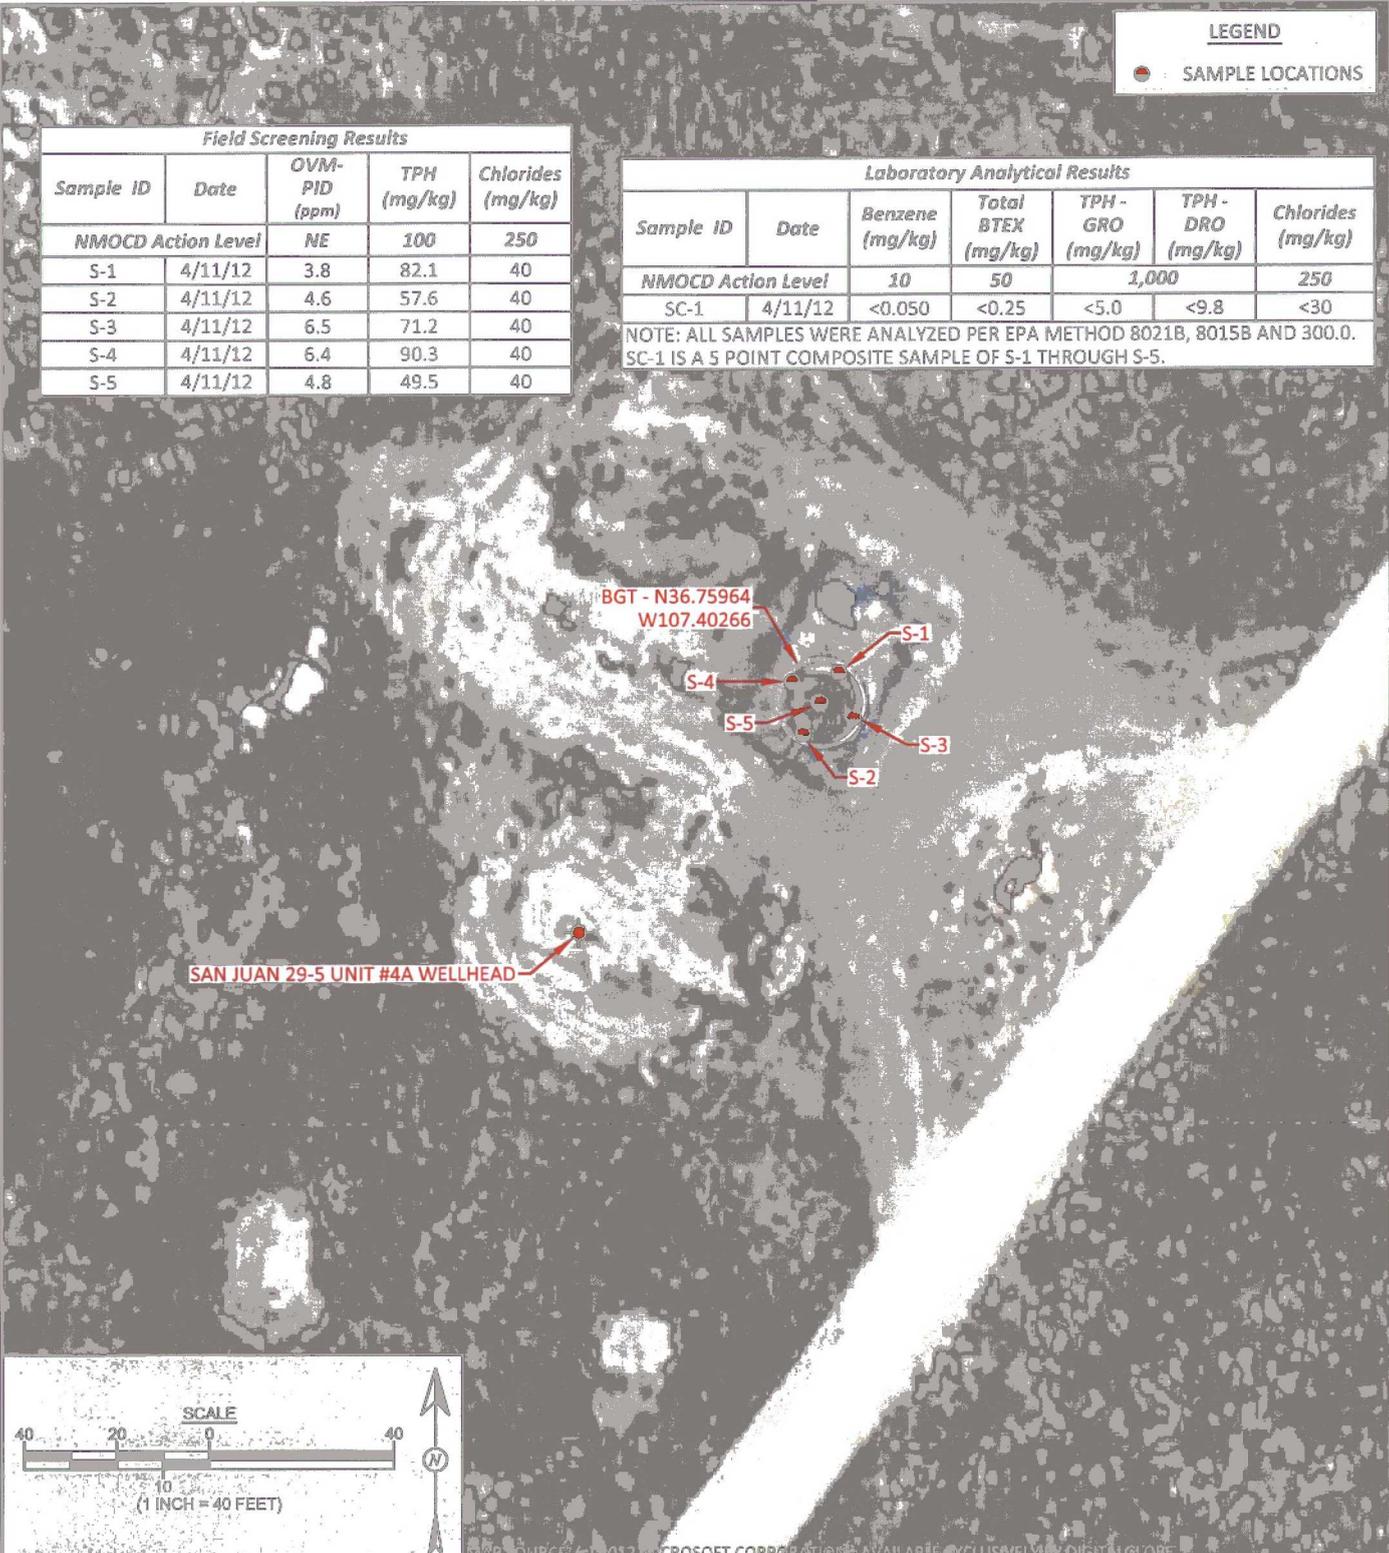
Sample ID	Date	Benzene (mg/kg)	Total BTEX (mg/kg)	TPH - GRO (mg/kg)	TPH - DRO (mg/kg)	Chlorides (mg/kg)
NMOCD Action Level		10	50	1,000	250	
SC-1	4/11/12	<0.050	<0.25	<5.0	<9.8	<30

NOTE: ALL SAMPLES WERE ANALYZED PER EPA METHOD 8021B, 8015B AND 300.0. SC-1 IS A 5 POINT COMPOSITE SAMPLE OF S-1 THROUGH S-5.
