Pit, Closed-Loop System, Below-Grade Tank, or
Proposed Alternative Method Permit or Closure Plan Application

BP AMERICA PRODUCTION COMPANY
SAN JUAN BASIN, NORTHWEST NEW MEXICO

BELOW-GRADE TANK CLOSURE PLAN

Gallegos Canyon Unit # 224 – Tank ID: A

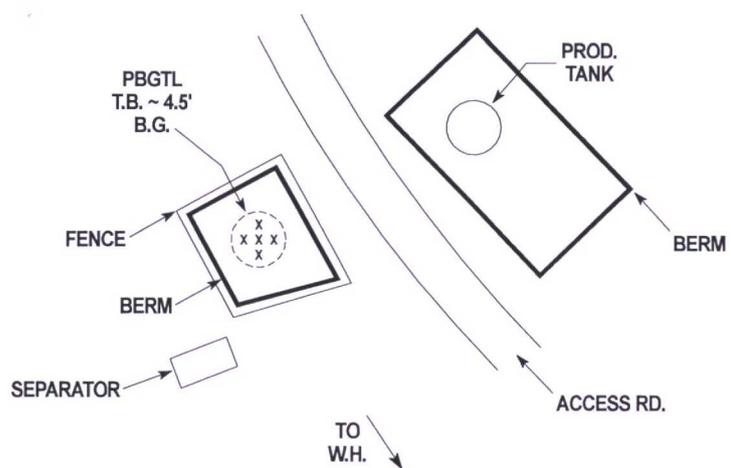
SITE SKETCH	BGT Located: off <input checked="" type="checkbox"/> on site	PLOT PLAN circle: attached	OVM CALIB. READ. = NA ppm RF=0.52
			OVM CALIB. GAS = NA ppm
			TIME: NA am/pm DATE: NA

SITE OBSERVATIONS:	LOST INTEGRITY OF EQUIPMENT: YES <input checked="" type="checkbox"/> NO <input type="checkbox"/> EXPLANATION - _____
APPARENT EVIDENCE OF A RELEASE OBSERVED AND/OR OCCURRED: YES <input checked="" type="checkbox"/> NO <input type="checkbox"/> EXPLANATION: _____	
EQUIPMENT SET OVER RECLAIMED AREA: YES <input checked="" type="checkbox"/> NO <input type="checkbox"/> EXPLANATION - _____	
OTHER: NMOCD REP. NOT PRESENT TO WITNESS CONFIRMATION SAMPLING.

SOIL IMPACT DIMENSION ESTIMATION: NA ft. X NA ft. X NA ft.	EXCAVATION ESTIMATION (Cubic Yards): NA
DEPTH TO GROUNDWATER: >100'	NEAREST WATER SOURCE: >1,000' NEAREST SURFACE WATER: <1,000' NMOCD TPH CLOSURE STD: 1,000 ppm
