Pit, Below-Grade Tank, or
Proposed Alternative Method Permit or Closure Plan Application

Burlington Resources Oil & Gas Company, LP
San Juan Basin
Below Grade Tank Closure Report

Lease Name: Dallabetta 1
API No.: 30-045-07937

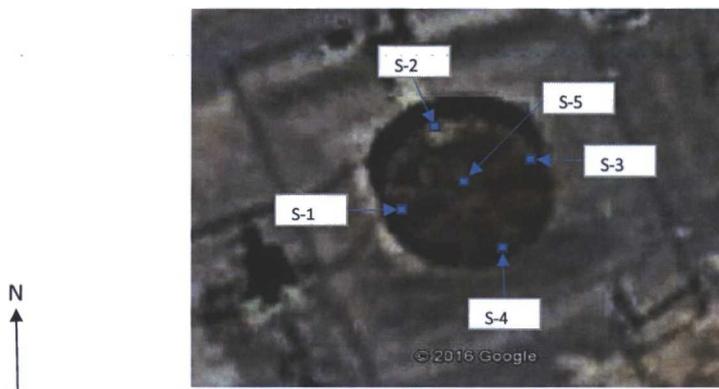
SC-1 is a 5-point composite of S-1 through S-5, collected 0.5 ft below BGT. Sample SC-1 was laboratory analyzed for TPH (8015), BTEX (8021) and chlorides (300.0).
