Pit, Below-Grade Tank, or  
Proposed Alternative Method Permit or Closure Plan Application

BELOW-GRADE TANK CLOSURE PLAN

Fields A 001A

API No. 3004522398

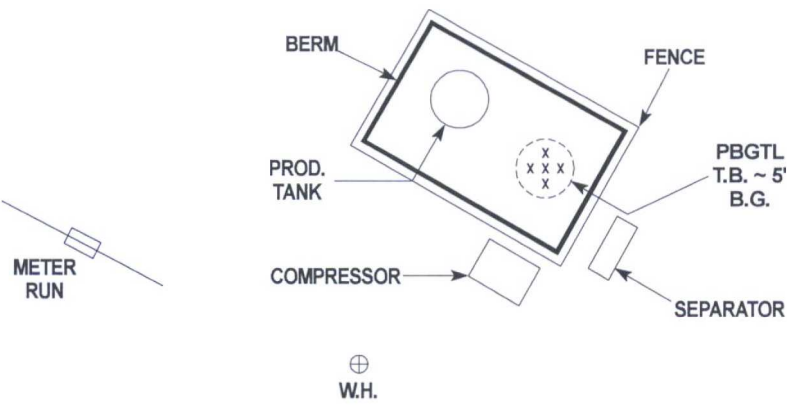
| <b>SITE SKETCH</b> | BGT Located : off / <u>on</u> site PLOT PLAN circle: <u>attached</u><br> |

| <b>SITE OBSERVATIONS:</b> | LOST INTEGRITY OF EQUIPMENT: YES <u>NO</u> EXPLANATION -<br>APPARENT EVIDENCE OF A RELEASE OBSERVED AND/OR OCCURRED: YES <u>NO</u> EXPLANATION:<br>EQUIPMENT SET OVER RECLAIMED AREA: YES <u>NO</u> EXPLANATION - <b>105 BBL SHALLOW LOW PROFILE ABOVE-GRADE TANK TO BE SET ATOP BGT LOCATION.</b><br>OTHER: |

| SOIL IMPACT DIMENSION ESTIMATION: <u>NA</u> ft. X <u>NA</u> ft. X <u>NA</u> ft. EXCAVATION ESTIMATION (Cubic Yards): <u>NA</u><br>DEPTH TO GROUNDWATER: <u>&lt;100'</u> NEAREST WATER SOURCE: <u>&gt;1,000'</u> NEAREST SURFACE WATER: <u>&lt;1,000'</u> NMOCD TPH CLOSURE STD: <b>100</b> ppm |

| <b>NOTES:</b> BGT = BELOW-GRADE TANK; E.D. = EXCAVATION DEPRESSION; B.G. = BELOW GRADE; B = BELOW; T.H. = TEST HOLE; ~ = APPROX.; W.H. = WELL HEAD; T.B. = TANK BOTTOM; PBGTL = PREVIOUS BELOW-GRADE TANK LOCATION; SPD = SAMPLE POINT DESIGNATION; R.W. = RETAINING WALL; NA = NOT APPLICABLE OR NOT AVAILABLE; SW - SINGLE WALL; DW - DOUBLE WALL; SB - SINGLE BOTTOM; DB - DOUBLE BOTTOM. | <b>MISCELL. NOTES</b><br>WO:<br>REF. #: <b>P-686</b><br>VID: <b>VHIXONEVB2</b><br>PJ #:<br>Permit date(s): <b>06/03/10</b><br>OCD Appr. date(s): <b>04/08/16</b><br>Tank ID: <b>A</b> OVM = Organic Vapor Meter ppm = parts per million<br>BGT Sidewalls Visible: Y / <u>N</u><br>BGT Sidewalls Visible: Y / N<br>BGT Sidewalls Visible: Y / N<br>Magnetic declination: <b>10° E</b> |

| NOTES: <b>GOOGLE EARTH IMAGERY DATE: 3/15/2015.</b> | ONSITE: <b>03/24/17</b> |
