Pit, Below-Grade Tank, or  
Proposed Alternative Method Permit or Closure Plan Application

**Burlington Resources Oil & Gas Company, LP**  
**San Juan Basin**  
**Below Grade Tank Closure Report**

**Lease Name: Atlantic 13**  
**API No.: 30-045-23283**

**BGT CLOSURE AND RELEASE ASSESSMENT SAMPLE LOCATIONS AND RESULTS NOVEMBER 2016 THROUGH FEBRUARY 2017**  
 ConocoPhillips  
 ATLANTIC 13  
 SW¼ SE¼, SECTION 23, T31N, R10W  
 SAN JUAN COUNTY, NEW MEXICO  
 N36.87965, W107.84867

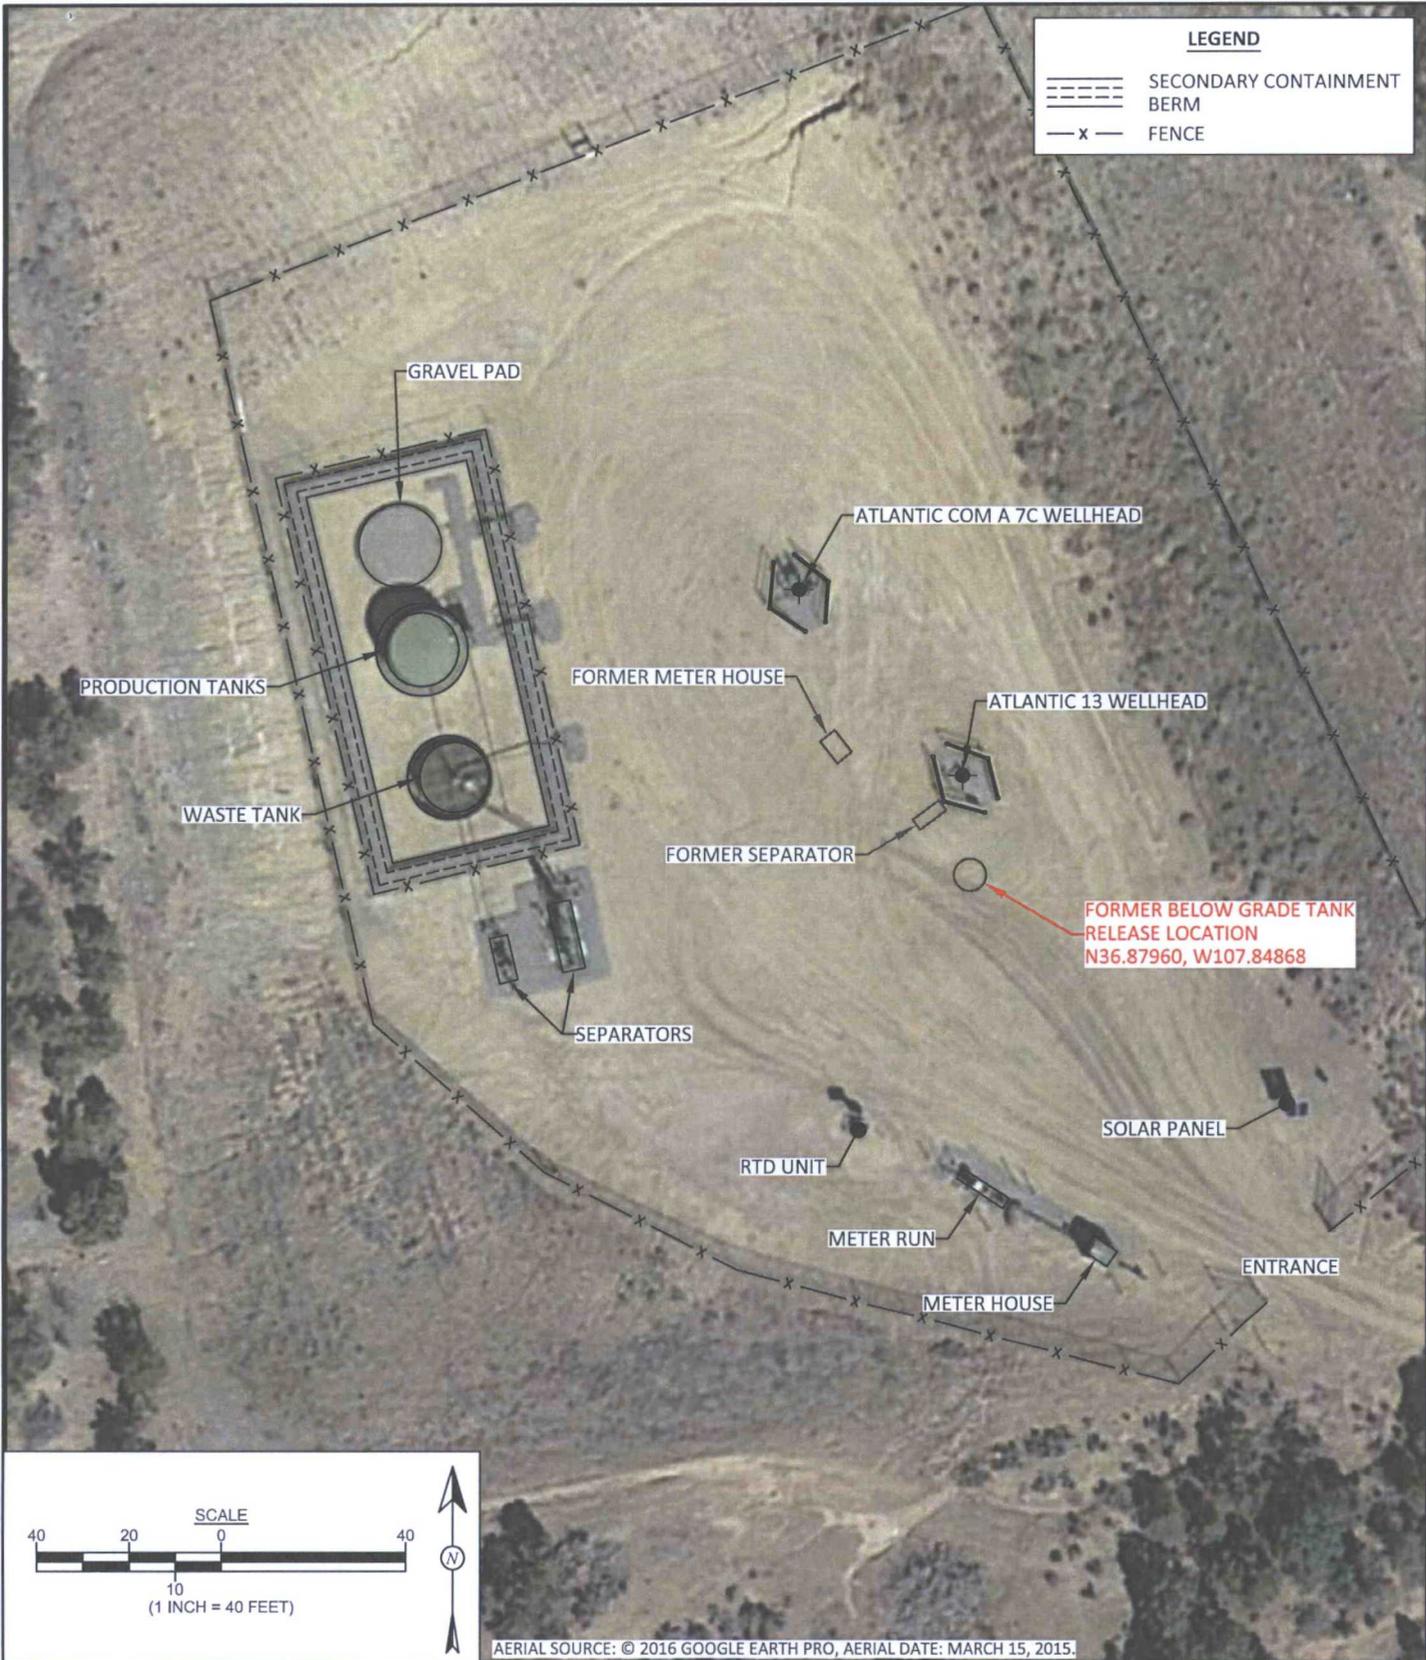
**FIGURE 2**

**AERIAL SITE MAP  
2016 AND 2017**  
ConocoPhillips  
ATLANTIC 13  
SW¼ SE¼, SECTION 23, T31N, R10W  
SAN JUAN COUNTY, NEW MEXICO  
N36.87965, W107.84867

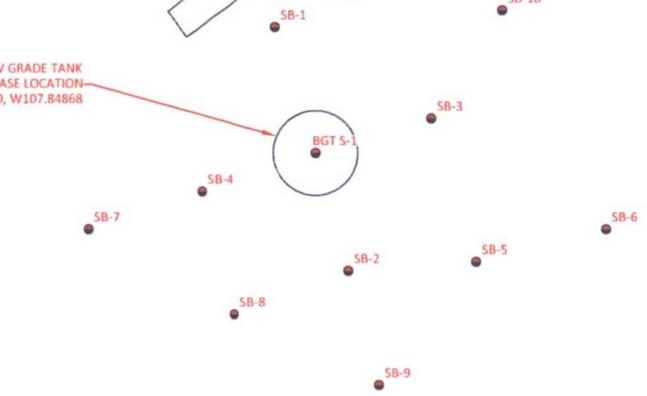
**FIGURE 3**

On December 21, 2016, and February 10, 2017, AES personnel returned to the location to complete the release assessment field work. The assessment included collection and field sampling of 20 samples from 10 soil borings (SB-1 through SB-10). Based on field sampling results, AES recommended excavation of the release area. Sample locations are shown on Figure 3.

concentration was reported in SB-5, with a concentration of 21,400 mg/kg TPH. Excavation of the release area was recommended.

Based on the final field sampling and laboratory analytical results of the excavation of petroleum contaminated soils at the Atlantic 13, benzene and total BTEX were below the applicable NMOCD action levels for the final base and sidewalls. TPH concentrations for the excavation side walls were also below NMOCD action levels. However, TPH exceeded the NMOCD action level for the base (SC-5) which was terminated on sandstone. However, NMOCD granted approval to spray the excavation with a potassium permanganate solution and backfill the excavation, and no further work is recommended.

1. NMOCD APPROVED APPLICATION OF POTASSIUM PERMANGANATE SOLUTION AND BACKFILL OF EXCAVATION.
