Pit, Below-Grade Tank, or
Proposed Alternative Method Permit or Closure Plan Application

1.
Operator: ConocoPhillips Company OGRID #: 217817
Address: PO BOX 4289, Farmington, NM 87499
Facility or well name: SAN JUAN 28-7 UNIT NP 109
API Number: 30-039-07036 OCD Permit Number: _____
U/L or Qtr/Qtr N (SESW) Section 18 Township 27N Range 7W County: Rio Arriba
Center of Proposed Design: Latitude 36.5679630 °N Longitude -107.6198955 °W NAD: 1927 1983
Surface Owner: Federal State Private Tribal Trust or Indian Allotment

ConocoPhillips Company
San Juan Basin: New Mexico Assets
Below Grade Tank Closure Report

Lease Name: San Juan 28-7 Unit NP 109
API No.: 30-039-07036

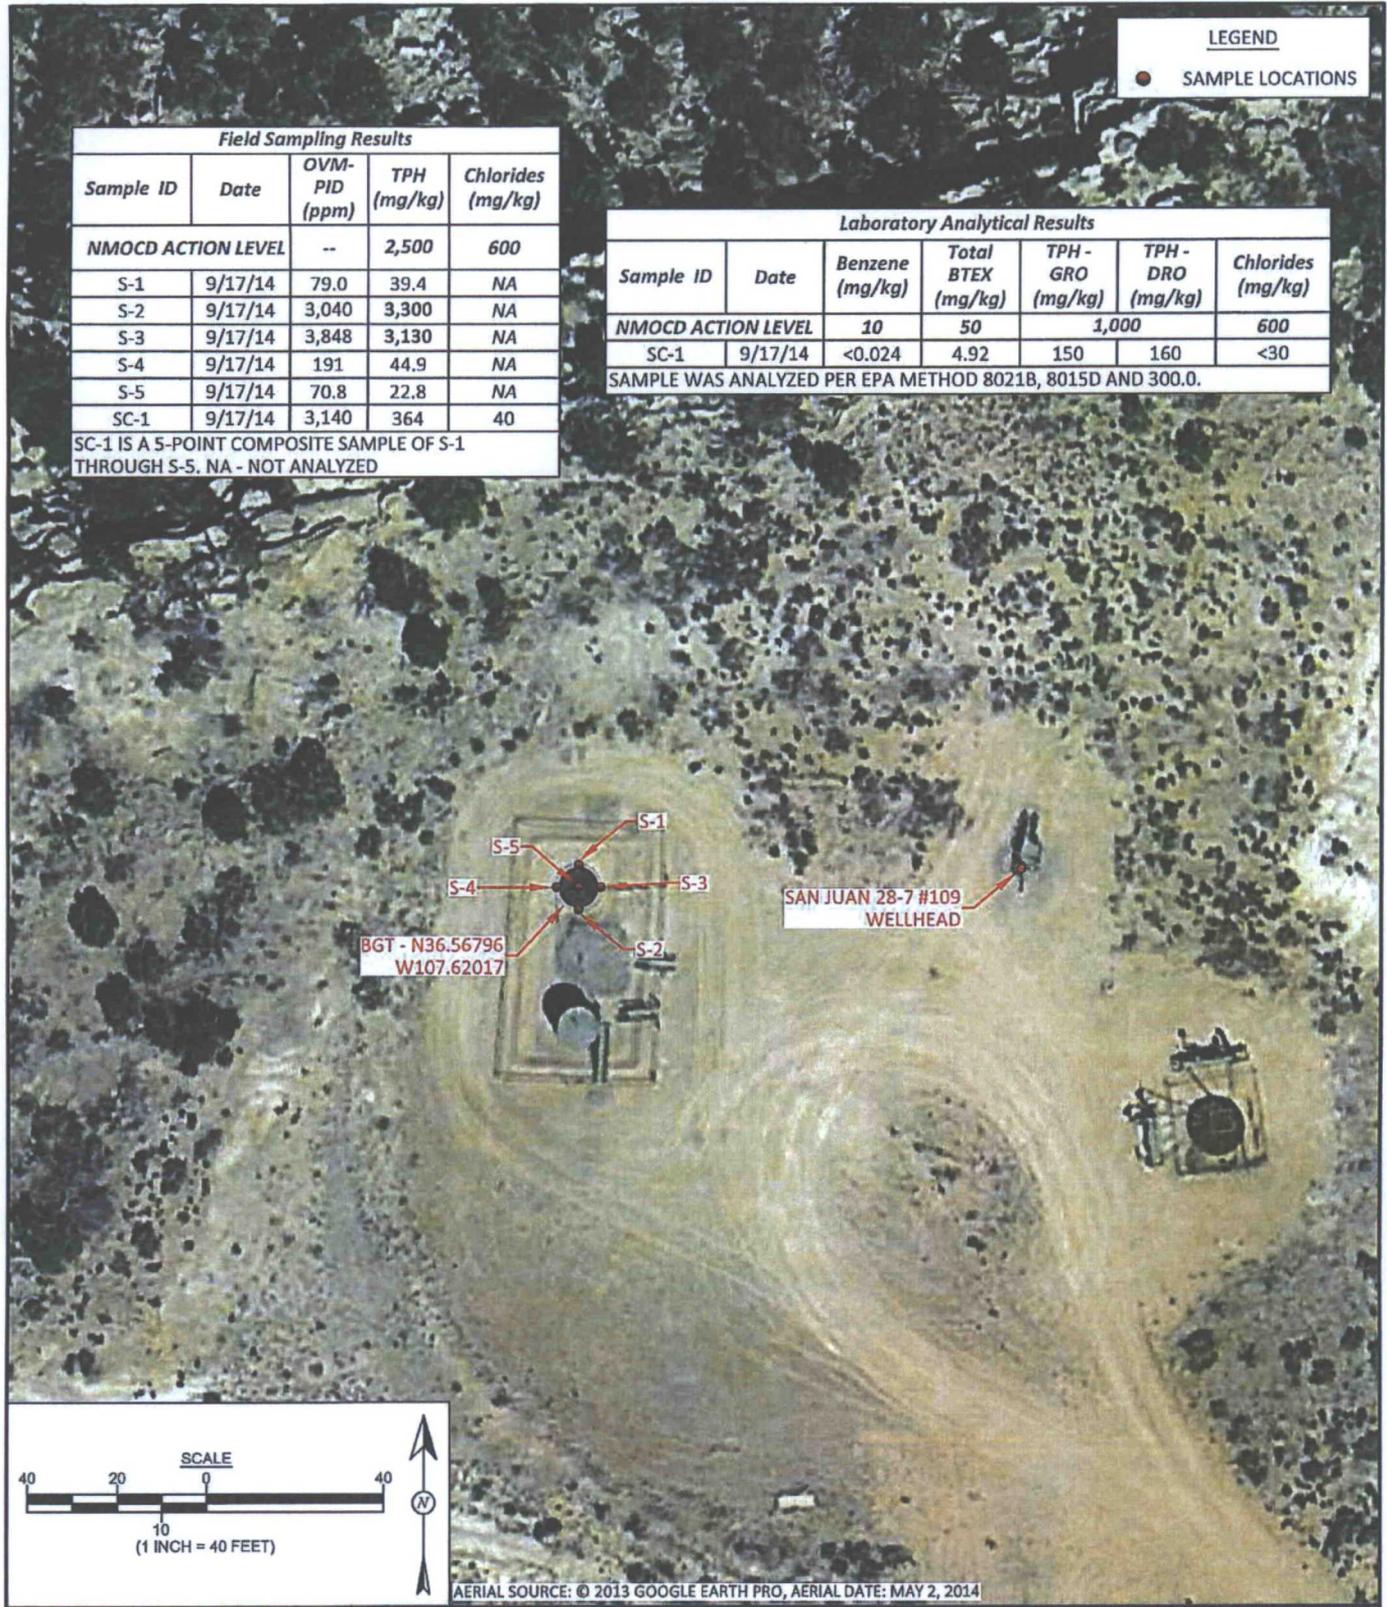
FIGURE 2
AERIAL SITE MAP
BELOW GRADE TANK CLOSURE
SEPTEMBER 2014
 ConocoPhillips
 SAN JUAN 28-7 #109
 SE¼ SW¼, SECTION 18, T27N, R7W
 RIO ARriba COUNTY, NEW MEXICO
 N36.56797, W107.61985

Laboratory Analytical Results						
Sample ID	Date	Benzene (mg/kg)	Total BTEX (mg/kg)	TPH - GRO (mg/kg)	TPH - DRO (mg/kg)	Chlorides (mg/kg)
NMOC ACTION LEVEL		10	50	1,000		600
SC-1	9/17/14	<0.024	4.92	150	160	<30

SAMPLE WAS ANALYZED PER EPA METHOD 8021B, 8015D AND 300.0.

AERIAL SOURCE: © 2013 GOOGLE EARTH PRO, AERIAL DATE: MAY 2, 2014
